Initial Wear Performance Evaluation of Partial Flange Bearing Frogs for Turnouts in Heavy Axle Load Service

Rafael Jimenez, David Davis, and Joseph LoPresti

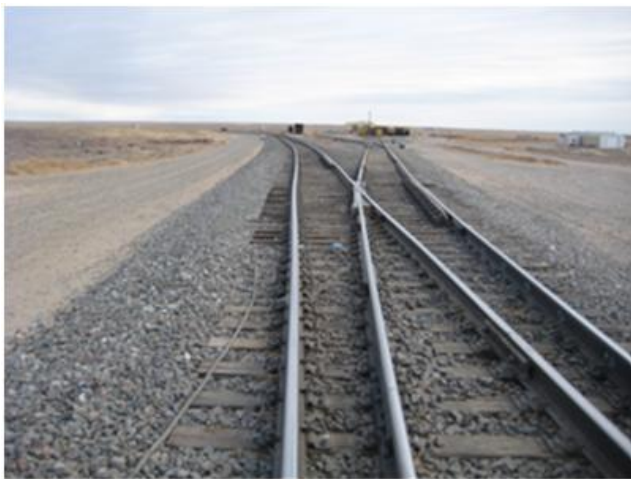
The Lift Frog in mainline service at FAST has required frequent maintenance (i.e., 25 MGT intervals) for alignment on the mainline route. The cause of the lateral alignment deviations was determined to be mainline flangeway guard strikes on the frog castings. These strikes would move the frog panel laterally, eventually exceeding class 4 maintenance limits. Figure 3 shows the alignment of the frog prior to maintenance. At FAST, the frog is in a short tangent between curves of opposite direction. Thus, in one direction, the

wheelsets may still be flanging the rail opposite the frog, and they would more likely come in contact with the flangeway guard.

In addition, the guard flare on the heel end of the mainline route casting is shorter than modern mainline standards. The flare, from 3-1/2 inches to flangeway width of 1-7/8 inches, occurs in about 24 inches. As a result of this test, the railway track standards engineers and the frog suppliers are redesigning the guard flare to decrease the angle of attack wheels will encounter. The new design will reflect entry designs used on frog guard rails,² with longer flares and curved shapes. Additional analysis is being conducted to determine if the lateral alignment issue is wholly or partially related to the particular configuration of test location at FAST. This will guide designers about any future changes needed for lateral panel stability. An additional *Technology Digest* is being planned.

Figure 3. View of FAST No. 11 Lift Frog Mainline Alignment Deviation

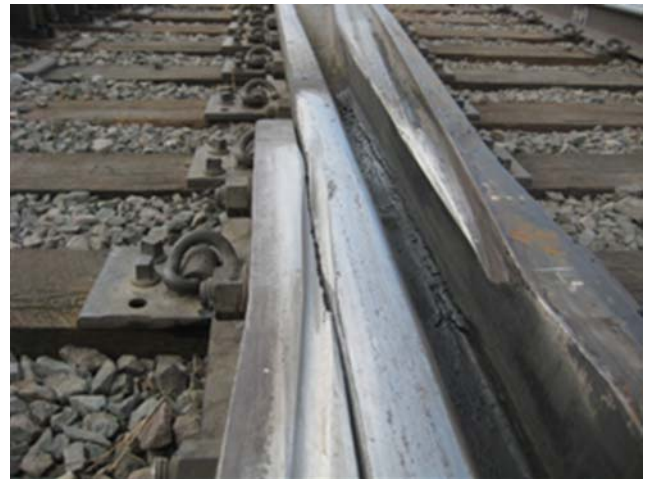
A groove has been worn in the mainline rail from the diverging traffic. The diverging traffic in this test consists of 315,000-pound cars operating at 10-15 mph. Diverging traffic is about 2 percent of the mainline traffic. Figure 4 shows the running surface groove. The groove is from flange bearing metal flow and wear. As the photo shows, the groove extends to about the middle third of the railhead from the field side. In trailing point diverging moves, most wheels have transitioned onto their treads, riding on the sloped running surface to the right of the flangeway (in this photo) beyond that point. The groove has had minimal effect on ride quality over the mainline side of the frog. The mainline running surface wear rate is high enough to erase the groove worn by any wheels still flange bearing beyond this point. Thus, cone shaped profile wheels running on the mainline have the properly shaped rail (from centerline to gage corner) to run on. The train at FAST has few wheels with revenue service hollow worn profiles. If a wheel was riding on the field side false flange of a hollow worn profile, it may experience some

dynamic forces in crossing this groove. Of course, the same wheels experience dynamic forces at the easers on the ends of most conventional frogs now.

Figure 4. Cross Grooving in Flange Bearing Turnout Frog

A time series of running surface profiles were taken on each frog to determine the vertical height loss rates of each frog. The flange bearing vertical height loss (i.e., wear) rate of the austenitic manganese steel frog castings exceeds the tread bearing wear rate for the same traffic. A cross groove has developed where the diverging traffic runs over the mainline rail in flange bearing. The 2 percent diverging traffic is sufficient to wear a groove in the mainline running rail field side. The mainline traffic tread bearing wear is insufficient to remove this groove entirely.

To date, the groove has had no noticeable effect on mainline ride quality. The groove is not present on the gage side of the mainline rail, see Figure 4. In this area, where most mainline wheels make tread contact, the tread bearing wear rate is sufficient to remove the wear caused by flange bearing.

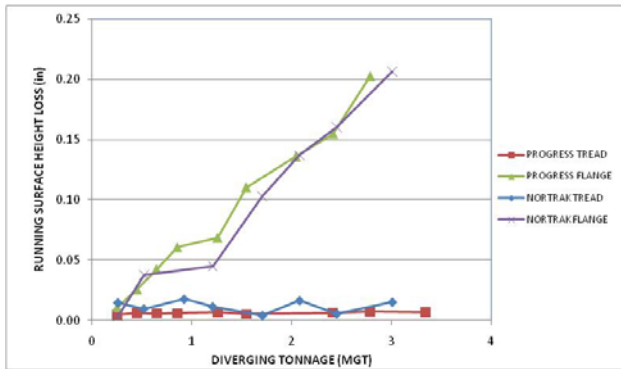
For the case where only diverging route moves were operated at 10 mph, the running surface height loss rates were compared. The flange bearing surface height loss rate is 10-25 times higher than the tread bearing rate. Figure 5 shows the calculated vertical height loss of flange and tread bearing running surfaces of each frog.

Figure 5. Comparison of Tread and Flange Bearing Running Surface Wear Rates on Turnout Frogs at FAST

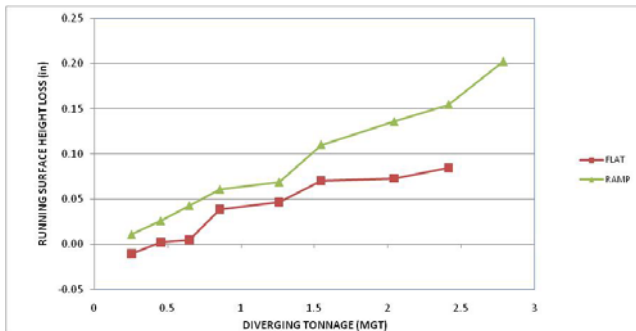
Further analysis of the running surface profiles shows that flange bearing wear rate is highest in the ramp portions of the frogs. Figure 6 shows a comparison of running surface height loss on the ramped and flat portions of the flange bearing running surfaces on the Lift Frog. Note that the wear rate is about 50 to 80 percent higher in the ramped portion. It also appears the flat portion wear rate decreased after about 2 MGT of diverging traffic.

Figure 6. Flange Bearing Wear Rates: Ramp and Flat Sections
