## Vertical and Lateral Movement of a Partial Flange Bearing Frog under HAL Traffic at FAST

Rafael Jimenez, David Davis, and Joseph LoPresti

### Summary

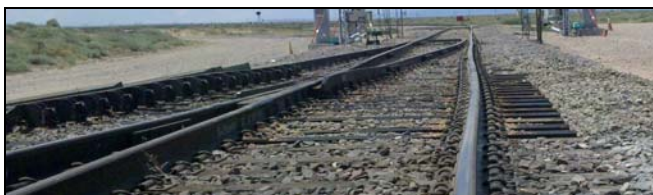
The lateral misalignment in the frog area, shown in Figure 2, occurred as a result of regular HAL traffic at turnout No. 405. The frog has required maintenance for realignment at about 25 MGT intervals during a period of performance of 240 MGT of accumulated tonnage over the main line and about 3 MGT through the turnout. Visual inspection pointed to lateral wheel impacts at the flair of the frog’s guard during mainline trailing-point operations as possibly the primary cause of the misalignment problem.

**Figure 2. Lateral Misalignment in the Area of the Partial Flange Bearing Frog from HAL Train Operations on the HTL**

On September 17, 2010, the transition between the flair of the guard and the main part of the guard was ground in an effort to reduce the severity of the wheel impacts. On October 12, 2010, a 26-foot guardrail was installed in open-track about 50 feet ahead of the frog heel to help guide the wheels away from the frog guard. Neither of these potential remedies eliminated the misalignment problem.

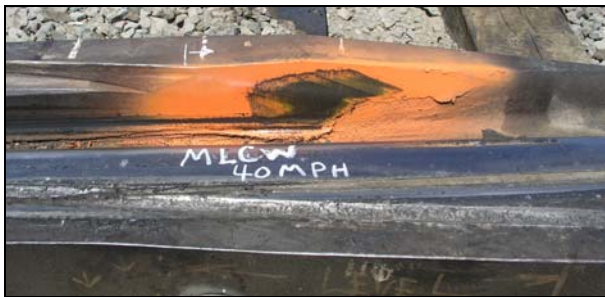
The LVDTs measured the vertical and lateral displacements in the frog area as the test train traveled in trailing point and facing point directions on the main line and as it diverged off the HTL (facing point) and back onto the HTL (trailing point). See Figure 1. Figure 4 shows the contact band (lower area of orange painted section), where the back of the wheels made contact along the main frog guard when the train was

operating in the facing point direction. In the trailing point direction, the wheels impact the flair at the end of the contact band and just above it. In both cases, the train was running on the main line. As indicated in the photograph, wheel impact on the flair of the frog in the trailing point direction occurred even at 40 mph coming out of the curve. The frog and its guard are on the extended high rail. This photo was taken during the vertical/lateral measurement test, before the flair was ground and the 26-foot open-track guardrail was installed.

Figure 4. Back of Wheel Impact Location on the Flair of the Frog Guard while running on the Main Line at 40 mph in Trailing Point Direction

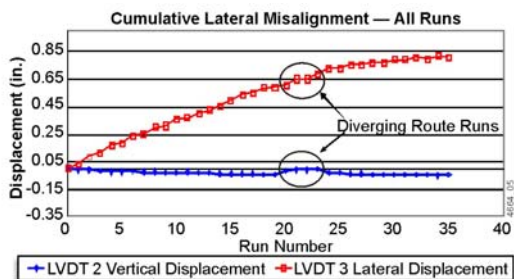
Figure 5 shows the cumulative lateral displacement (permanent misalignment) and the vertical displacement resulting from all the runs, including four runs on the diverging route, as a function of runs over the frog. Figure 5 shows that the track moved toward the main line as expected. Total movement was just under 0.85 inch. The slope of the curve suggests that the diverging runs (runs 20 through 23) and the main line runs contributed similarly to the permanent misalignment of the frog area. The upward shift in the vertical displacement during the turnout moves is likely the result of upward teetering as the train ran with wheels over the frog and the turnout rail. When the mainline passes resumed with run 24, where the train returned to running with wheels over the frog and the mainline rail, the vertical curve shifted back down indicating the mainline running rail resettled (the LVDTs were mounted on the mainline rail). By about run 25, it appears the track structure was approaching the maximum possible permanent misalignment as indicated by the shallowing slope.

Figure 5. Cumulative Lateral Displacement (permanent misalignment) and Vertical Displacement resulting from All Runs over the Frog

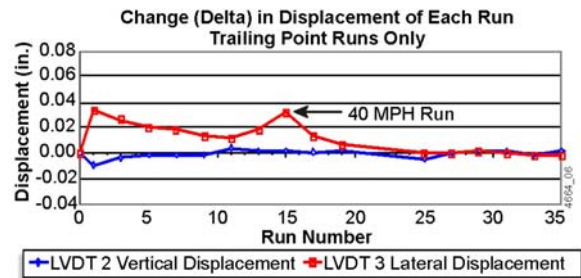
in lateral position before and after the run). The odd number runs were in the trailing point direction (direction of wheel impact), and the even number runs were in the facing point direction. Note that the two locomotives were leading in the trailing point direction and the three loaded cars were leading in the facing point direction. Figure 6 shows the change in vertical and lateral displacement for the trailing point mainline runs only. The spike at run 15 of the lateral displacement curve coincides with the 40 mph run. Run 13 was at 29 mph (all other runs were at 20 mph; the turnout runs were at 10 mph).

Figure 6. Change in Vertical and Lateral Displacement resulting from Each Trailing Point Run over the Frog on the Main Line

A comparison of Figures 6 and 7 indicates that the mainline runs over the frog in the facing point direction contributed more to the permanent misalignment in the frog area than the runs in the trailing point direction. It appears the permanent displacement resulting from trailing point traffic reached steady state after about the 25<sup>th</sup> run.

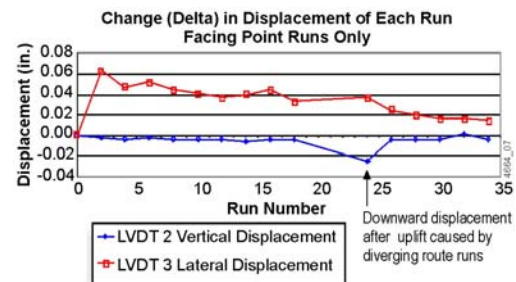
Figure 7 illustrates the same type of change in displacement data as the one in Figure 6 but for mainline runs over the frog in the facing point direction only. The diverging route data was excluded in both graphs.

Figure 7. Change in Vertical and Lateral Displacement resulting from Each CCW Run over the Frog on the Main Line

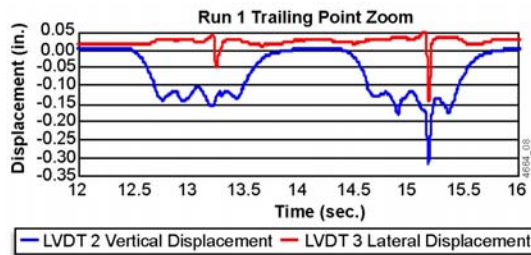
During the first run of the test (and subsequent trailing point direction runs), two wheels impacted the guard flare; they were the leading axle of the leading truck of two different cars. Figure 8 shows the two impacts recorded in the first run. Both impacts are seen as small spikes in the positive direction toward the misalignment. Immediately after each small positive spike, there is a much larger spike in the negative direction toward the frog, which was likely caused by rebound after the initial high-frequency impact. The spring strength of the LVDT may not have been adequate to keep the LVDT's plunger in contact with the surface of the steel plate as the track rebounded. This would have caused the plunger to be

launched into the LVDT tube then returning to contact the plate. The large rebound spike in the data served to pin point the wheels that impacted the guard. The permanent misalignment measured as a result of the entire first run was about 0.31 inch.

Figure 8. Zoomed-in View of the 2-Wheel Impacts Recorded during Run 1 in Trailing Point Direction

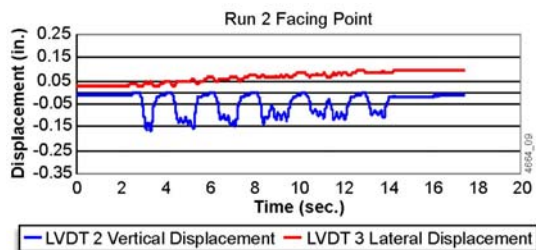
Figure 9 shows the response of the track in the frog area during the second run (facing point direction) of the test. In this run, the hits are absent but the permanent misalignment measured was about 0.062 inch, twice that of run 1.

Figure 9. Vertical and Lateral Displacement during the Second Run of the Test, Facing Point — Permanent Lateral Misalignment resulting from this Run was 0.062 inch
