Teardowns of Cars Identified by Optical Geometry Detectors

Scott Cummings, Benjamin Madrill, and Kim Bowling (CSXT)

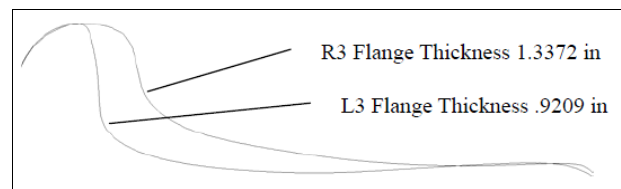
Figure 2. Asymmetric Wheel Wear¹

The transverse profile of the two wheels of a wheelset can have a large influence over the tracking position of that wheelset. Sometimes one wheel experiences significant wear in the flange and flange root while the mate wheel experiences wear primarily on the tread surface. This condition is called asymmetric wheel wear and can be quantified by comparing flange thickness or wheel tape size between wheels on the same wheelset. Wheelsets with asymmetric wheel wear force themselves into a position with lateral displacement relative to the track centerline in order to produce equivalent rolling radii on each rail of the track. Figure 2 shows an example of wheels with asymmetric wheel wear.
