Inspection Results and Impact Load History of Vertical Split Rim Wheels

Scott Cummings

Summary

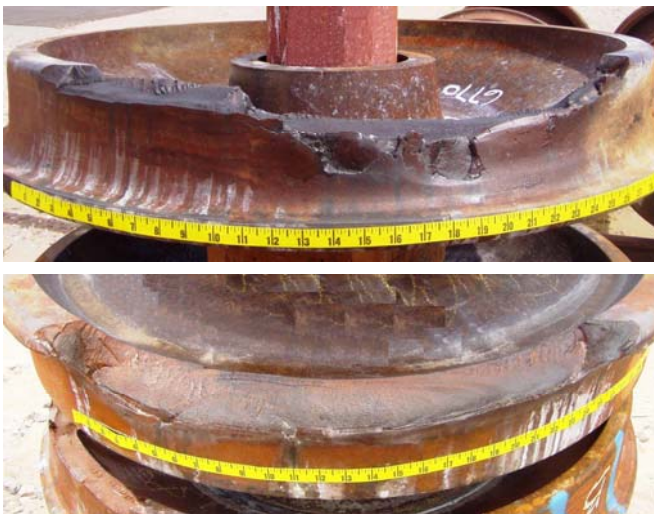
TTCI requested and received a total of 29 VSR wheels and six broken flange wheels from three different railroads to analyze the fracture surfaces and conduct laboratory tests. VSR and broken flange wheels are thought to be the result of related failure modes. Figure 1 shows photos of a VSR wheel and a broken flange wheel.

Figure 1. Wheels with VSR (Top) and Broken Flange (Bottom)

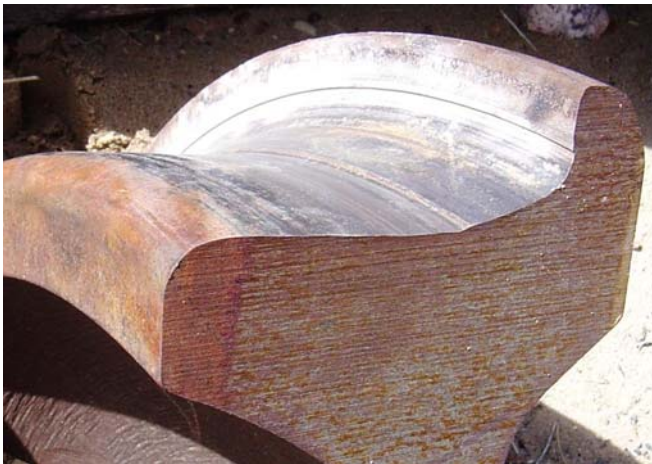
One VSR wheel was found to have a severe 0.234 inch hollow tread as the apparent result of sustained contact between the tread surface and the brake head. Figure 2 shows a cross section of this wheel. Six of the other broken wheels inspected had tread hollow ranging from 0.0195 inch to 0.117 inch.

Flange thickness of the broken wheels ranged from 1.01 inches to 1.38 inches, with a median of 1.25 inches. The VSR wheel with the brake head wear had a flange that was 0.33-inch thinner than its mate. For all of the other wheelsets inspected, the broken wheel and mate wheel had similar flange thicknesses typically within 0.1 inch. Flange height of the broken wheels ranged from 1.01 inches to 1.48 inches with a median of 1.18 inches. Flange height differences between the broken wheel and its mate were typically less than 0.05 inch and never more than 0.15 inch. Flange thickness, flange height, and tread hollow were similar between the broken flange wheels and the VSR wheels.

Figure 2. Cross Section from an Unusual VSR Wheel Showing Wear Groves in the Tread and Flange from Apparent Contact with the Brake Head

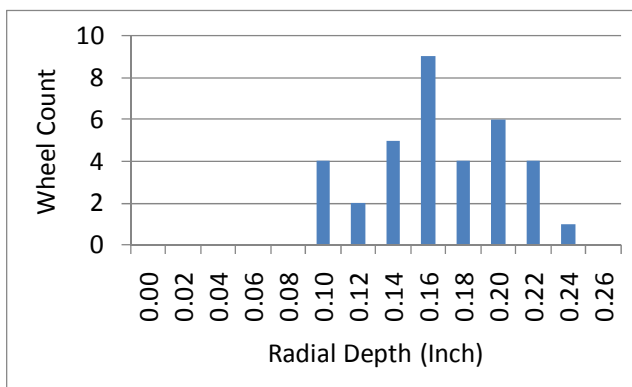
The location of the origin of the failure was determined by visually examining the failure surface. VSR and broken flange wheels usually exhibit faint markings on the failure surface that show the direction in which the crack propagated. By tracing these marks backwards, an origin point was established for each broken wheel. The radial depth of the origin point was then established relative to the existing tread surface, and the axial location was established relative to either the front rim face or the back of the flange. Origin radial depths were similar for both VSR and broken flange wheels and ranged from 0.10 inch to 0.25 inch below the tread surface, with a median value of 0.17 inch. Figure 3 shows a histogram of the origin radial depth relative to the worn tread surface. For VSR wheels, axial locations of the origin ranged from 1.25 inches to 2.60 inches from the front rim face, with a median value of 2.10 inches. For broken flange wheels, axial locations of the origin ranged from 3.00 inches to 3.75 inches from the front rim face, with a median value of 3.25 inches.

Figure 3. Histogram of Failure Origin Radial Depths

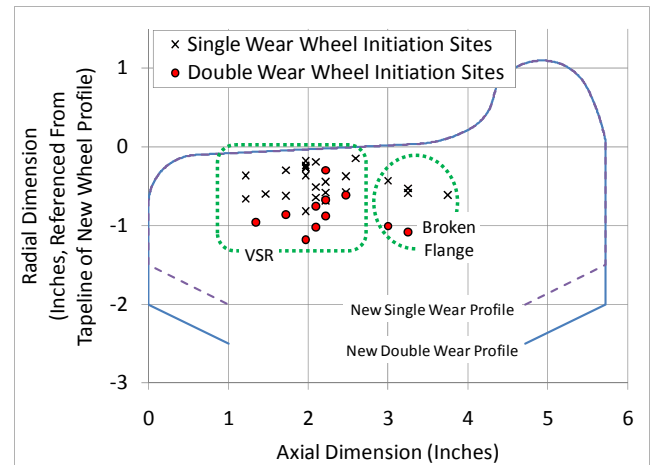
Figure 4 shows the axial and radial locations of the failure origins. The radial dimensions of this figure have been referenced to brand new wheel profiles by incorporating the origin radial depth below the worn tread surface and the tread wear as determined by the difference in the measured rim thickness from the nominal rim thickness. Although the origins are at a consistent radial depth from the worn tread

surface, the radial depth varies considerably when referencing the new wheel tread surface. This is an indication that broken wheels are not typically the result of microstructures such as bainite or martensite that can inadvertently be formed near the tread surface from the quenching operation during the manufacturing heat treatment.

Figure 4. Origin Locations Relative to New Wheel Profiles – Note: This Figure Does Not Indicate the Radial Depth Relative to the Worn Wheel Tread Surface

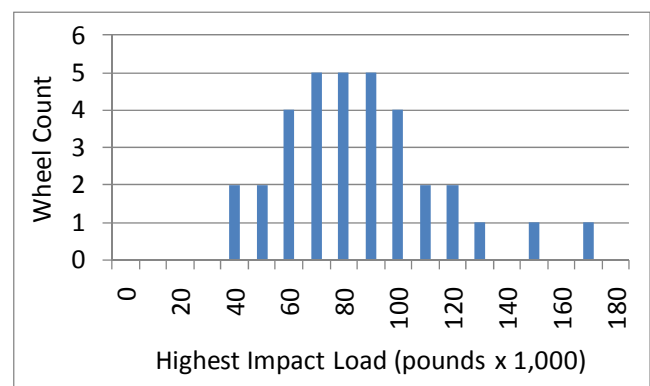
The wheel impact load detector (WILD) data history from each broken wheel was queried from InteRRIS®. Figure 5 contains a histogram of the highest impact load for each broken wheel up to and including the official failure date. For some wheels, the failure may have occurred prior to passing a WILD site; and therefore, the impact load would indicate the conditions after the failure rather than the conditions immediately prior to failure. Sixteen of the broken wheels analyzed had exceeded the AAR condemning limit of 90,000 pounds impact load prior to removal.

Figure 5. Histogram of WILD Data

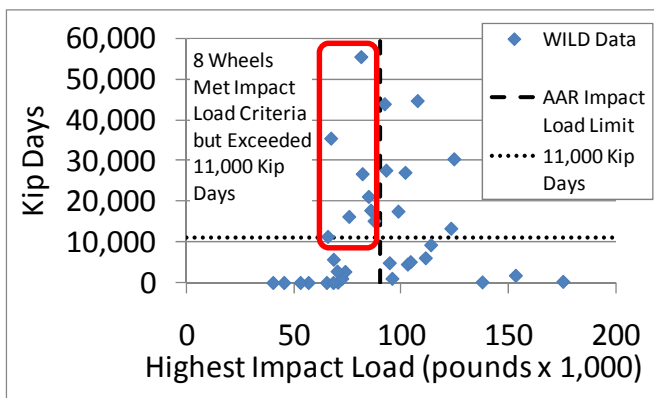
Another way to analyze WILD data is by calculating “kip days.” A kip is a unit of force equal to 1,000 pounds. The kip day calculation is a way to identify wheels that have been producing noncondemnable impact loads for a long time. A wheel begins accumulating kip days the first time it exceeds 30,000 pounds dynamic load (i.e., maximum impact load minus average load). Each day thereafter, the highest impact load (in kips) experienced by that wheel is added to the kip days total for the wheel. For example, a wheel with a maximum impact load of 70,000 pounds would have a daily accumulation of 70 kip days. The kip days total for a wheel is set back to zero when the wheelset is changed. One railroad has suggested that 11,000 kip days could be used as a limit. A wheel with a 65,000-pound maximum impact load would accumulate 11,000 kip days in just less than 6 months. Figure 6 shows that if an 11,000 kip day removal criteria was used as well as the current 90,000-pound impact load limit, 24 of the 35 broken wheels would have been condemnable based on WILD readings.

Figure 6. Kip Days and Highest Impact Loads

The kip days calculation is one way to monitor the overall damage sustained by a wheel rather than just the maximum impact load produced. Because different cars move different distances per month, the kip days criteria could give similar values for a car that had traveled 50,000 miles with 65 kip impacts and a car that had traveled 1,000 miles with 65 kip impacts. A distance-based parameter may be more effective than a time-based parameter at identifying wheels sustaining a large number of cycles of impact load. A kip miles criteria could be used to evaluate wheels once suitable data collection and storage of individual car mileage becomes available. Such a database is expected from Railinc in 2011.
