# Ultrasonic Inspection and Subsurface Cracking of Vertical Split Rim Wheels

Scott Cummings

## Summary

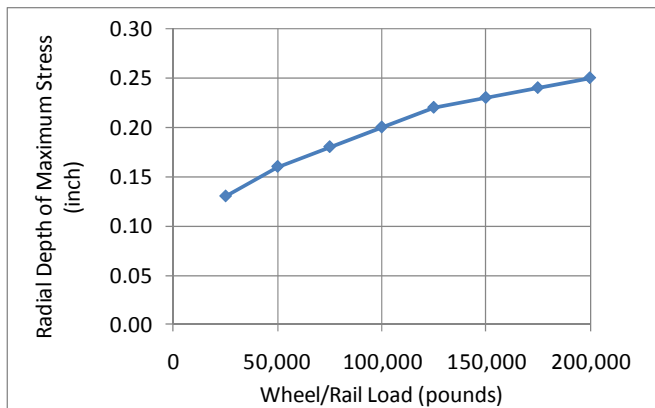
VSR and broken flange wheels are thought to be related failure modes, both the result of cracking of the wheel rim. (See Figure 6, page 4, for profile sketches of VSR and broken flange wheels). Cracks develop and propagate in the presence of large stresses. Hamilton<sup>1</sup> developed explicit formulas for calculating the subsurface stress fields due to contact of objects such as wheels and rails. Over the wheel load range of 25,000 pounds to 200,000 pounds and in the absence of tangential forces, the maximum Von Mises stress in the wheel due to contact with the rail is located approximately 0.14 to 0.25 inch deep relative to the surface of the tread. Figure 1 shows the relationship between the wheel/rail contact load and the radial depth of the maximum stress using Hamilton’s equations and assuming a new 36-inch diameter wheel in Hertzian contact with a 14-inch crown radius rail. Tangential wheel/rail forces reduce the depth of the maximum stress. Increased contact patch size from causes, such as hollow wheel wear and/or flattened rail crowns, increase the depth of the maximum stress.

Figure 1. Radial Depth of Maximum Stress Related to Wheel/Rail Load

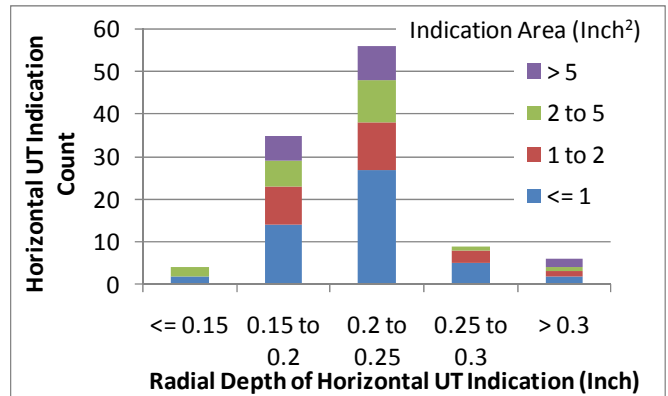
A total of 111 horizontal UT indications were found on 27 of the 35 broken wheels. No horizontal UT indications were found on the other 8 broken wheels. The UT indications are considered subsurface cracks rather than manufacturing defects, such as voids or inclusions, because of their large size. The horizontal UT indications ranged in size from 0.1 in<sup>2</sup> to 24.7 in<sup>2</sup> with a median value of 1.3 in<sup>2</sup>. The radial depth of the horizontal UT indications ranged from 0.11 inch to 0.60 inch with a median value of 0.21 inch. Figure 2 shows the depth and area of the horizontal UT indications found in the broken wheels. The majority of the horizontal UT indications (83 percent) were found in the same range of radial depths as the expected maximum stress and the failure origins.

Figure 2. Size and Depth of Horizontal UT Indications

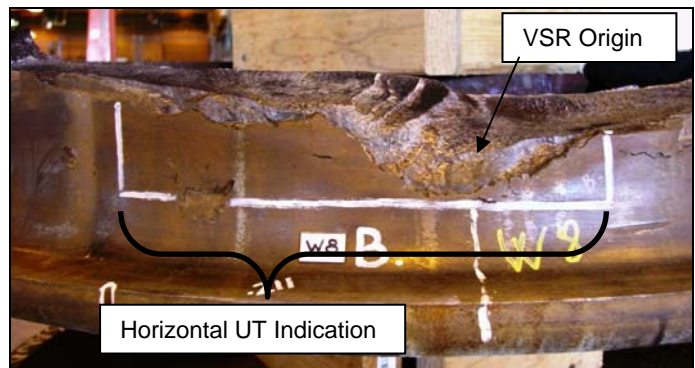
Horizontal UT indications were found in the immediate vicinity of the failure origin on 13 of the broken wheels. Figure 3 shows an example of a broken wheel with a large horizontal UT indication (outlined in white paint) surrounding the VSR origin.

Figure 3. VSR Wheel with a Large Horizontal UT Indication Surrounding VSR Origin

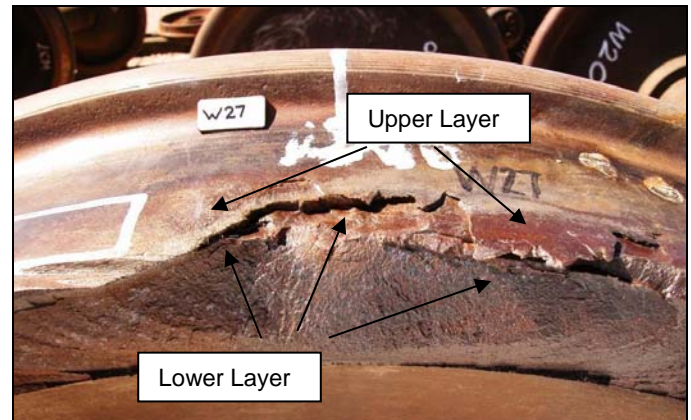
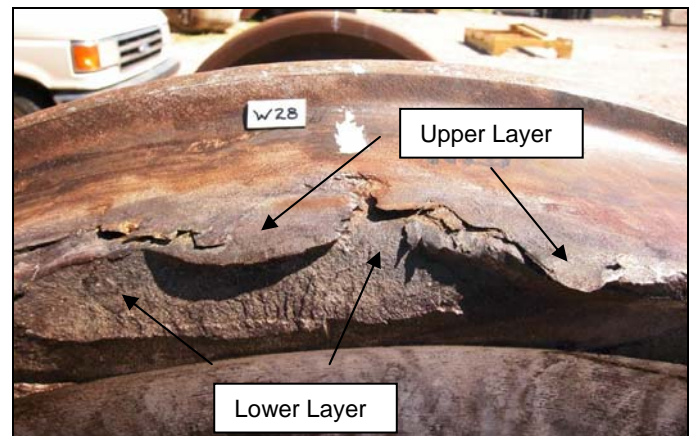
A common feature found on many of the broken wheels was a horizontal (approximately parallel to the tread surface) separation between two visually distinct layers in the wheel rim. Figure 4 shows examples of two VSR wheels with distinct upper and lower layers in the rim. The upper layer is typically no more than 0.25 inch thick and the lower layer is comprised of the remainder of the rim thickness. The vertical crack does not extend directly across the horizontal separation. In some wheels, the upper layer extends axially past (overhangs) the VSR crack in the lower layer. In other broken wheels, the opposite is found: the horizontal surface of the lower layer is exposed because the upper layer has shelled out or broken off above it. For both wheels pictured in Figure 4, the upper layer overhangs the VSR crack in some circumferential locations and has broken off the lower layer at other locations.

Figure 4. Examples of VSR Wheels with Two Distinct Horizontal Layers in the Rim

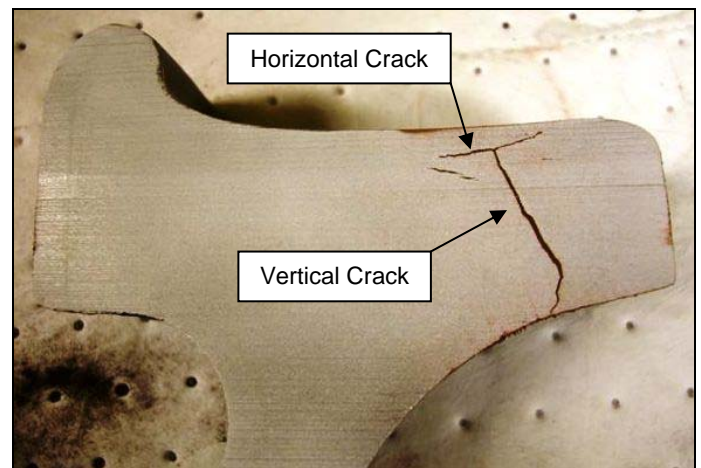
Figure 5 shows a wheel section with a horizontal crack that ranges in radial depth from about 0.1 inch to 0.25 inch below the tread surface and a vertical crack that intersects the horizontal crack at about 0.18 inch radial depth. These dimensions are typical of most of the horizontal UT indications on the broken wheels and the radial depths of the VSR origins (where the horizontal crack turned into a vertical crack). The horizontal crack in this wheel separates the upper and lower layers of the rim.

Figure 5. Branching between a Horizontal Subsurface Crack and a Vertical Crack

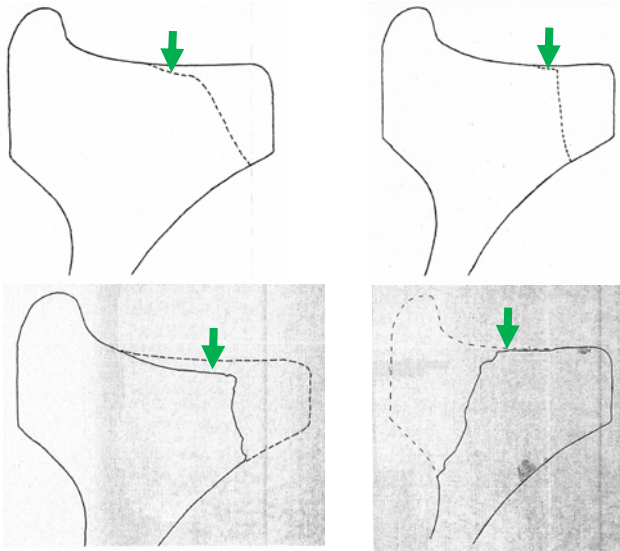
The horizontal separation of tread layers associated with VSR and broken flange wheels has been shown previously; however, it has typically been attributed to shelling rather than subsurface cracking. Berge<sup>2</sup> sketched the transverse profiles of four broken wheels and each one showed a shallow horizontal component to the vertically broken piece. Figure 6 shows these profiles.

**Figure 6. Sketches of VSR and Broken Flange Wheel Profiles Showing the Broken Piece with a Dashed Line.<sup>2</sup> (Green arrows have been added to indicate the shallow horizontal component of the broken piece.)**
