Bracing and Lateral Deflections: Vintage Steel Bridge Span at the Facility for Accelerated Service Testing

Kyle Ninness, Lucy Tunna, and Duane Otter

Summary

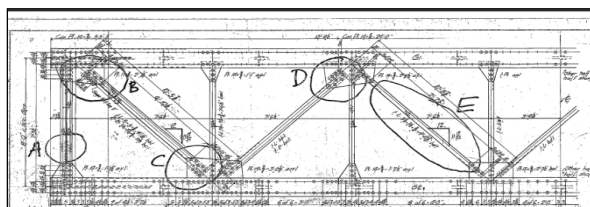
Figure 1. Plan View of Vintage Span Repair Areas

Before the vintage span could be installed in the steel bridge at FAST, an initial inspection was made. Several repairs were needed before installing the span. Figure 1 shows the areas where initial repairs were made to the top lateral bracing system.

Rusted gusset plates at locations B and C were replaced. Lateral bracing members on both ends of the bridge had broken off. The lateral braces were left off until baseline data was collected.

At Location D, the gusset plate and rivets were rusted through. Also, the rusted lateral brace was unattached. The gusset plate was replaced and

Location E completely lacked a lateral bracing member. The gusset plate was prepared for a new member to be installed after baseline data was collected.

prepared for a bolted connection for a brace after baseline data was collected.

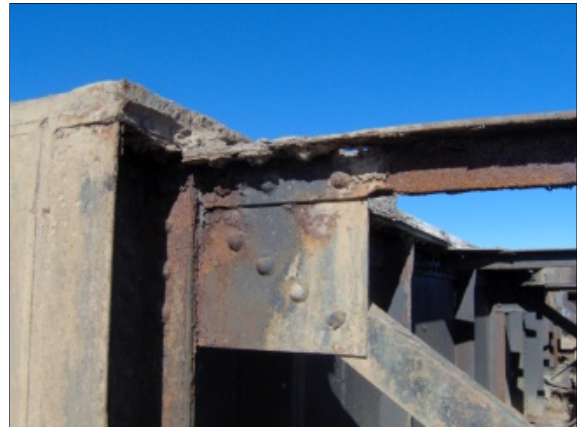
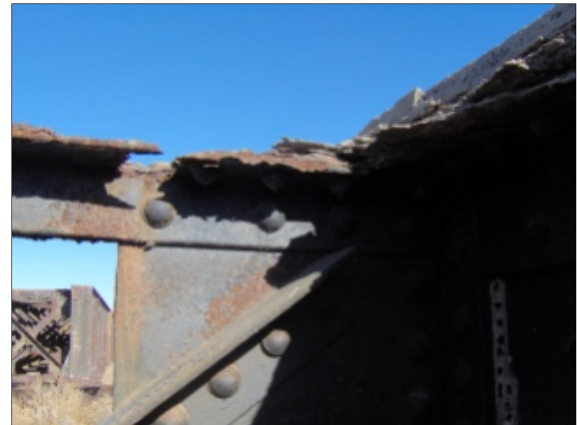
Figure 2a. Pre-existing Rusted Member

At Location A, the horizontal cross members were rusted all the way through. To correct this, the angles were replaced with the same size angle. Bolted connections were used instead of rivets. Figures 2a and 2b show the rusted horizontal member.

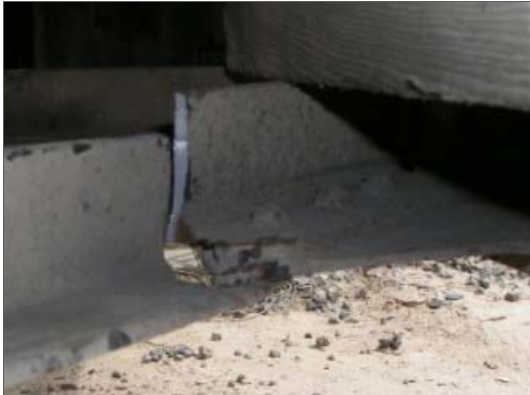
Figure 3a. Broken Member

After 72 MGT of traffic at FAST a broken bracing member was found on the vintage span. The brace was a bottom lateral angle at mid-span. It broke at the gusset plate connection to the bottom flange of the south girder. The horizontal leg of the angle, which connected to the gusset plate, was rusted through most of its cross section. There appeared to be about a 1/2-inch crack growth region near the corner of the angle. The vertical leg was fractured resulting in a pull-apart gap of about 3/16 inch. Horizontal displacement was also about 3/16 inch. Vertical displacement was about 1 inch, which was primarily due to the dead weight of the member (see Figure 3a).

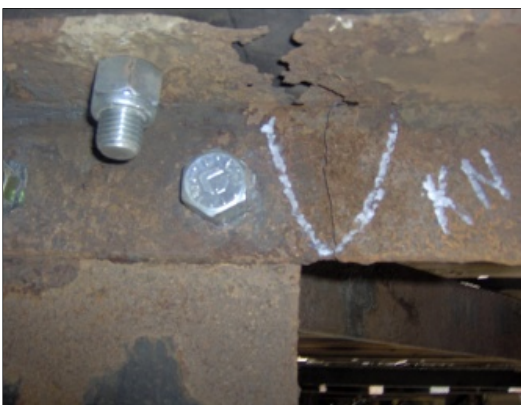
Figure 4a. Cracked Lateral Bracing Member

After 83 MGT of traffic at FAST, another broken bracing member on the vintage span was found. The brace was a top cross frame member at the east intermediate diaphragm. It broke at the gusset plate connection to the top flange of the south girder. Figure 4a shows the horizontal leg of the angle, which connected to the gusset plate, was rusted through for most of its length. The train ran one night (127 train passes) before the brace was repaired (Figure 4b). No additional damage was noted. The repair was once again a simple splice of the vertical leg of the angle.

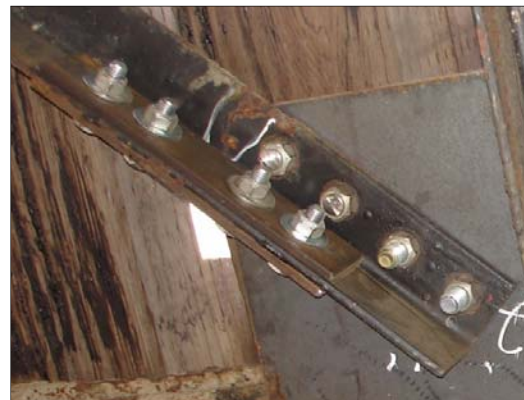
Figure 5. Splice Repair to Vertical Leg of Top Lateral Brace

After approximately 100 MGT, a splice repair was made to a top lateral brace. The horizontal leg of the brace was mostly corroded, with a crack beginning from the corrosion. The crack propagated about 2 inches into the vertical leg before repair, leaving only about 1 inch of the cross section remaining. Figure 5 shows the repair to the vertical leg.

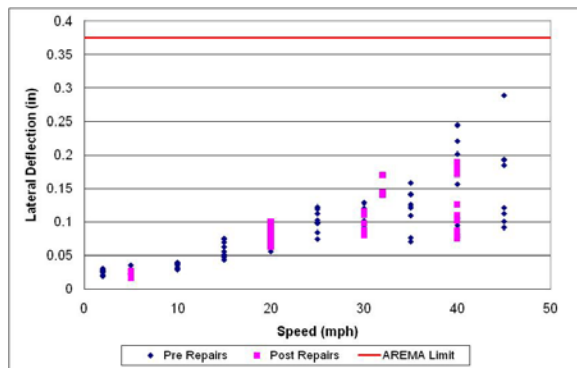
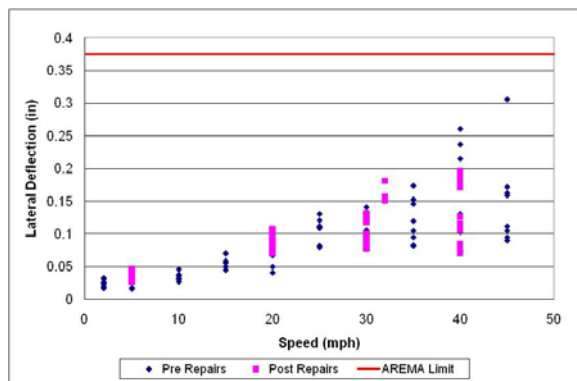
Figures 6a and 6b show the top flange lateral deflections of the north and south girders before and after repairs to the lateral bracing. As expected, the amount of deflection increased with increase in train speed. Note that the bracing limits the amount of lateral deflection. Without the bracing repairs, the maximum lateral deflections were over 30 percent higher under the HAL train (Figure 7).

Both the north and south girder measurements for lateral deflection are within the American Railway Engineering and Maintenance-of-Way Association limit of 3/8 inch.⁴ The results for lateral deflection show higher deflections than those measured on three CN steel bridges¹ despite the lateral bracing that had been repaired. The train at FAST has heavier cars, and the post-repair data was collected under the entire train of more than 100 cars. The CN data was collected at higher train speeds. A short test train was used for the CN tests.
