Revenue Service Evaluation of Steels for Flange Bearing Frog Crossing Diamonds

David D. Davis, Rafael Jimenez and
Jim Beyerl (CSX)

Summary

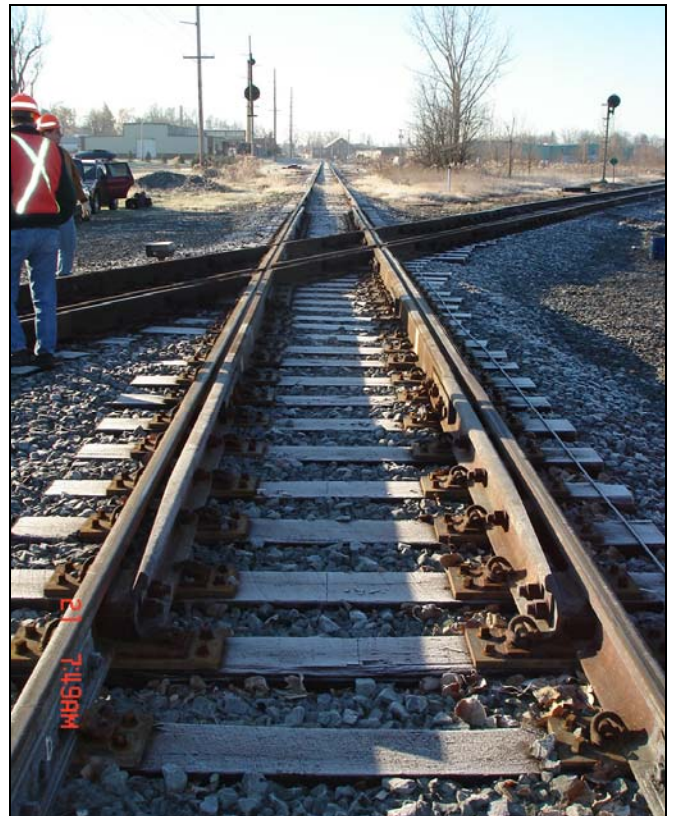
Figure 1. CSX FBF Diamond, Shelby, OH

The first full FBF crossing diamond installed in track with operating speeds above 10 mph was installed by CSX at Shelby, Ohio, in July 2006. Figure 1 shows the diamond. The performance of the diamond was very good in terms of operations, dynamic loading, and required maintenance. The diamond was operated at 40 mph on the CSX mainline side for about 4 years without any speed restrictions. No operating

issues were noted by either CSX or the Ashland Railroad, which operated across the other track of the diamond at 10 to 20 mph. Routine maintenance, such as track surfacing, was significantly reduced on the FBF diamond, as compared to maintenance required on the previous conventional tread bearing diamonds. The flange bearing design did reduce dynamic loading on the frogs as evidenced by the reduction in track settlement and reductions in noise when trains are on the diamond. The use of a hydraulic wrench to keep all bolts in the diamond properly tight also contributed to the good performance seen.

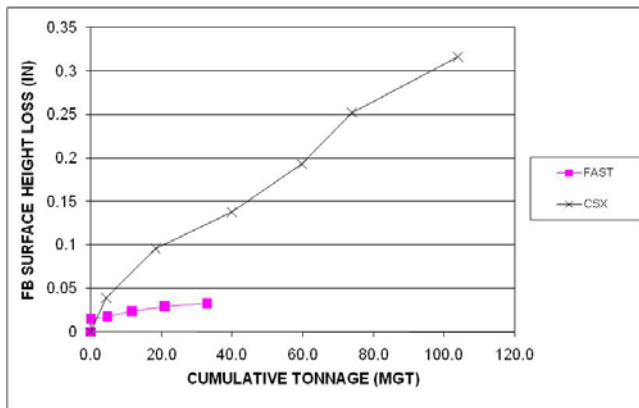
Figure 2. Flange Bearing Surface Height Loss versus Tonnage

The flange bearing running surfaces made of Hadfield’s steel or AMS (typically 1.2% carbon, 14% manganese) did not perform as well as expected, based on laboratory tests and tests at FAST. The running surface height loss (i.e., deformation) rates in the earlier tests decreased rapidly after the first few passes. In revenue service, however, the deformation rates remained nearly constant. Figure 2 shows running surface height loss versus tonnage for AMS frogs in test at FAST and in revenue service. AMS flange bearing surfaces on the CSX diamond had a wear life of about 80 MGT (0.25-inch height loss) before reverting to tread bearing. The actual diamond was in service for over 200 MGT. During some of that time, the tread running surfaces carried a significant portion of the wheels. Also the tread running surfaces were ground to provide more clearance for flange bearing after about 105 MGT of traffic.

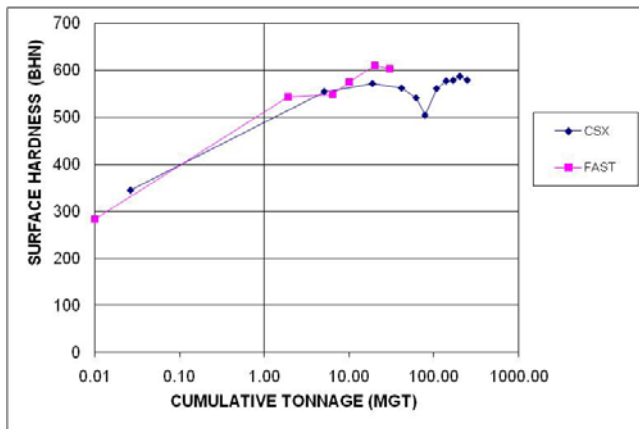
Figure 3. Flange Bearing Surface Hardness versus Tonnage

In looking at the surface hardness data from the two tests (see Figure 3), the frog materials showed the same work hardening rates. The primary variable that changed between the two tests was the wheels. At FAST, the same train accumulated all of the tonnage over the diamond. In revenue service, the CSX diamond saw a much larger population of wheels. In the tests at FAST, the wheel flanges and frog running surfaces quickly became conformal to each other. This lowered the contact stresses and the deformation rate over time. In revenue service, the frogs had nonconformal wheels running across them throughout the test.

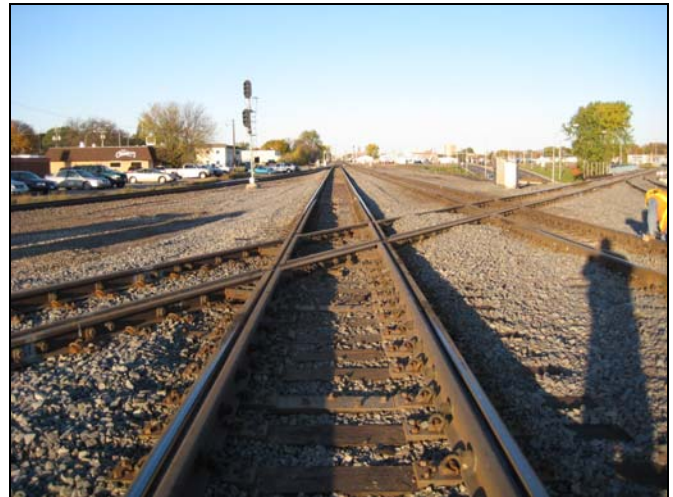
Figure 4. BNSF FBF Diamonds at Moorhead Junction, MN

The die steel material diamonds were installed in BNSF track at Moorhead Junction, Minnesota, in September 2008. Figure 4 shows the two diamonds in track.

The performance of the diamonds was very good in terms of operations, dynamic loading, and required maintenance. The diamonds were operated at 35 mph on the double track mainline and at 25 mph on the single track crossing line. Speed restrictions are in place because of adjacent curves and bridges on the two routes. No crossing diamond condition related speed restrictions have been issued in the nearly three years of operation. No operating issues were noted by BNSF on either of their two routes that cross at the diamonds. Routine maintenance, such as track surfacing, was significantly reduced on the FBF diamonds, as compared to maintenance required on the previous conventional tread bearing diamonds. The flange bearing design did reduce dynamic loading on the frogs as evidenced by the reduction in track settlement and reductions in noise when trains are on the diamonds.

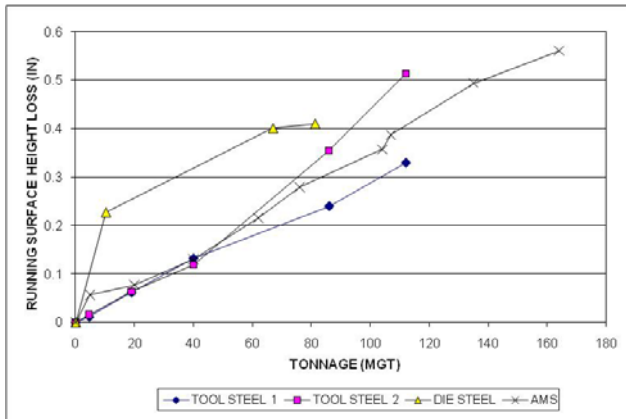
Figure 5. Candidate FBF Materials Height Loss versus Tonnage at Moorhead Junction, MN

The performance of the die steel was also disappointing. The initial height loss rates were higher than those seen on the AMS frogs. Figure 5 shows the height loss versus tonnage relationship for the die steel diamonds. The rates quickly dropped after sufficient height loss caused many wheels to revert to tread bearing across the diamond. Ultimately, the vertical height loss rate of the rail controlled the wear rates of the flange bearing surfaces. With this dual sharing of load, the reductions seen in dynamic loading and noise were largely eliminated. The diamonds began to look and sound more like tread bearing diamonds. The usual impact sounds and frog flangeway corner fatigue are now evident. The AMS frogs underwent rapid work hardening, as compared to the die steel, as Figure 6 shows.

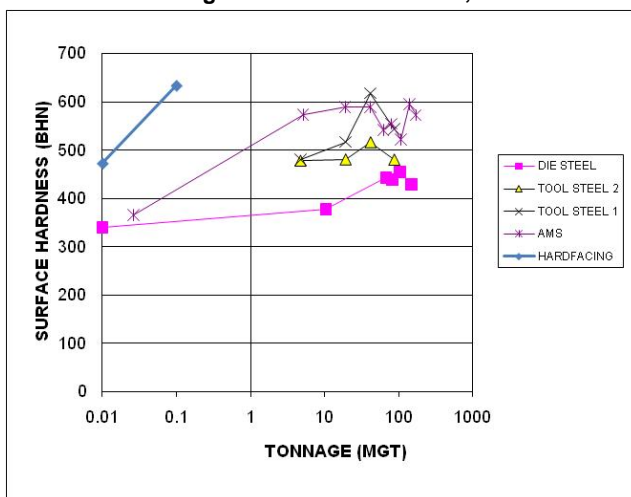
Figure 6. Candidate FBF Materials Surface Hardness versus Tonnage at Moorhead Junction, MN

The material labeled as “HARDFACING” in Figure 6 was a second iteration test panel material: Tool Steel 2 with a weld deposited surface layer of high strength steel. The running surface rapidly deteriorated as the weld deposits cracked and broke away from the Tool Steel 2 substrate within 1 MGT of service. This material was too brittle and/or incompatible with the substrate.

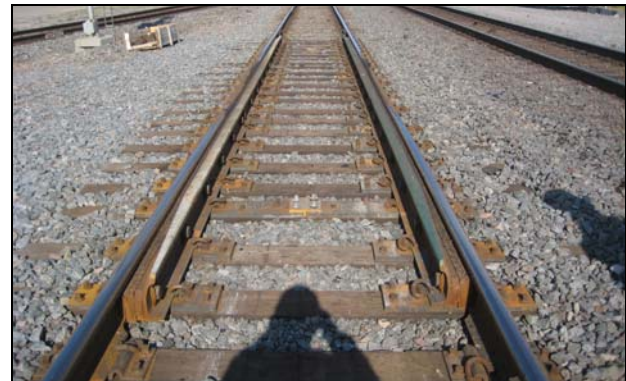
Figure 7. BNSF Flange Bearing Test Panel at Moorhead Junction, MN

A flange bearing test panel was built and installed near the Moorhead Junction diamonds to provide a lower cost proof test of additional candidate materials. The test panel was built to the same flange bearing ramp design as the diamonds. The frogs are replaced in the test panel with a flat section approximately 12 feet long. This allows a flange bearing length of more than one complete wheel revolution for all wheel sizes. Two candidate flange bearing materials were evaluated in the panel. Figure 7 shows the test panel in June 2009, shortly after installation. The candidate materials in the test panel were Tool Steel 2 and Tool Steel 1. Both are high strength tool steels, with surface hardness values of 450 and 500 BHN. Figure 5 also shows their performance in comparison to the other flange bearing materials tested in revenue service. Tool Steel 1 has a projected wear rate that is 15-20 percent lower than AMS. As Figure 6 shows, Tool Steel 1 also has relatively good ability to work harden with deformation. From this test, it appears that Tool Steel 1 is the likely candidate for the next FBF diamonds. The material performed better than AMS in a test panel that better simulated revenue service conditions.
