Evaluation of a Movable Bridge Rail Joint on the Steel Bridge at FAST

Summary

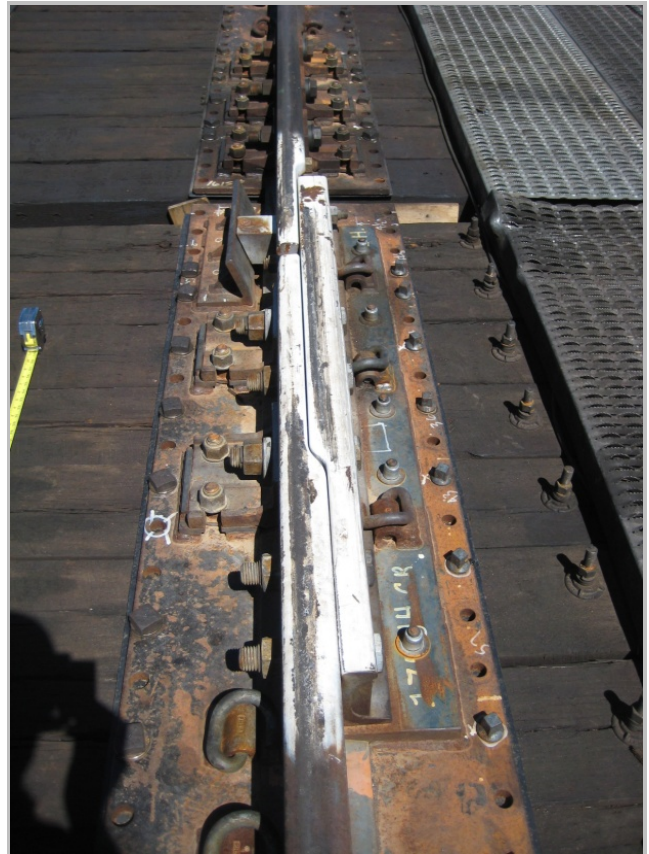
Figure 1. Rail Joint Detail for One Running Rail

Progress Rail Services (PRS) provided an improved version of an easer rail bridge joint for testing. Figure 1 shows the rail joint detail for a single running rail, with wheel tread path indicated where the paint has worn off. Note how the wheel tread transfers from the running rail to the easer rail to carry the wheel over the gap in the running rail. The gap allows for thermal expansion and contraction of the rail and bridge spans, as well as other tolerances needed for a movable bridge span.

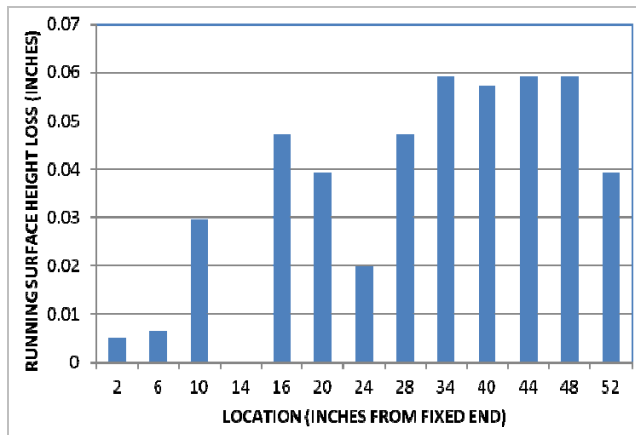
Figure 2. Running Surface Vertical Height Loss versus Location (at 102 MGT)

Wear (reported as vertical height loss) of the joint running surfaces were measured over the service life of the joints. Figure 2 shows the average height loss of the two joints (left and right rail) over 102 MGT.

The height loss is greatest in the transition zone between the easer rail and the movable span running rail. The height loss is greatest over about a 24 inch length. This is the zone of wheel transfer, which is influenced by the temperature and location of the movable span rail. The same conclusion is confirmed from the running surface hardness measurements; the wheel transfer zone shows the most surface hardening.

Some refinement of the running surface profiles of the joint can be done to improve wheel-rail contact conditions. This should lower initial deformation rates and reduce dynamic loading. For example, the easer rail is made with a flat running surface and a relatively small radius “gage” corner. A sloped running surface, inclined at 1:20 to the gage side would be more conformal to the field side of the wheel tread that will contact it.

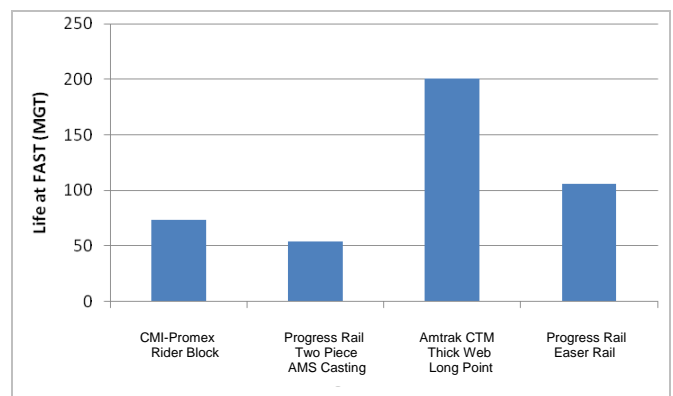
Figure 3. Comparison of Bridge Joint Life at FAST

After 106 MGT of HAL traffic, this bridge joint was removed from service. Reasons for removal included repeated cracking of the base plates, deterioration of the rail surface, increasing impact forces, and increasing maintenance demand. Maintenance demand included repair of bridge walkways and handrails that broke or became loose because of the impacts. The deck hook bolt fasteners on the timber ties supporting the bridge joint also required frequent tightening, in spite of using locking clips and double nuts. Hook bolts were frequently breaking as well, presumably because of the high impact environment. The maintenance demand had grown to the point where some type of maintenance was required almost every day of train operation. When the joint was new, the required maintenance was less than once per week (5 to 8 MGT) during train operations.

Figure 3 shows a comparison of bridge joint life at FAST. Joints were removed previously for similar reasons.²

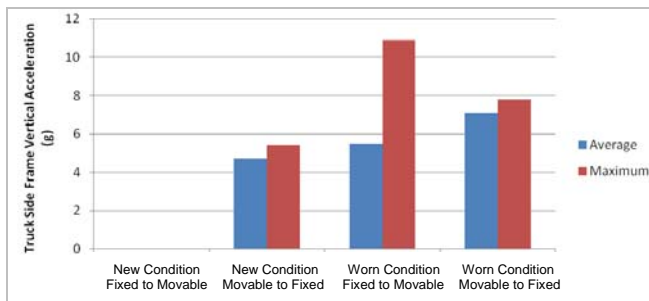
Figure 4. Vertical Acceleration Levels over Bridge Joint for New and Worn Conditions and Both Directions of Travel

When the joint was new, the IFC noted exceptions near the movable bridge joint only while operating in the direction from movable span to fixed span (in the clockwise direction around the loop). No exceptions were noted while operating in the direction from fixed span to movable span. The only exception parameter was a truck side frame vertical acceleration exceeding 4 g.

When the joint was worn, the IFC noted exceptions near the movable bridge joint while operating in both directions. In addition to the truck side frame vertical acceleration exceptions, there were exceptions to the truck side frame lateral accelerations exceeding 3 g. Figure 4 compares the exceptions for the joint in both the new and worn conditions. In some cases, more than one exception was noted per train pass, indicating that sometimes both truck side frames experienced high vertical accelerations, or that high accelerations were experienced in both vertical and lateral directions. As expected, the impact acceleration values, both average and maximum, were greater in the worn condition.
