Thermite Railhead Repair Weld Test 2 at Facility for Accelerated Service Testing

Daniel Gutscher

Summary

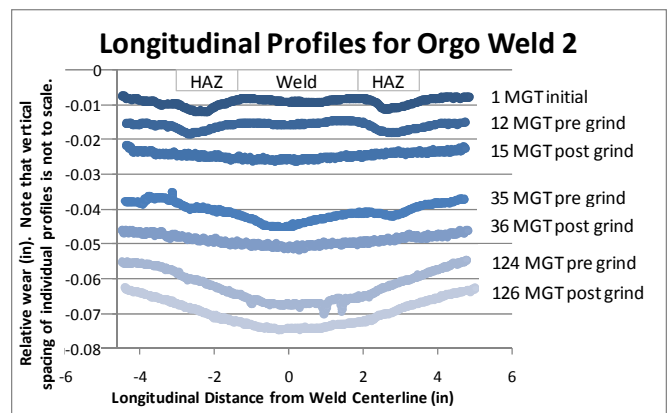
The running surface for each weld type quickly developed the typical batter in the HAZ. The initial grinding at 12 MGT effectively removed the accumulated batter without eliminating early gains in running surface hardness at the HAZ. Figures 2 and 3 show the running surface profiles for Orgo-Thermit and Railtech Boutet welds, respectively. As with all thermite welds, batter of the HAZ occurs very quickly. The dipping of the HAZ causes high impact loading at the weld that promoted shelling as observed in the first round of testing in 2008. Rail grinding removes high spots to produce a smooth running surface. As a result, a gentle dip develops across the weld over time that results in lower impacts at the weld than those created by the HAZ batter. Rail grinding appears to have become less effective in subsequent grindings as a result of cumulative gains in HAZ hardness and corresponding reduced formation of batter.

Figure 2. Longitudinal Profiles for Orgo Weld No. 2
Note that vertical spacing of the welds does not represent the amount of wear between measurements or total wear. Spacing was chosen to aid comparison of before and after grinding profiles.

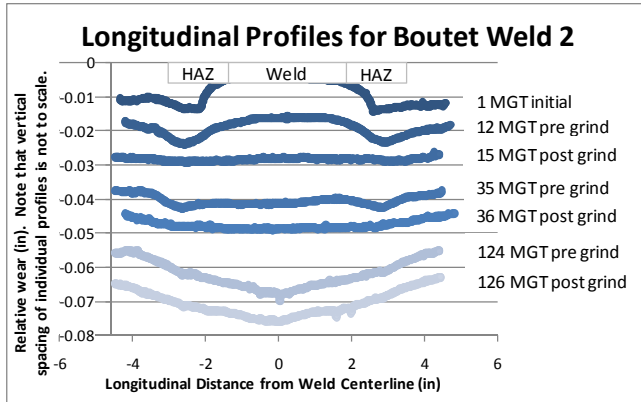
Figure 3. Longitudinal Profiles for Boutet Weld No. 2

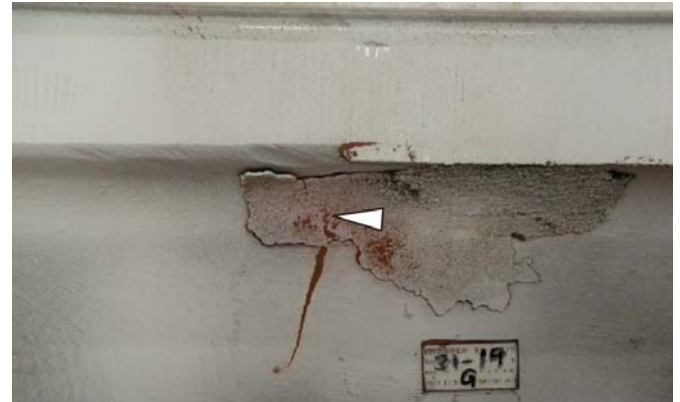
The welds have received rail maintenance grinding at 1.5, 35, 51, and 71 MGT. As of June 2011, the welds have accumulated between 102 and 116 MGT, depending on the actual installation date. Periodic rail flaw detection found one Railtech Boutet weld that had a fatigue crack growing into the web. The crack initiated at flashing under the railhead about 1 inch from the EFB HAZ. Figure 4 shows the weld and crack. Figure 5 shows an internal macro etch view of the crack that reveals the crack propagation up into the railhead toward the thermite weld and downward into the rail web away from the EFB weld. Flashing under the railhead has been previously identified as a potential crack initiation site.^{1,2,3} Another weld was removed due to an unrelated adjacent rail break.

Figure 4. Magnetic Particle Inspection of Crack under Railhead (Arrow indicates location of crack initiation behind flashing under the railhead.)

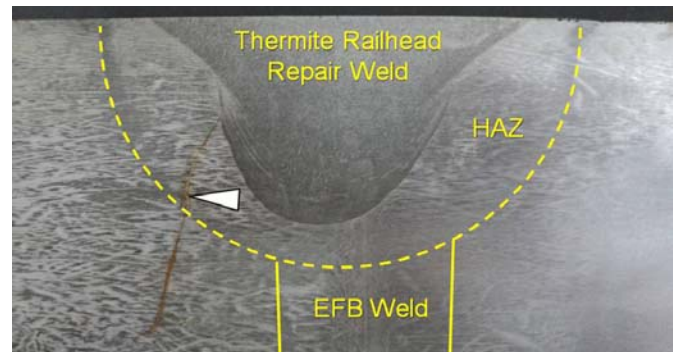
Figure 5. Macro Etch of Longitudinal Centerline Cut (Arrow shows part of visible crack nearest to origin.)
