Root Causes of Rail Roll/Reverse Rail Cant and Remedies

Huimin Wu, TTCI
Brad Kerchof, Norfolk Southern

Summary

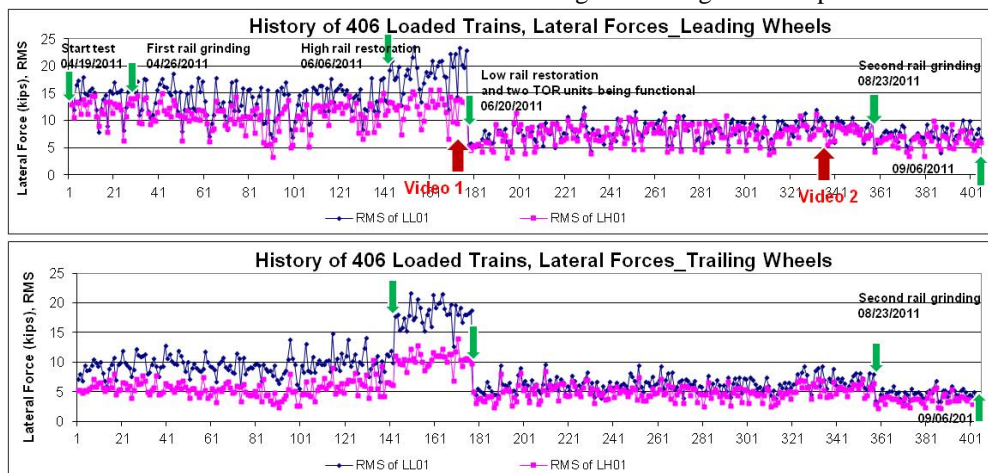
Figure 1 shows the lateral force history for 406 loaded coal trains negotiating the test curve for these five maintenance conditions (the green arrows indicate the beginning of each condition). This data was for trains having at least 75 cars and an average wheel vertical load greater than 28,000 pounds. The root mean square (RMS) value for the lateral forces in the complete train was used to represent the force level for each train.

On June 6, when the high rail was restored and the track was gaged to 56-3/8 inches on 18-inch wide tie plates with cut spikes and elastic fasteners, the lateral forces increased significantly. Constraining high rail resulted in strong two-point contact and, consequently, very poor curving performance. Lateral displacement was transferred to the low rail, which rotated up to 7 degrees under a loaded coal train; the risk of rail rollover was increased. The spikes at gage side were found to be raised 7/8 inch over a distance of 40 feet.

The bottom graph in Figure 1 shows an increase in lateral forces on the trailing wheels almost equal to the forces of the lead wheels after the high rail was restored (between trains 141 and 181), which suggests the trucks could have had a significant degree of warp.

Figure 1. Lateral Force History for 406 Loaded Train Passes (average wheel force > 28,000 pounds, cars per train >75), LL01 – low rail lateral force, LH01 – high rail lateral force. Both high and low rail lateral forces are gage spreading forces.

On June 21, two TORFM units located 0.5 mile east and 0.5 mile west of the test site were repaired. The combination of 3/8-inch gage widening and the TORFM application lowered lateral forces significantly (Figure 1). The individual contributions of each of these actions are being investigated.

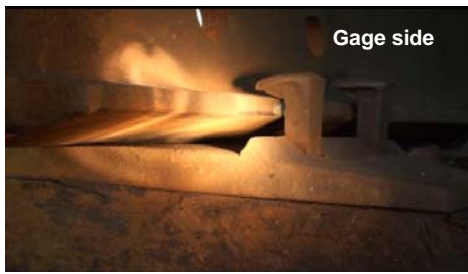
Figure 2 displays a frame from a video showing the low rail rotation. The low rail at that section was restrained only by its torsional rigidity and the vertical force applied by adjacent wheels. (The red arrows in Figure 1 indicate when this video, as well as a second, were recorded.)

Figure 2. Frame from a Video Showing Low Rail Rotation under Loaded Coal Train

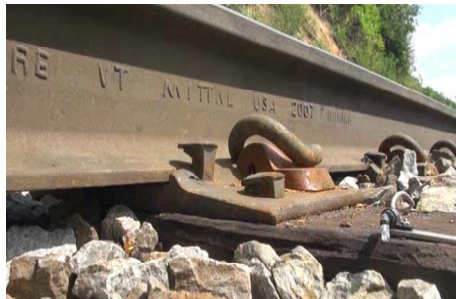
On June 20, to increase the low rail constraint, wide tie plates and elastic fasteners, similar to those applied previously to the high rail, were also installed (Figure 3). The track was regaged (widened) to 56-3/4 inches.

Figure 3. 18-inch Tie Plates and Elastic Fasteners

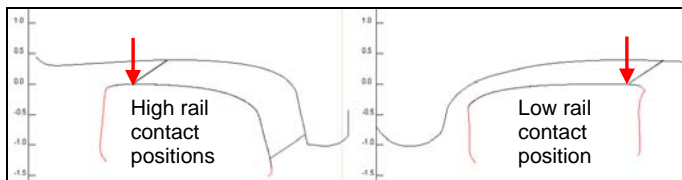
On August 8, the second video was recorded and it showed no rail rotation. Even with greatly reduced lateral forces and the absence of rail rotation, wheel/rail contact patterns were still poor. Many wheels continued to contact the field side of both the high and low rails (Figure 4).

Figure 4. Contact Position toward the Field Side of Both High and Low Rails after Rail Cant Restoration

- Certain track maintenance tasks, such as gaging and tie renewal, can have the unintended consequence of causing poor wheel/rail contact, resulting in high lateral forces. Figure 4 illustrates that a high rail restored to a 1:40 cant without rail grinding can result in strong two-point contact and produce high lateral forces.
- Asymmetrically worn wheels can produce high lateral forces on both leading and trailing axles. The wheel profile analysis on passing trains indicated the existence of many asymmetrically worn wheels in the coal cars passing the test site.
- Combinations of the above undesired conditions increase the risk of rail rollover derailments.

- Restore designed rail profiles by grinding after rail cant restoration. This is particularly important with the high rail.
- Maintain controlled TORFM and gage face lubrication.

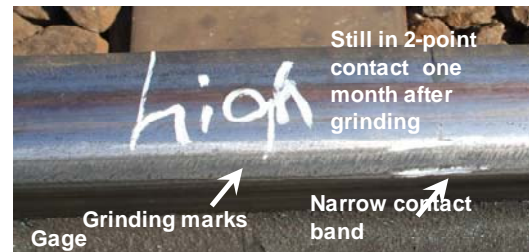
- High wheel/rail lateral forces caused by poor steering trucks and extreme two-point contact (Figures 4 & 5).¹

Figure 5. High Rail Showing Strong Two-Point Contact

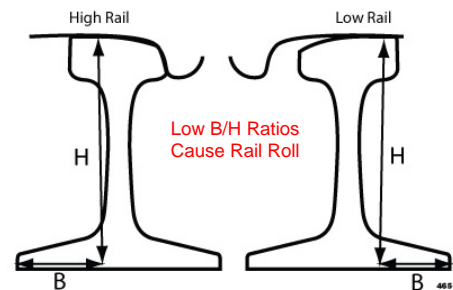
- Vertical load applied toward the field side of the rails (both high and low) due to undesirable rail profiles, can result in low B/H ratios illustrated in Figures 6 and 7.² Excessive wide gage and hollow worn wheels also, contribute to the contact toward the field side.

Figure 6. High Risk of Rail Roll under Low B/H Ratios

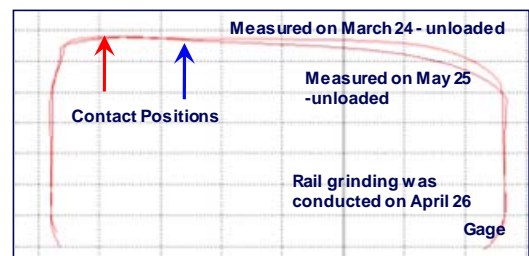
Figure 7. Low Rail Contact Position toward the Field Side

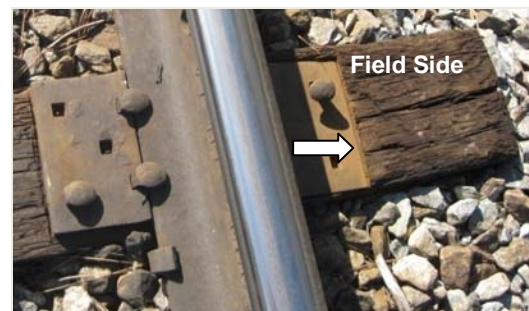
- Weak rail restraint (Figures 2 and 8).³ The investigation indicated that cut spikes do not provide sufficient and sustainable restraint against rail roll on curves under the adverse vehicle/wheel conditions.
- Field side tie plate cutting (Figure 8).³

Figure 8. Tie Plate Cutting

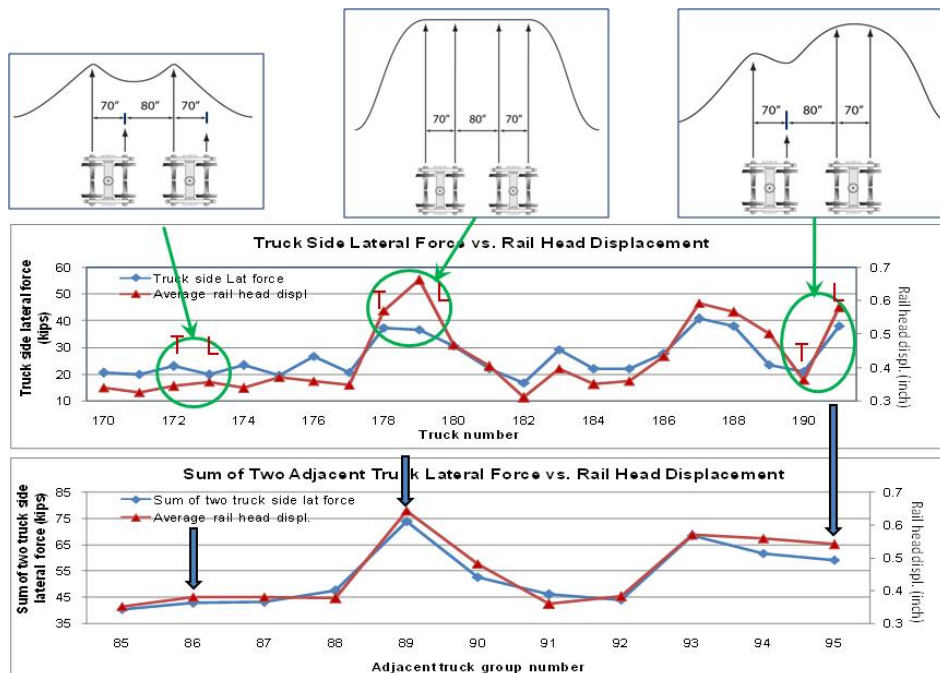
Figure 9 shows the force and railhead lateral displacement data from the instrumented site. The rail rotation angle can be computed by the railhead lateral displacement and the height relative to the rail base. The results indicate large rail rotation occurs when adjacent trucks (trail truck of the previous car and lead truck of the following car) both produce high lateral forces (see middle circle, 5 degrees rotation).

Figure 9. Summation of Adjacent Truck Side Lateral Force (blue) and Railhead Lateral Displacement (red)
