# Evaluation of an Automated Turnout Inspection System

Rafael Jimenez and David D. Davis

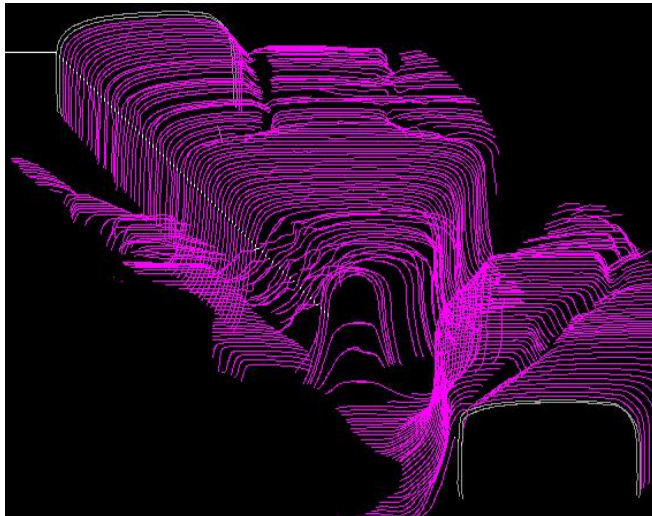
Figure 2a. Frog at TTC Turnout 212a showing Flangeway Obstruction

In addition to the tight gage indication shown in Figure 3, where the gage was adjusted to 55 7/8 inches, another critical condition correctly detected and reported by ASIV was the obstruction in the flangeway gap of the frog at turnout 212a.

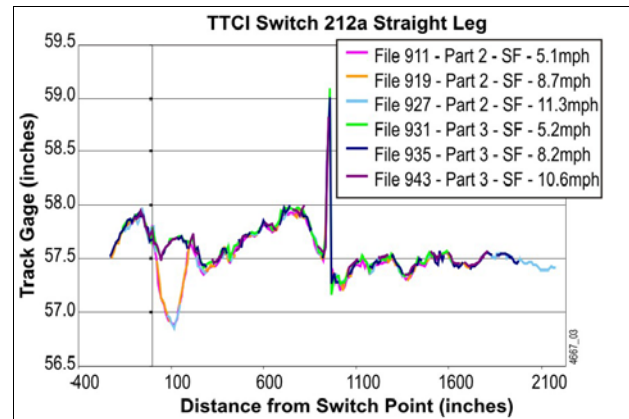
Figure 3. Track Gage along TTC Turnout 212a. Switch Rail 0-223 inch; Frog area 926-1036 inch; Frog Point 963 inch

Figure 3 shows track gage, where the switch rail is between the 0- (point of switch, POS) and 223-inch locations. The frog area is between 926 inch and 1036 inch, and the frog point is at 963 inch.

Wide track gage was incorrectly reported as FRA-exceptions for the four turnouts at the PCD. For the TTC turnouts, track gage values were not shown in the ASIV report form (Part 2 tables). The graph in Figure 3, however, was presented in the Zeta-Tech report<sup>1</sup> (graph has been enhanced by TTCI) and contains gage data for six runs over turnout 212a. Based on Figure 3, it’s clear that the ASIV has the capability to measure track gage, given the correct relative difference shown at about 100 inches past the switch points. This is the location where an alteration was done to tighten the gage. The absolute gage measurements, however, are incorrect.

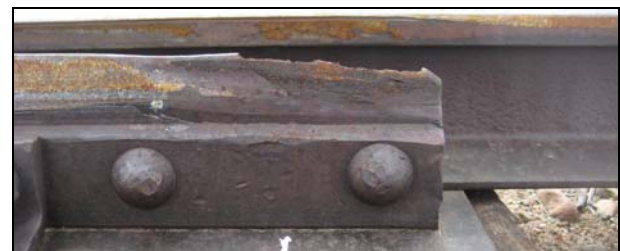
Figure 4. Four-inch Chip Broken off a Switch Point

Data post-processing is required with the current ASIV. The ASIV successfully reported numerous maintenance considerations and FRA-exception conditions as a result of its inspection, including “Point Below Stock.” This point had a 4-inch chip broken off, as Figure 4 shows. Interestingly, this condition was reported quantitatively but not in the qualitative section of the report where “Point Condition and Point Fit” were both described as “Good.”

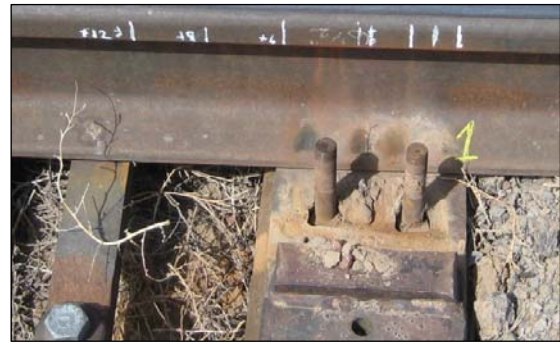
Figure 8. Chair Brace Missing (No. 1 at POS)

There were a number of rail related conditions that were not reported by the ASIV. The most critical include two switch points with a 1/8-inch gap (Figure 5 shows one of the points), a crushed wing rail and heel rail (Figures 6 and 7), chair brace (No. 1 at POS) missing (Figure 8), a weld repaired frog point in very poor condition, cracked joint bars, and missing joint bar bolts.
