# Performance of a Moveable Point Frog under Heavy Axle Load Traffic

David D. Davis, Daniel Szablewski, Rafael Jimenez, and Joseph LoPresti

## Summary

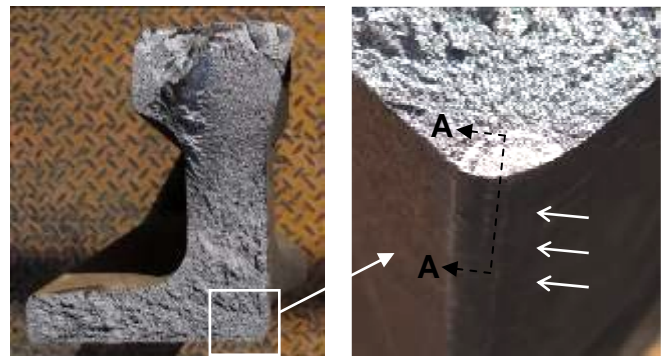
Investigation of the defect root cause found that both main and diverging wing rails had similar failure mechanisms on the fracture surfaces. Both fractures originated at the curved wing base, which was ground when creating the radius. The grind marks made those locations notch sensitive during loading, which ultimately lead to the formation of fatigue cracks (Figure 2). Once those cracks propagated to a certain length, critical brittle failure follows.

Figure 2. (L) Wing Rail Fractured Surface indicating Fracture Origin and Fracture Initiation Grind Marks (Multiple Arrows); (R) Cross-Section taken for Microstructural Analysis, A-A

Initial observation suggested that excessive grinding in the curved region may have led to the microstructural modification of the wing rail, consequently contributing to the fracture mode in both defects. However, microstructural analysis of the fatigue locations in both wing rail failures (A-A, see Figure 3) indicated that microstructures in the immediate subsurface of the fatigue defect were fully pearlitic and similar to the bulk wing rail microstructure.

This observation helped identify that the two contributing factors to the fracture failures were the presence of notch sensitive scratch marks and their location in a highly stressed tensile field found at the wing base. Elimination of the grind marks, while keeping the current smooth radius profile on the wing base, will most likely alleviate or in the least delay this fracture mechanism.

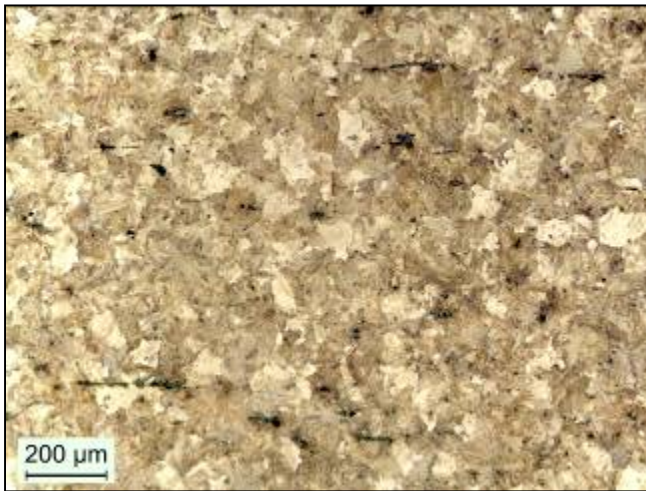
Figure 3. Micrograph of Cross-Section A-A indicating the Microstructure to be fully Pearlitic

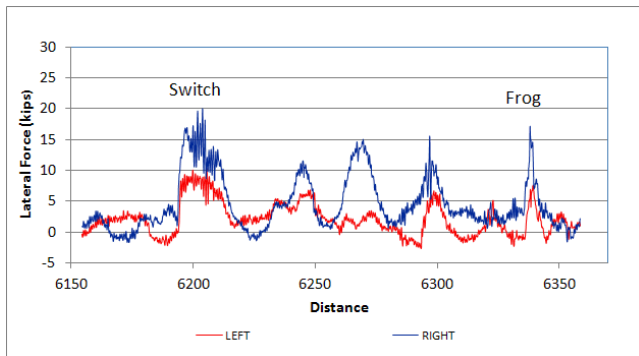
Figure 4. Measured Lateral Loads on the MPF at FAST (Lead Axle, 40 mph, Facing Point, Diverging)

The train was moving from left to right in the figure; passing through the point of switch at around 6,190 feet and the frog at around 6,345 feet. Note that the maximum lateral wheel load at the switch in this diverging move is 20,000 pounds. Also note that the maximum lateral load at the frog is about 17,000 pounds. The lateral load spike at the switch was expected, but the one measured at the frog was not.

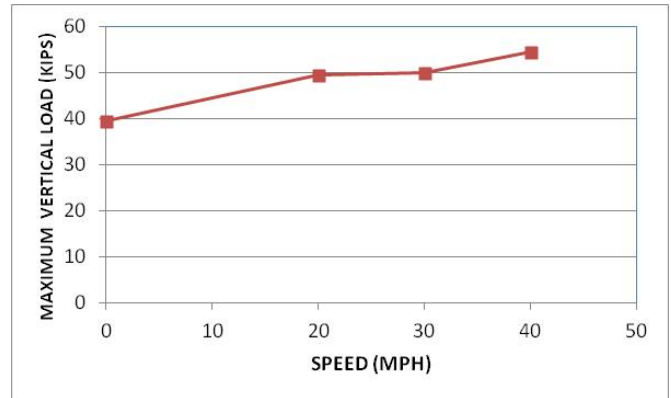
As expected, the vertical wheel loads are relatively low, as compared to fixed-point frogs. The MPF does a good job of reducing dynamic loads from flangeway gaps. As Figure 5 shows, the maximum load at 40 mph is 54 kips. This compares well with the typical 60 to 80 kips measured on fixed-point frogs at 40 mph.

Figure 5. Measured Vertical Wheel Load on Moveable Point Frog at FAST

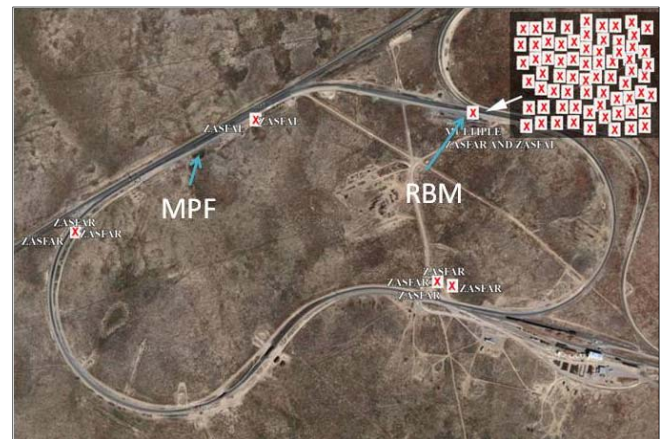
As measurements taken at FAST show, the ride quality is good for a No. 20 frog. However, the frog had mediocre ride quality compared to what would be expected for open track. There were occasional truck side frame vertical acceleration exceedences of the 4 g threshold. There were also a few exceedences of the side frame lateral threshold of 3 gs. In comparison, the rail-bound manganese (RBM) frog in the turnout at the opposite end of the same siding has regular exceedences of the vertical threshold. This is shown qualitatively in Figure 6, which is a map of locations with side frame vertical exceptions for October 2011. There were none on the MPF (upper left in the plot) and many for the RBM (upper right in the plot). The exceptions are shown as flags all pointing to the frog location.

Figure 6. Vertical Side Frame Acceleration Exceptions FAST HTL October 2011

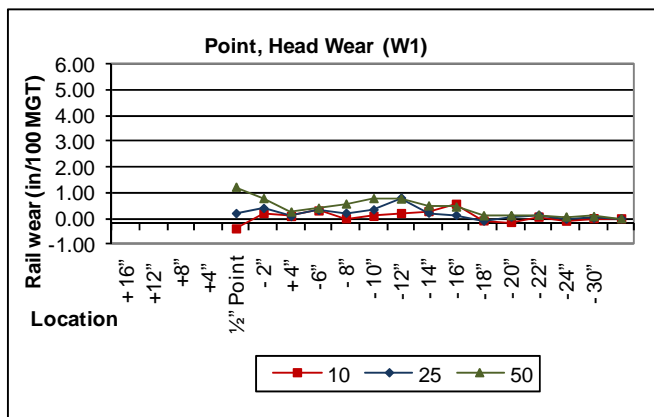
Wear and metal flow of the MPF running surfaces was determined from a time series of transverse profiles. Data from the first 50 MGT of operations was used to determine wear performance. In general, the frog is wearing well, with low wear rates and fairly uniform wear throughout. Figure 7 shows height loss versus distance from the point of frog for the moveable point. The wear rate is relatively uniform from about 6 inches to about 18 inches from the point of frog. Beyond 18 inches, the wear rates are comparable to open track rails.<sup>1,2</sup> For fixed-point frogs, more proportionately wear is seen closer to the point of frog.

Figure 7. Point Height Loss vs. Tonnage

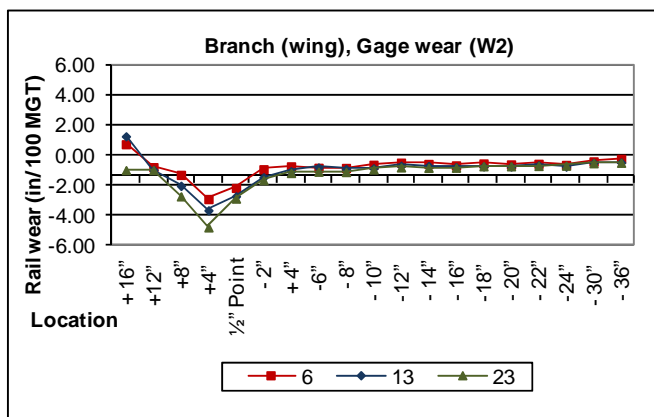
There is more lateral metal flow on the wing rails near the point of frog. This can be seen in the gage wear measurement as shown for the diverging wing in Figure 8. Note that the gage wear is negative, indicating that the rail is growing (i.e., plastic flow laterally).

Figure 8. Frog Wing Lateral Wear vs. Tonnage

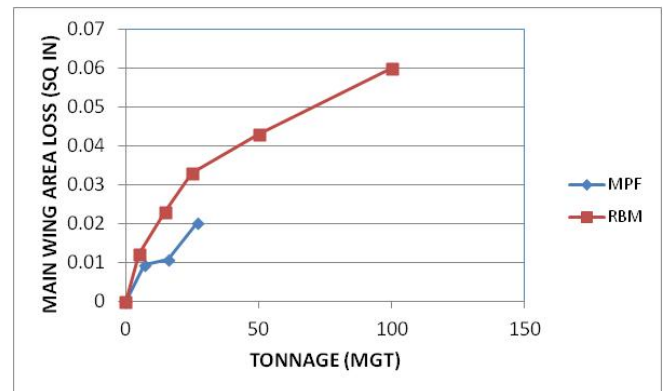
For comparison purposes, the cross-section area loss from a recently tested fixed-point RBM heavy point frog was compared to the MPF. Using the average cross-section area loss of the point from locations at 2, 4, and 6 inches from the point of frog, the plot in Figure 9 was produced. In the first 25 MGT, the MPF has about 40 percent less wear. Note that the RBM frog, due to the work hardening capability of AMS (austenitic manganese steel), has decreasing wear rates with tonnage. The MPF is likely to have a more consistent wear rate over time.

Figure 9. Frog Point Wear Under HAL Traffic
