Attempt at Creation of Vertical Split Rim Wheel Failure

Scott Cummings and Daniel Szablewski

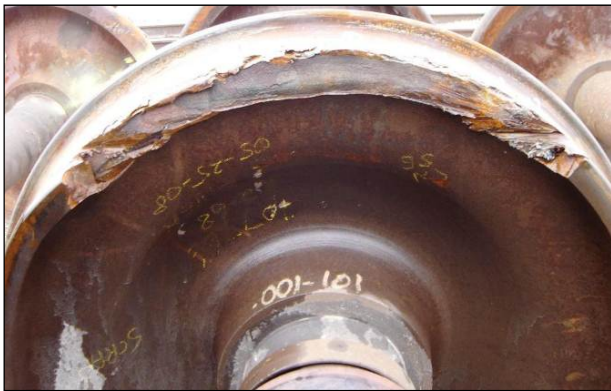
VSR cracks develop in the wheel rim and usually propagate to the front rim fillet, but can sometimes propagate to the back rim fillet resulting in a broken flange. Two reports describe largely similar theories on the formation of VSR cracks.^{1,2} Tread damage on the wheel surface in the form of a shell or spall initiates cracking that propagates into a region of tensile residual stress in the rim. The tensile residual stress encourages further crack growth until a portion of the rim breaks free from the wheel. Figure 1 shows an example of a typical VSR wheel.

Figure 1. Wheel with VSR

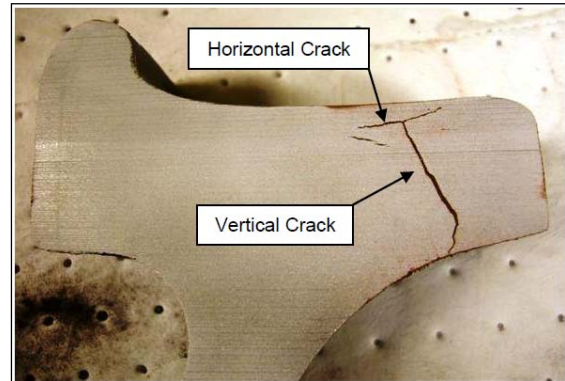
Inspections of 29 VSR wheels and 6 broken flange wheels were conducted to evaluate the appearance of the cracked surface. A VSR origin location was identified for each wheel, and radial depths of these origins were all found in a tight band ranging from 0.10 inch to 0.25 inch below the tread surface with a median value of 0.17 inch.⁴ Ultrasonic testing (UT) revealed horizontal cracks at radial depths similar to the VSR crack origins in 27 of the 35 broken wheels and in 18 of the 35 mate wheels.⁵ There is 95 percent confidence that more horizontal cracks were present on the broken wheels than the mate wheels. The broken wheel had more cracks than the mate wheel on 80 percent of the wheelsets. No inferences can be made to the general population of wheels at this time. Figure 2 shows a section from a wheel that failed from VSR with a vertical crack branching from a horizontal crack.

Figure 2. Wheel Rim with Horizontal and Vertical Cracks

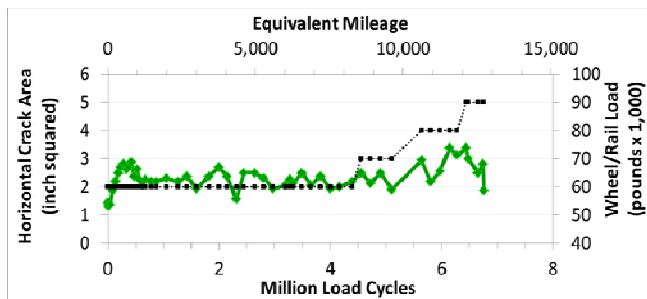
A service worn wheel originally mounted on the same wheelset as a VSR wheel was selected as the first test wheel. Based on UT, this wheel was known to have a large subsurface horizontal crack. The wheel was installed on the test machine so that the field side edge of the horizontal crack was approximately in the center of the contact patch between the wheel and rail. Computer modeling had shown this positioning to produce the maximum stress condition. The vertical load was set to 60,000 pounds at the beginning of the test. After 4.5-million load cycles, the load was increased by 10,000 pounds approximately every million-load cycle until the maximum load rating for the machine was achieved. The test was intended to force the horizontal crack to turn vertically. Instead, the horizontal crack expanded in area early in the test, and then stopped growing until the vertical load was increased. The initial area of the crack was 1.4 square inches and grew to 3.4 square inches. Crack area was

estimated daily by scanning the wheel with a handheld UT device and noting the edges of the horizontal crack compared to a grid overlaid on the wheel with 0.50-inch grid spacing increments. TTCI believes decreases in the estimated crack area are the result of changes in the tread surface condition during the test that at times provided a suboptimal surface for the contacting ultrasonic probe.

Significant radial runout of 0.110 inch developed on the wheel tread from deformation and wear forcing the rolling load machine to work harder on every load cycle. After 6.8-million load cycles, the test was stopped, because the machine was no longer able to cycle the rail because of the combination of large contact force and radial runout on the wheel. Figure 4 shows the crack area and the wheel/rail contact force from this test as a function of the number of load cycles.

Figure 4. Horizontal Crack Area (Green) and Contact Loads (Black) from the First Rolling Load Test

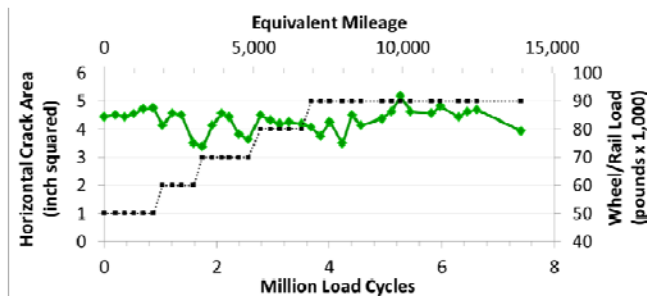
A second wheel with a 4.3 square inch preexisting horizontal crack was selected (also originally mounted on the same wheelset as a VSR wheel), and testing was resumed. The vertical load was initially set to 50,000 pounds and increased by 10,000 pounds approximately every million-load cycle up to the machine maximum. Again, the wheel developed significant radial runout of 0.120 inch from deformation and wear during the test. After 7.4-million load cycles, the machine experienced a failure in one of the support posts, and the test was stopped. The crack area in the wheel did not change appreciably during this test. Figure 5 shows the crack area and the wheel/rail contact force from the second test.

Figure 5. Horizontal Crack Area (Green) and Contact Loads (Black) from the Second Rolling Load Test

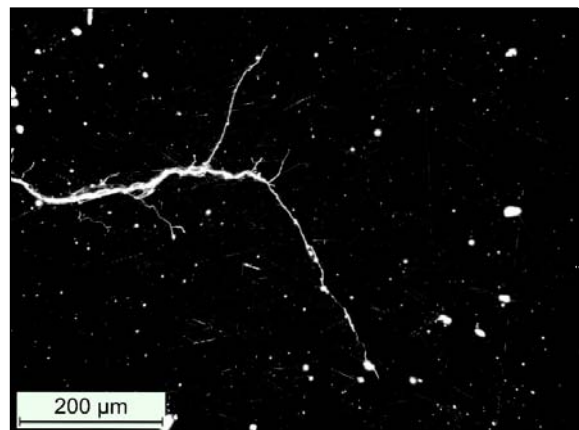
depth of 0.15 inch. Multiple short vertical branches stem from the main horizontal cracks. Figure 6 shows the longest vertical branch found, about 350 μm, at the end of a horizontal crack. This vertical branch is linking a number of small inclusions, and numerous other smaller vertical branches can be seen growing toward the tread surface (top of photo) and further into the rim (bottom of photo). Interestingly, the majority of the vertical crack branches found in these two wheels through optical microscopy were on the flange side of the horizontal cracks, even though the wheel/rail contact during the rolling load test was on the field side of the horizontal cracks. This may be an indication that the bending moment generated in the rim by wheel/rail contact is more important to producing vertical crack branching than localized stresses nearest to the contact patch.

Figure 6. Dark Field Optical Microscopy Shows a Horizontal Crack with Multiple Vertical Branches

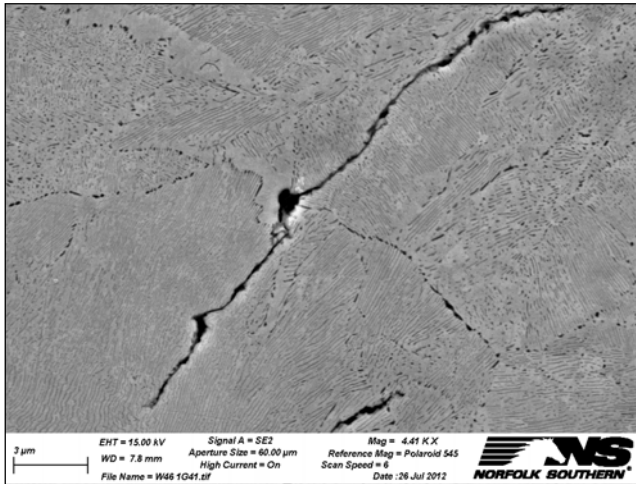
Understanding the propagation path of a crack can help define the relative influence of high stress levels and localized material weaknesses. Nonmetallic inclusions act as stress concentrators and tend to segregate out to the grain boundaries as ingots solidify. The crack propagation paths of selected cracked specimens from the rolling load test wheels were further investigated using Norfolk Southern Railway’s scanning electron microscope (SEM). The polished samples were etched with a saturated solution of picric acid to show the microstructure including the boundaries between prior austenite grains. The horizontal cracks and the vertical crack branches examined in the samples removed from the two wheels that failed to develop VSR cracks all showed crack propagation through the grains (transgranular cracks) rather than alongside prior austenite grain boundaries (intergranular cracks). This is a strong indication that high stress levels were the main driving force in the crack propagation in these two wheels. If the cracks had followed prior austenite grain boundaries, it would have been an indication that material weakness played a large role in the crack development, because the cracks would have followed paths of least resistance.

Figure 7 shows a typical example of a crack in one of the test wheels as viewed through the SEM using the secondary electron detector.

Figure 7. Transgranular Crack Propagation
(Image Courtesy of Norfolk Southern Railway)
