The work described in this document was performed by Transportation Technology Center, Inc., a wholly owned subsidiary of the Association of American Railroads.

FAST Steel Bridge Repairs for Effects of Corrosion and Corrugated Rail

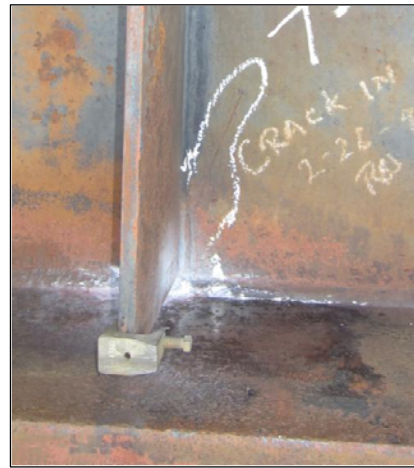
Figure 1. New 8-inch Crack in Web and Tension Flange of 65-foot Welded Girder Span

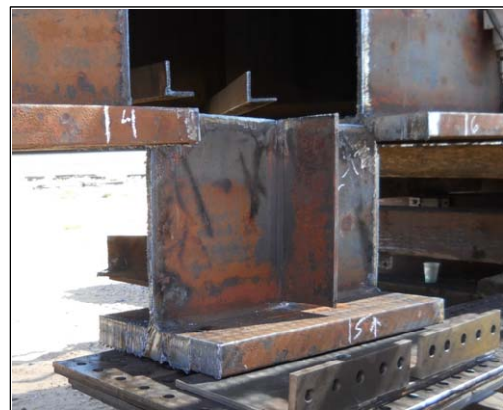
Figure 2. Sample Removed for Fractographic Analysis of Major Crack

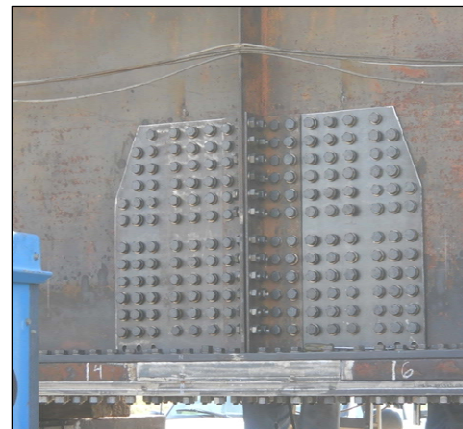
Figure 3. Repair Installed on Web and Tension Flange of 65-foot Welded Girder Span

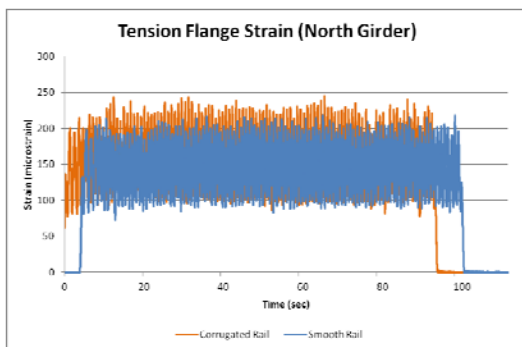
Figure 4. Increased Bridge Strains Due to Corrugated Rail on FAST Steel Bridge

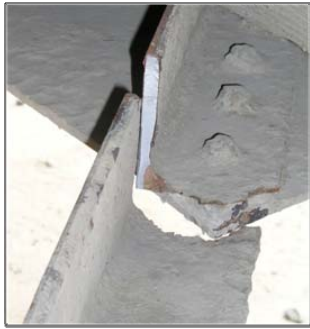
Figure 5. Typical Corrosion and Fracture of Bracing Angle Member in 55.5-foot Riveted Girder Span at FAST

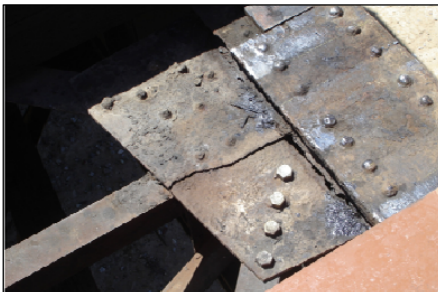
Figure 6. Top Gusset Plate Defects in 55.5-foot Riveted Girder Span at FAST

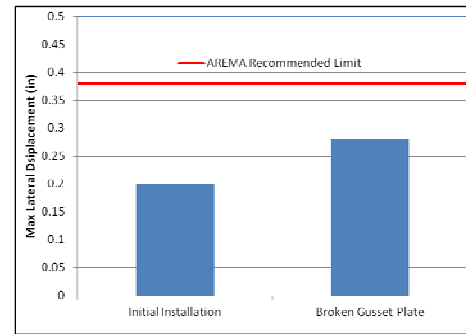
Figure 7. Lateral Deflections in 55.5-foot Riveted Girder Span at FAST under HAL Train Operations
