Wide-Gap Weld Testing at Eastern Mega Site

Daniel Gutscher and Dingqing Li, TTCI
Steven Lakata, NS

Summary

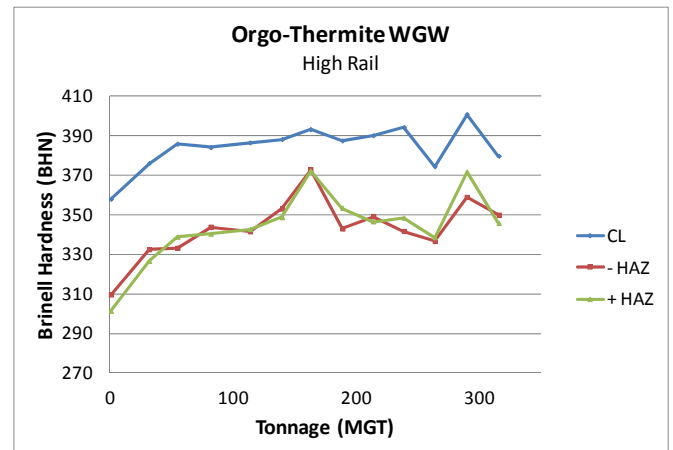
Figures 2 and 3 show how the welds and HAZs work hardened with accumulated tonnage. The majority of hardening of the weld and HAZ running surfaces occurred within the first 50 to 60 MGT of traffic, and then the rate of hardening decreased. This pattern of rapid initial hardening is normal for thermite welds.

Figure 2. Average Running Surface Hardness in the Weld and HAZ for Orgo-Thermit WGWs Installed in High Rail

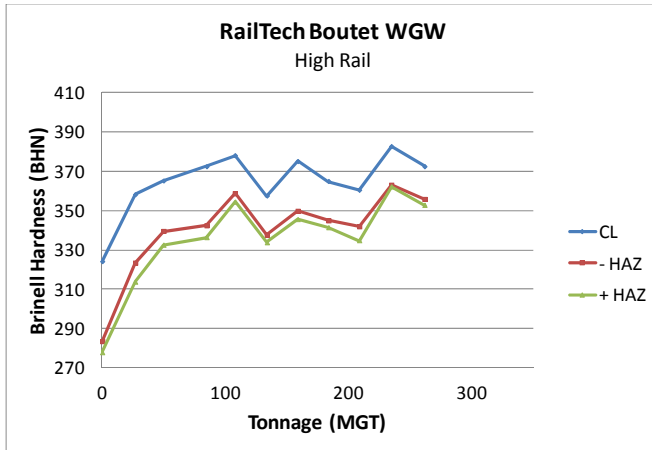
Figure 3. Average Running Surface Hardness in the Weld and HAZ for Railtech Boutet WGWs Installed in High Rail

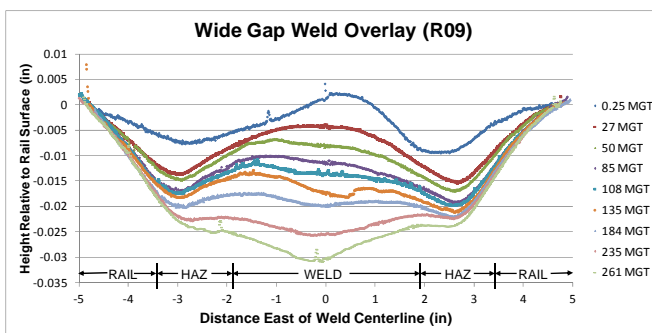
Figure 4 shows longitudinal running surface profiles for one WGW. The WGWs followed a typical wear/batter pattern for the thermite welds. The soft HAZs quickly battered as the running surface work hardened, but then the rate of batter slowed in comparison to the adjacent rail wear. (Batter is metal deformation and flow at the rail running surface in the HAZ and weld that results from high contact forces at the wheel/rail interface.) The WGWs followed the same pattern observed in work hardening of the HAZ. The result was a rapid formation of HAZ dipping on both sides of the welds. The thermite weld metal experienced a steady batter rate resulting from wheel impacts as they traversed the HAZ.

Figure 4. Weld Profile Degradation – Primary Direction of Loaded Traffic is Left to Right

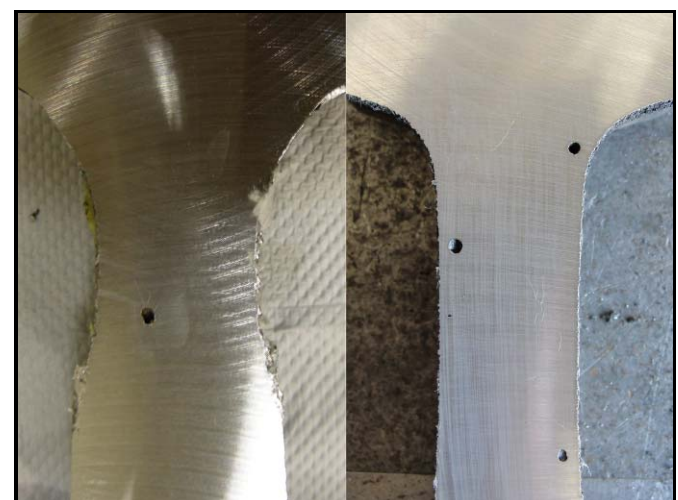
- Two Railtech Boutet WGWs were removed because of internal porosity defects detected by ultrasonic inspection. The first defect was found upon installation, and the weld was replaced. The second defect was found after 209 MGT, and the weld was removed from the test.

As part of the initial installation inspection, all welds were scanned ultrasonically by NS technicians. The Railtech Boutet weld R4 was identified as containing a defect and was removed. A new WGW was installed in its place and was also labeled as R4. The first weld was sectioned by NS and found to contain a gas pore. In October 2010, a second Railtech Boutet weld (WGW R12) was identified by ultrasonic inspection to have a defect. Laboratory evaluation revealed porosity similar to that found in the initial WGW R4. Figure 5 shows the transverse cross sections of WGWs R4 and R12.

Figure 5. Gas Holes in Railtech Welds R4 (left) and R12 (right)

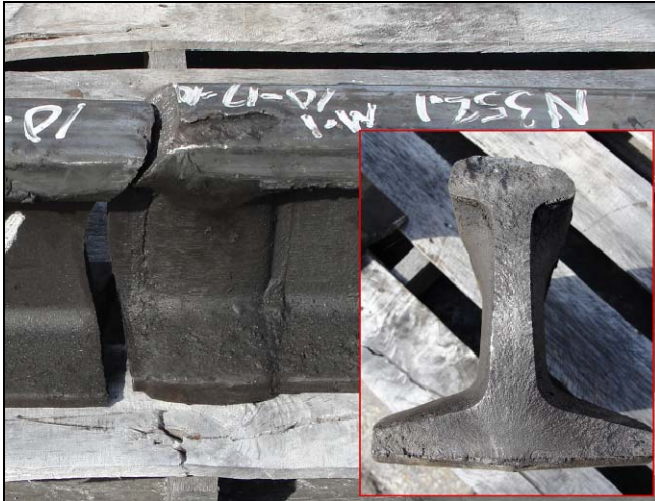
- Two Orgo-Thermit WGWs were removed. One weld experienced a fatigue fracture at 265 MGT that initiated at flashing under the base. The fracture occurred shortly after the weld developed a shell on the gage corner of the weld. The second weld was removed by NS when inspection revealed a similar gage corner shell.

Two Orgo-Thermit welds were removed during the test. In September 2010, a large shell was observed on the gage corner of WGW O6. In October 2010, the weld fractured due to fatigue that initiated at runout flashing under the base of the rail. Figure 6 shows WGW O6 and the fracture surface. One year later a second weld, WGW O3, developed a large shell on the gage corner, and NS removed the weld. Figure 7 shows the shell on WGW O3.

Figure 6. WGW O6 with Shelling on Gage Corner and Fatigue Fracture from Base of Weld — Inset Shows Fracture Face — Fatigue Initiated at Runout at Base of Weld

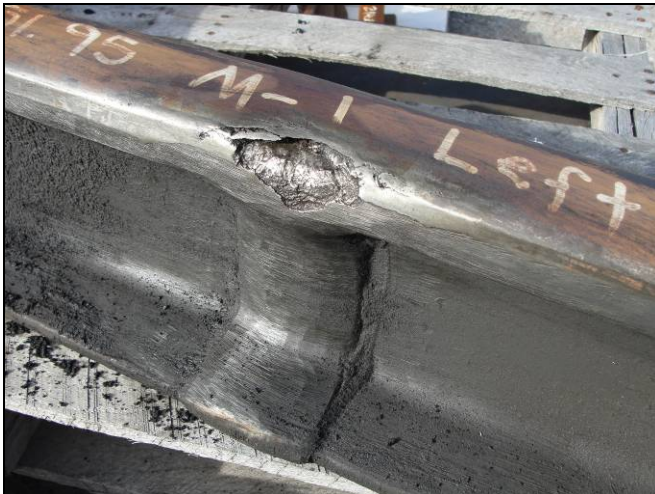
Figure 7. WGW O3 Shelling on Gage Corner
