Degradation of Thermite Weld Running Surface in Heavy Axle Load Environment

Daniel Gutscher

Summary

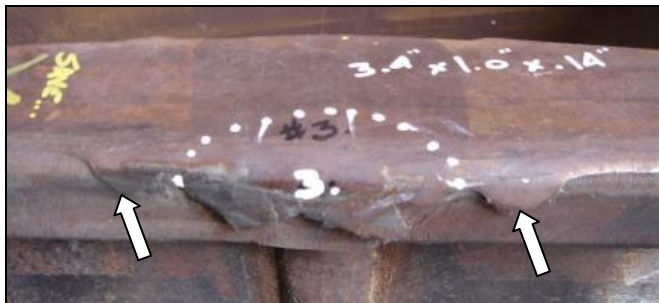
Under heavy axle load (HAL) service conditions, the running surfaces of thermite welds can rapidly degrade, resulting in weld failures or unplanned maintenance. Figure 1 shows a thermite weld that has batter of the HAZs on each side of the weld and gage corner shelling on the weld itself. Batter is metal deformation and flow at the rail running surface in the HAZ and welds, which results from high contact forces at the wheel/rail interface. TTCI has conducted laboratory testing and in-track observations at FAST to better understand how and why thermite welds degrade.

Figure 1. Thermite Weld Showing Batter of HAZ (indicated by arrows) and Shelling at Gage Corner of Weld

Based on the results of the study, TTCI implemented a basic post-weld grinding practice at FAST. After approximately 1 to 2 weeks of operation (from 5 to 14 MGT of traffic) on a new maintenance weld, the welders returned to the weld and conducted a light manual grind of the weld and adjacent rail.

Light maintenance grinding reduced the overall dip of the weld and HAZ compared to the adjacent rail. The grinding of rails did not remove the full depth of work hardened material in the dipped HAZ, but resulted in a smaller hardness differential at the running surface between the HAZ and surrounding material. This delayed the onset of running surface degradation.

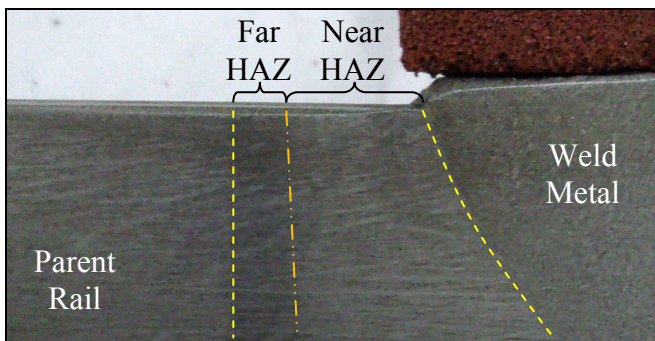
A thermite weld HAZ can be generally divided into two distinct regions. First is the near HAZ, which is located immediately adjacent to the thermite weld metal. Second is the far HAZ, which is located just outside the near HAZ. Figure 2 shows a cross section of a thermite weld HAZ at the running surface and identifies the near HAZ and the far HAZ.

Figure 2. Longitudinal Cross Section of a Thermite HAZ at the Running Surface

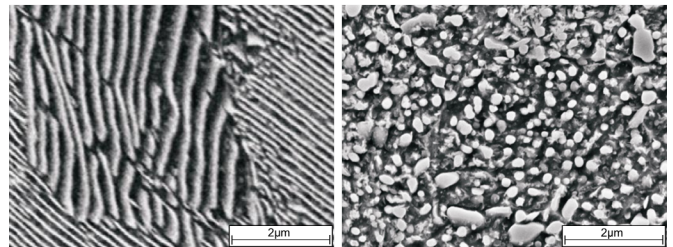
Figure 3. Scanning Electron Micrographs of Pearlitic Microstructure Typical of Rails and Thermite Welds (left) and Cementite Spheres in the Far HAZ (right)

The transformation of the rail microstructure to spheres of cementite effectively erases the benefits of the thermo-mechanical processing (TMP) that produces the high strength characteristics of the rail. The result is a reduction of the hardness (i.e., yield strength) that allows the material in the far HAZ to batter rapidly under HAL traffic in comparison to the nearby rail and weld. HAZ and weld microstructures are presented and discussed in greater depth in TD-10-015.¹

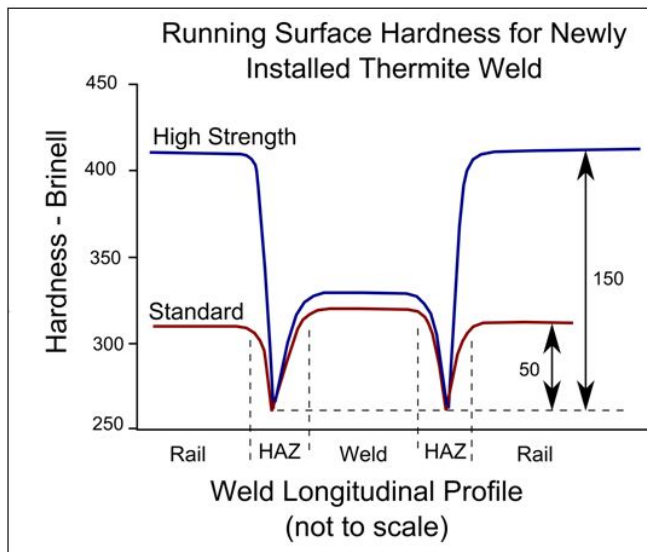
Figure 4 illustrates this by comparing the hardness profile for a thermite weld made in high strength rail with a thermite weld made in standard strength rail. In the illustration, the high strength rail has a hardness of 410 Brinell and the standard strength rail has a hardness of 310 Brinell. In both cases, the hardness in the soft region of the HAZ drops to 260 Brinell. In the high strength rail this is a difference of 150 Brinell, whereas in the standard strength rail the difference is only 50 Brinell.

Figure 4. Conceptual Hardness Diagram Showing HAZ Hardness Dip is more severe in High Strength Rails compared to Standard Strength Rails (Note weld hardness represents intermediate hardness portion commonly used in North America)

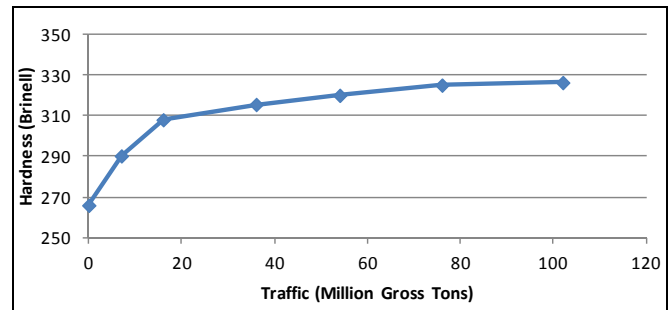
Hardness measurements of thermite welds at FAST reveal a rapid increase in HAZ hardness during the first 25 to 50 million gross tons (MGT) of weld life, and then the rate slows. This period, when the HAZ surface is still relatively soft

compared to the adjacent rail, is when batter of the running surface occurs the fastest. Longitudinal profiles across the running surface of a weld show that the initial batter in a HAZ forms very quickly. Figure 5 shows the hardness progression with MGT for a typical thermite weld HAZ at FAST. Figure 6 shows several longitudinal profiles that illustrate how quickly batter begins to set in for a typical thermite weld at FAST. As the HAZ work hardens, the rate of batter decreases.

Figure 5. Hardness Progression for the HAZ of a Typical Thermite Weld at FAST

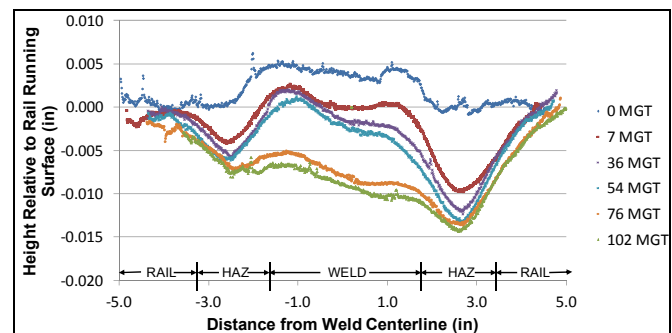
Figure 6. Longitudinal Profile for a Thermite Weld Running Surface that Illustrates the Rapid Onset of Batter in the HAZ followed by Batter of the Weld
