Testing of Electric Flash Railhead Repair Welds at FAST

Daniel Gutscher and Joseph LoPresti

Summary

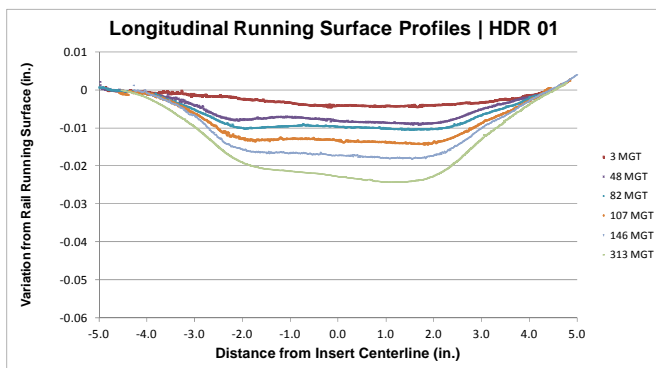
TTCI conducted periodic measurements of longitudinal running surface profile and hardness of the test welds. Profiles were overlaid to reveal trends in running surface metal flow and wear. Figure 5 shows the longitudinal profiles for one of the laboratory produced welds, and Figure 6 shows the profiles for one of the mobile unit in-track welds. For both groups of welds, metal flow occurred across the entire length of the insert (i.e., between both ends of the flash weld at the running surface). After installation, the laboratory weld inserts had running surface hardness values near 410 Brinell, and the mobile unit weld inserts had hardness values near 360 Brinell. A comparison of running surface metal flow showed the mobile unit welds at 100 MGT had more than twice the height loss of laboratory produced welds at 107 MGT.

Figure 5. Longitudinal Profiles for a Laboratory Produced HDR Weld

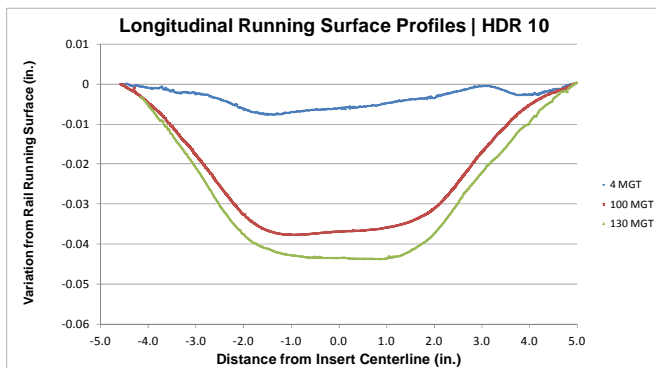
Figure 6. Longitudinal Profiles for a Mobile Unit In-track Weld

2. Inserts are being manufactured with improved chemistry and heat treatment to better produce the desired hardness for strong running surface performance and resistance to batter.
3. The mobile welder head transformer is being reworked to better distribute the power between the rail and insert. This will result in reduced heating of the insert, which will improve the metallurgical integrity and target hardness.
4. Modifications were made to the welder hydraulic system to change how the wedge inserts are forged into place. This results in reduced stresses and improved running surface.

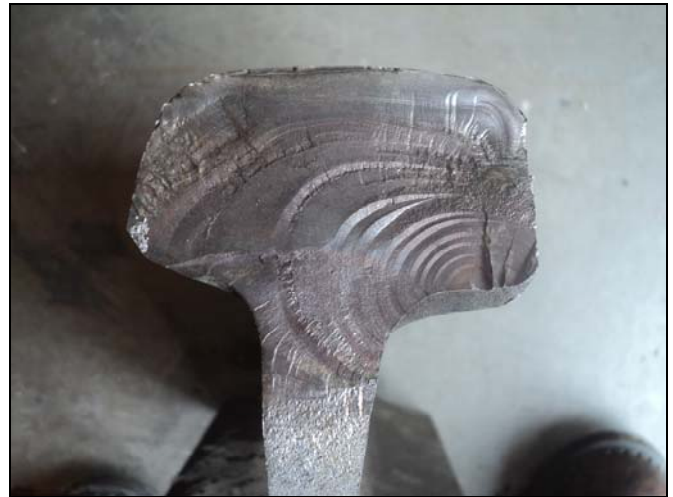
None of the original laboratory generated welds have failed in service and have accumulated 449 MGT of traffic. Of the eight mobile unit produced welds, two were removed for non test related maintenance on the track. Three of the mobile HDR welds experienced fatigue fractures in service. Figure 7 shows one of the fatigue fractures. One weld was identified by rail flaw detection to have a fatigue crack and was removed from service. Of the four welds that had fatigue cracking, three of these initiated at geometry transitions under the railhead and the fourth initiated under the railhead at a defect near the center of the insert. Figure 8 shows the sharp geometry transition under the railhead where three of the

fatigue cracks occurred. The bottom of the railhead has been identified as a high stress region in standard rail weld types, thermite railhead repair welds, and rails.³⁻⁵ (The geometry discontinuity under the railhead can be addressed with under head post weld grinding.)

Figure 7. Fatigue Fracture Initiated at Stress Concentrator at bottom of Railhead

1. The inserts are being machined to better match the rails, and the weld shear is being redesigned to better conform to the rail. The result of these changes will be a final weld that is more conformal to the rail and eliminates the sharp under head transition from rail to insert that acted as stress concentrators and contributed to fractures observed in this test. This change will also reduce the post weld grind time.

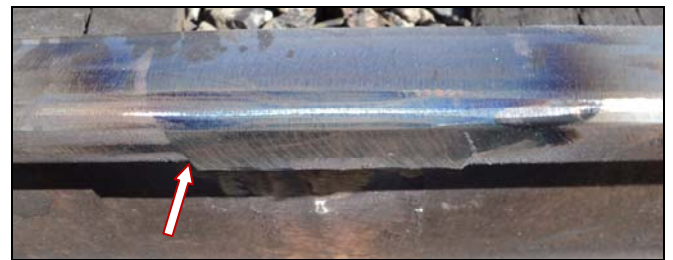
Figure 8. HDR Weld after Production (Arrow indicates geometry transition at the bottom of the railhead that acted as a stress concentrator)
