# Initial Service Testing Results of Thermite Welds with Treated Heat Affected Zones

Daniel Gutscher, Joseph LoPresti, and Martita Mullen\*

## Summary

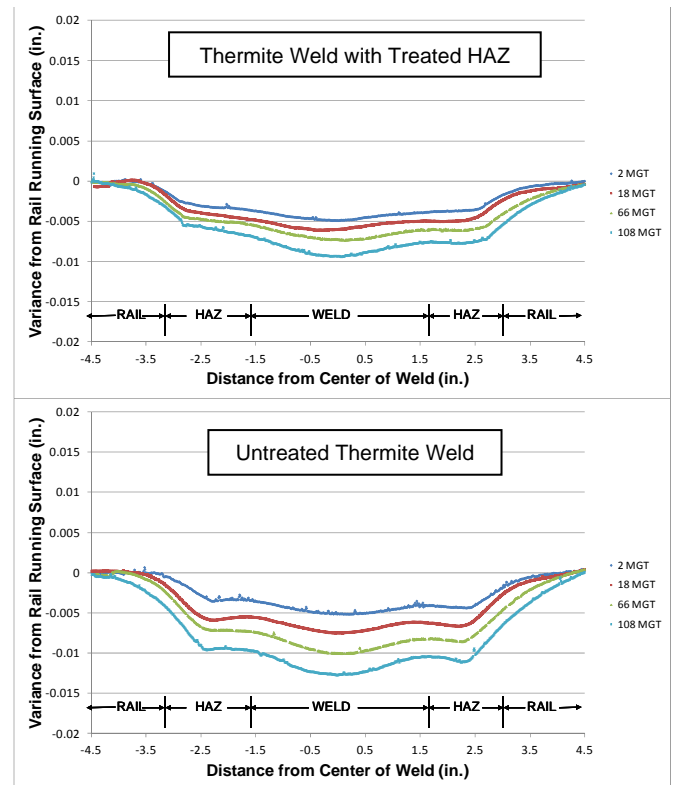
TTCI conducted longitudinal profile measurements of the welds along the centerline of the rail. Figure 1 shows representative profiles for a treated and an untreated weld. The first graph, a treated weld, shows minimal HAZ dipping, although still present. The second graph, an untreated weld, shows the HAZ dipping on both sides of the weld.

**Figure 1. Profiles for Two Welds in Test at FAST (Top) Thermite Weld with Treated HAZ, (Bottom) Untreated Thermite Weld**

The dipping in the HAZ of the treated weld is more than expected based on the preliminary testing conducted at FAST. This is likely due to a modification in the weld procedure that was implemented in this test. In the standard procedure, the overlay weld is applied to the top of the rail on the thermite HAZ starting at the gage side and finishing at the field side. The procedure implemented with this round of testing applied the overlay in two steps. The overlay weld started next to the gage side and ended at the center of the rail. Then a second weld was started at the field side and finished at the center of the railhead on top of the first overlay weld. Figure 2 illustrates these procedures. This process likely produced a second HAZ at the center of the railhead where the longitudinal profiles are taken. To evaluate this hypothesis, TTCI engineers will examine the internal microstructures of the welds as they are removed.

The treatment of the HAZ does not directly affect the thermite metal properties; however, from the two sets of profiles, the overlay does affect the rate of batter (represented by the vertical spacing between profiles) at the weld centerline. For the profiles shown, this is approximately a

30 percent reduction. This effect is likely due to a reduction in dynamic forces experienced by the weld because of a smoother transition across the weld running surface (i.e., the wheel does not impact the weld as hard).

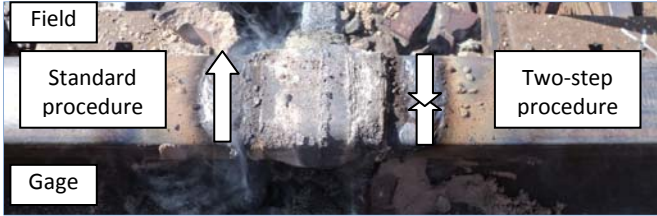
Figure 2. Two Weld Procedures showing Application of HAZ Overlay Next to Sheared Weld

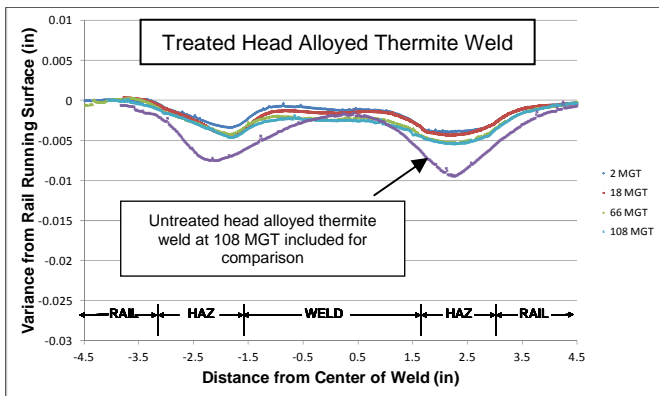
Figure 3 shows a series of longitudinal profiles for a head alloyed thermite weld with overlay treated HAZ. A profile for an untreated head alloyed weld is also included for comparison. There was approximately a 50 percent reduction in HAZ batter for the treated weld compared to the untreated weld. The combination of the two processes produced welds with the least amount of overall batter at the running surface.

Figure 3. Overlay Treated Head Alloyed Thermite Weld

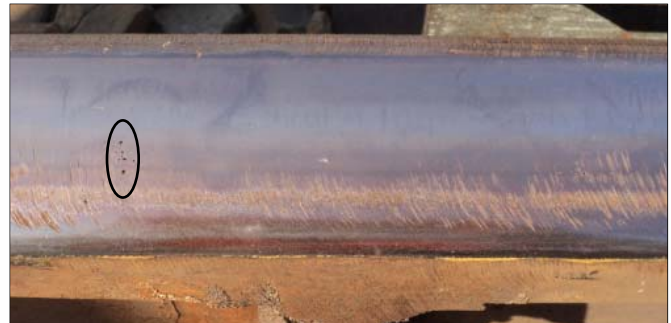
As of January 2014, none of the welds have failed and all remain in service. The welds near Superior, Wisconsin, have accumulated approximately 56 MGT, and the welds near Toronto and Winnipeg have accumulated approximately 51 MGT. Figures 4 and 5 show a treated weld and an untreated weld near Winnipeg. Visually, the treated weld shows almost no metal flow at the running surface while the untreated weld is already developing signs of lateral metal flow at the soft HAZ.

Figure 4. Treated Thermite Weld Running Surface at approximately 36 MGT, 5 MGT after Rail Grind (Oval indicates surface porosity at overlay.)

The overlay treatments were performed as soon as possible after the thermite weld head riser was sheared (but no later than 5 minutes after shearing). Upon completion of the overlay treatment, the weld was hot ground and then covered. In general, the application of the overlay treatment in service conditions worked well. The biggest challenge encountered was that several welds had porosity at the running surface where the overlay treatment was applied. The oval in Figure 4 shows porosity. TTCI is investigating automation of the overlay treatment, which should significantly reduce quality related issues such as porosity.

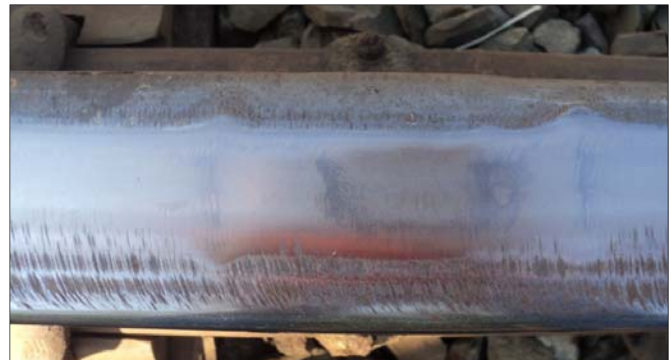
Figure 5. Untreated Thermite Weld Running Surface at approximately 36 MGT, 5 MGT after Rail Grind

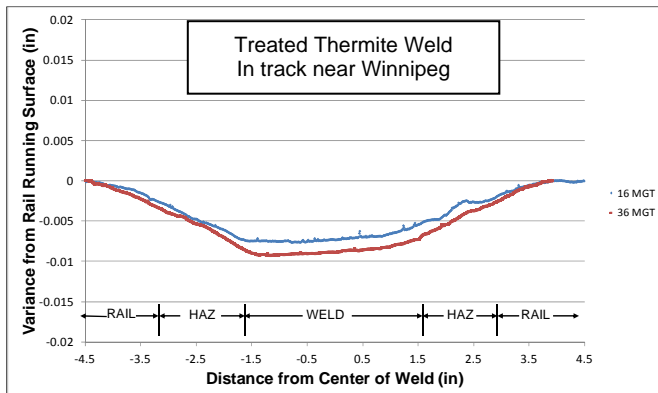
TTCI is monitoring weld longitudinal profiles twice yearly. Figure 6 shows the running surface profiles for one of the welds installed near Winnipeg. The treatment eliminated the HAZ dipping on the sides of the weld. More in-depth analysis will be conducted as additional tonnage is accumulated and data is collected.

Figure 6. Overlay Treated Thermite Weld in Track near Winnipeg

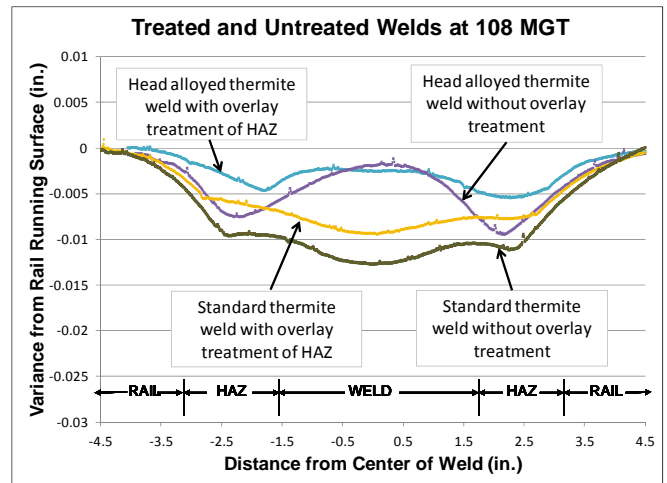
Welds at FAST have accumulated 108 MGT with one weld failure in a control weld as of January 2014. Figure 7 shows representative profiles for the four general weld/treatment combinations tested at FAST. Based on limited data, overlay treatments reduce the overall rate of thermite weld batter, including at the weld centerline. The combination of overlay treatment and alloying of the weld head produced the greatest reduction in running surface degradation.

Figure 7. Summary Profiles for FAST Test Welds at 108 MGT
