# Intermediate Strength Rail Testing at FAST: Wear, RCF, and Deep-Seated Shelling Analysis

Daniel Szablewski and Joseph LoPresti

## Summary

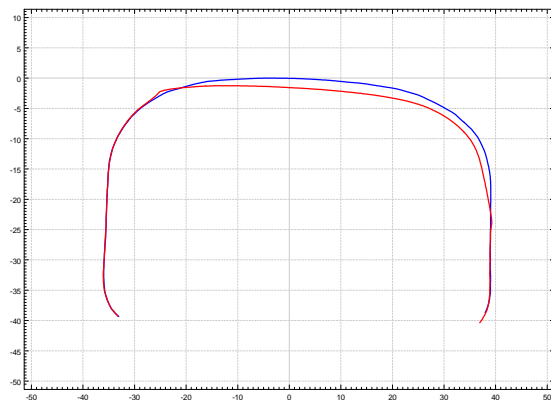
**Figure 1. Typical IS Rail Wear Representing High Rail Profile at 0 MGT (blue) and Worn Rail Profile at 340 MGT (red)**

Wear in the high rail is controlled by wayside GF lubrication using biodegradable lubricant. Figure 1 indicates typical wear differences between 0 MGT new rail profile (blue line) and 340 MGT worn rail profile (red line). Relatively minor wear on the high rail in that time frame is attributed to use of GF lubrication.

IS rail profile differences between 0 MGT and 340 MGT of accumulated tonnage (Figure 1) show that high-rail metal loss remained minimal. This is primarily due from the use of GF lubrication and lack of grinding on the high rail through the life of the test.

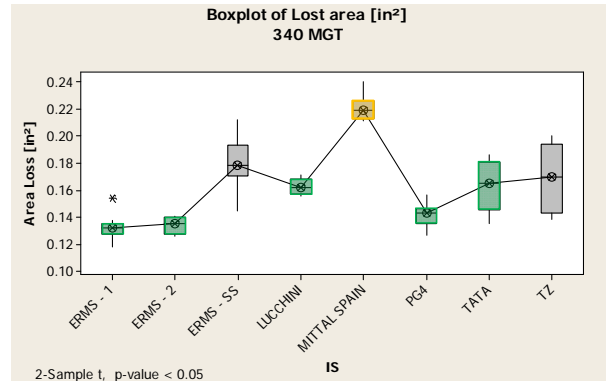
**Figure 2. Statistical Analysis of IS Rail Wear at 340 MGT of Accumulated Tonnage**

A two-sample t-test comparing ERMS-SS (standard strength) control rail type to other rails in the test zone at 340 MGT indicated that one rail type (Mittal Spain) has statistically more wear than the control rail, five rail types (namely, ERMS-1, ERMS-2, Lucchini, PG4, and TATA Steel) have less wear statistically than the control rail, and the TZ rail type has wear that is statistically no different from the control rail (Figure 2).

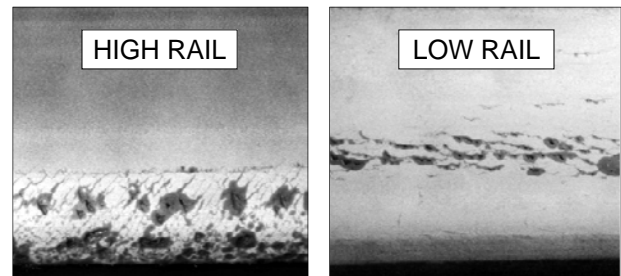
**Figure 3. Typical RCF Condition in the High Rail and Low Rail at 340 MGT of Accumulated Tonnage in IS Rail Test Curve; Rail GF is on the Bottom of Each Image (Note that visibility of RCF was enhanced with dye penetrant.)**

RCF on the IS high rail was initiated after more than 100 MGT of accumulated tonnage and progressed very slowly over time. It occurred uniformly in all of the test rails. RCF began on the GF corner of the rail and was confined mostly to the high rail location (Figure 3). This limited RCF (as compared to the premium rail test<sup>4</sup>) is due primarily to the use of wayside GF lubrication in the test curve, but benefits may also be attributed to the rail metallurgy. Figure 3 shows a typical high and low rail RCF condition at 340 MGT.

The low rail had RCF on the top surface of the rail. It initiated at approximately the same time as in the high rail and was also uniformly distributed through all the rail types tested. As Figure 3 shows, the RCF was present as a narrow band of longitudinal cracks. None of the cracks (in either high or low rail), however, led to rail critical failures.

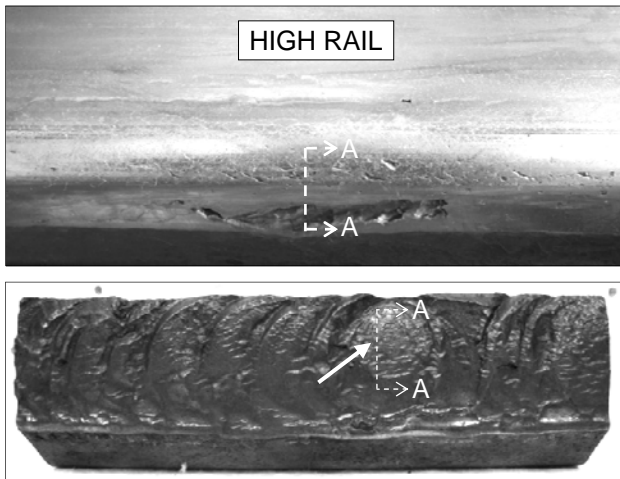
**Figure 4. Typical High Rail Gage Corner Shell Defect Indicating the Condition of the Running Surface (top image), and Opened-up Shell Fracture Surface Showing Defect Origin (arrow in bottom image)**

Closer inspection of shell defect surfaces revealed that all shell origins laid in very close proximity to the rail GF corner. An analysis of 11 shell origins indicated that their distribution lies at a vertical depth of 0.29±0.05 inch from the top running surface and at a horizontal distance of 0.43±0.06 inch from the high rail gage running surface.

Figure 4 indicates a typical GF shell defect, as seen from the outside (prior to exposing the defect fracture surface) and at the fracture surface (following exposing defect fracture surface), where shell origin is clearly identifiable.

Grinding allows overall stress reduction in the railhead, and it offers an effective way to reduce the fatigue damage at the shell initiation site by moving the stress field downward into the railhead and preventing a 2-point contact on the rail running surface. This would most likely prevent shell initiation.

The current IS rail test implements preventive grinding to displace the stressed zone downward into the railhead to prevent shell initiation.

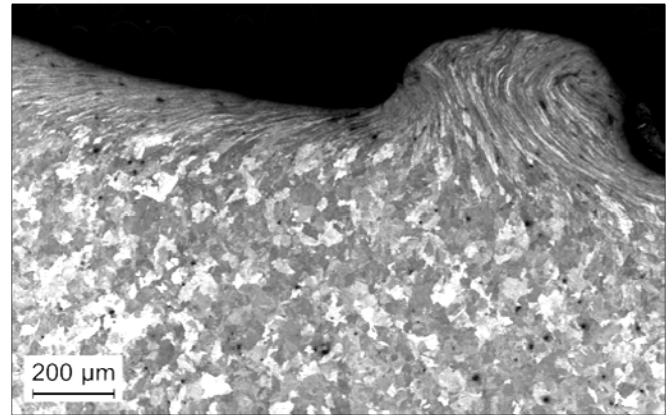
**Figure 5. Light Optical Microscopy Image of Cross-Sectional Microstructure at the Shell Origin (see A-A in Figure 4) Indicating Localized Microstructural Deformation**

Microstructural analysis of the shell origin cross-sections revealed that microstructures surrounding the shell initiation points were no different from the bulk rail microstructure and lacked any discontinuities (e.g., inclusions, porosity, cracks) that might have contributed to shell initiation. In some instances, these microstructures were locally deformed (Figure 5). However, these localized deformations are believed to have been caused in the post-fracture rubbing of the two cracked rail surfaces during train operation, which resulted in microstructural deformities. These microstructural artifacts are not believed to be related to shell initiations.

Traverse hardness profiles were taken through some shell origin locations (both above and below the shell origins). This analysis indicated smooth hardness transitions through the shell origins supporting the observation of visible lack of microstructural inhomogeneities surrounding the shell origins. In addition, microsegregation at the shell origin location was not found in any of the shell defect cross-sections.

mainly to lack of a GF lubrication on the premium rail test curve). Considering that fact and in light of the information presented above, namely, presence of localized shell origins, lack of any microstructural inhomogeneities in the vicinity of shell origins, and a lack of hardness increase surrounding shell origins suggest that shell defects are most likely not due to the rail microstructure but rather are related to the load environment in the railhead through the life cycle of the rail. Rail mechanical properties may have contributed to shell initiation as well.
