Steel Bridge Life Extension for Welded Girder Span at FAST

Duane Otter

Summary

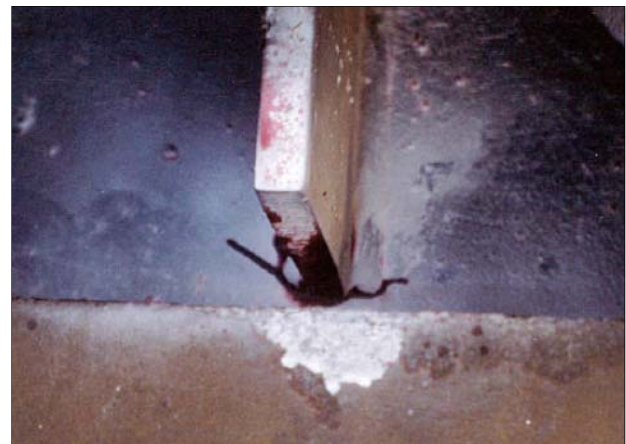
During the 16 years that the 65-foot welded girder span was in service at FAST, more than 40 cracks developed. Many of the cracks initiated at the bottom of the intermediate stiffeners, just above the tension flange, as Figure 2 shows. Cracking of this type has been commonly noted in welded steel girder spans.⁵ In three cases during the early years, crack stop holes were drilled at the crack tips to halt crack propagation.² In each case, no further crack growth was noted after more than a decade of service. In many cases, the ends of the cracks were simply marked and monitored for further crack growth. In many cases for these below-the-stiffener cracks, crack growth halted with a crack length of about 2 inches or less on either side of a stiffener. For most of these cracks, routine inspection turned out to be sufficient for keeping the span in service for regular train operations; as long as the crack did not continue to grow, no remedial action was taken.

Figure 2: Web Crack beneath Intermediate Stiffener Just Above Tension Flange

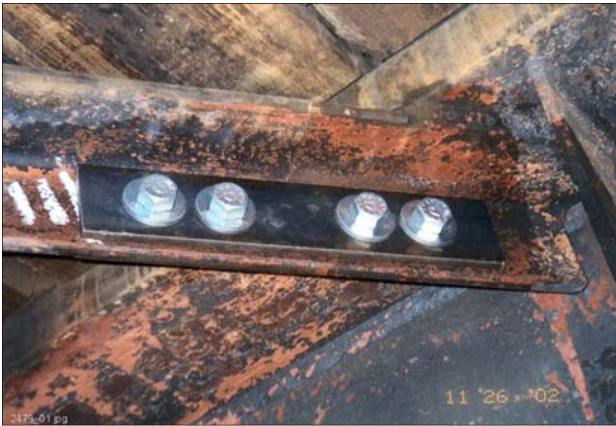
Testing of movable bridge rail joints introduced dynamic vertical wheel load impacts into the steel bridge spans. Some of the rail joint assemblies tested were attached to the adjoining running rails with bolted rail joints rather than with welds, introducing even more wheel impact locations. The impacts increased the rate of crack growth at locations near the joints. Cracks also developed in top lateral bracing members near joints.^{6,7} Cracks in the top lateral bracing members tended to propagate quickly. In some cases, the cracks grew from partial to complete in a matter of only one or two days of train operations. In other cases, the cracks were not discovered until they were completely through the cross section of the member. Over the 16 years of train operations, a total of five lateral braces developed complete cracks. In each case, the crack appeared to initiate at the weld connecting the brace to the top flange of the girder.

Figure 3: Simple Bolted Splice Repair to Top Lateral Brace

In each case of a cracked top lateral brace, the brace was repaired using a simple bolted splice on one leg of the angle, as Figure 3 shows. Due to the location of the cracks, it was not feasible to splice the other leg of the angle in a similar fashion. In each case, the bolted splice performed well. Two of the splices served for over 1,500 MGT and two more served for over 1,200 MGT. The fifth splice was installed much more recently. These simple splice repairs are much easier and quicker to make than a full member replacement.
