# Long-Term Performance of Bridge Approach Remedies Implemented at Western Mega Site

Dingqing Li, Rafael Jimenez, Jay Baillargeon, TTCI  
Luis Maal, FRA

## Summary

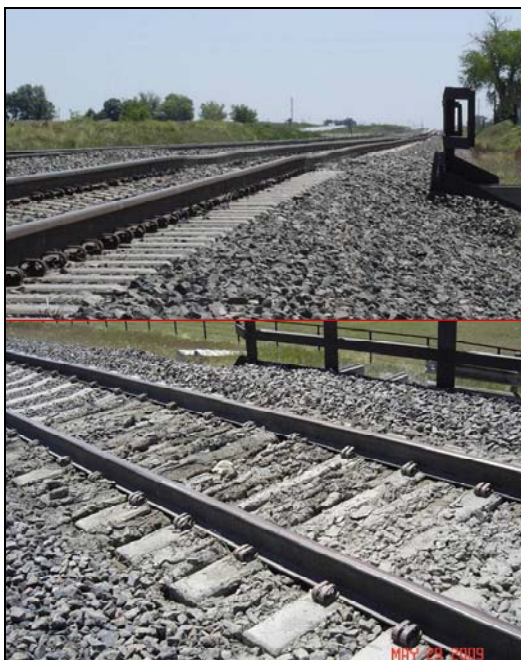
At bridge approaches, track inherently deforms and settles more due to HAL train operations than the track on the bridge, as a result of the change in track structure from the open track to the bridge. In general, for the track on the bridge, there is less ballast and no subballast, and obviously no subgrade foundation, as compared to the adjacent open track. As a result, differential track settlement (Figure 1 top) would occur along the track, leading to higher dynamic vehicle-track interaction.

**Figure 1. Rough Track Geometry and Mud Pumping Associated with Bridge Approaches**

In some cases, development of differential track settlement, in conjunction with high track stiffness and low track damping, produces a vicious cycle, leading to higher dynamic wheel-rail forces, larger differential track settlement, degradation of ballast particles, and mud pumping when track drainage condition is also poor. Figure 1 bottom shows such an example of mud pumping. At one bridge location at the western mega site, measurements of dynamic wheel loads have shown that the maximum dynamic wheel loads generated were three times as high as the static wheel loads (Figure 2 and Reference 2).

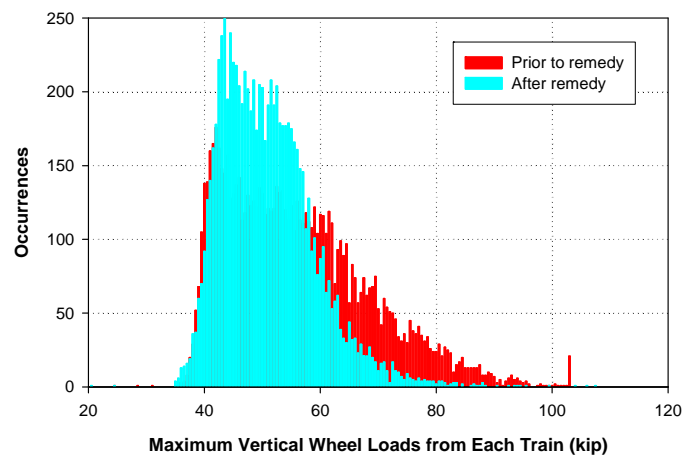
**Figure 2. Maximum Dynamic Wheel Loads at a Bridge Location Measured before and after Remediation**

At the first bridge location, dynamic responses (i.e., wheel-rail forces, vibration of rails and ties, and bending strains of concrete ties and bridge beam) were measured before and after remediation.<sup>2</sup> Figure 2 shows a considerable reduction of maximum dynamic impact forces, especially in the range of 60,000 to 105,000 pounds, as a result of improved track geometry, track stiffness, and damping characteristics.

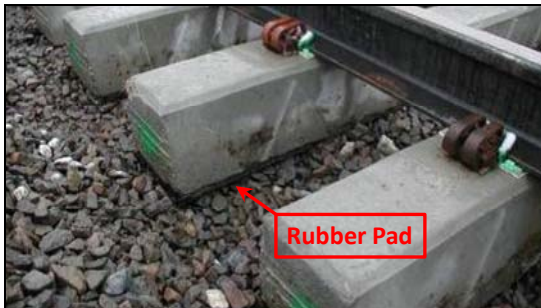
Figure 3. Concrete Ties Fitted With Rubber Pads

In September 2007, a short single-span ballast deck concrete bridge was reconfigured with concrete ties fitted with rubber pads on the bottom surface (Figure 3) and, in June 2009 a 3-span ballast deck steel bridge was reconfigured with a ballast mat installed between the ballast layer and the bridge deck (Figure 4). Before remediation, both bridges and their approaches had problems similar to those shown in the photos in Figure 1, which were taken at the second bridge location. As part of the remediation, degraded ballast was replaced with at least 12 inches of new ballast between the bottom of the ties and the surface of the bridge deck. The ballast section of the 3-span steel bridge, which had a minimum depth of 10 inches before remediation, was replaced with a 14.5-inch section.

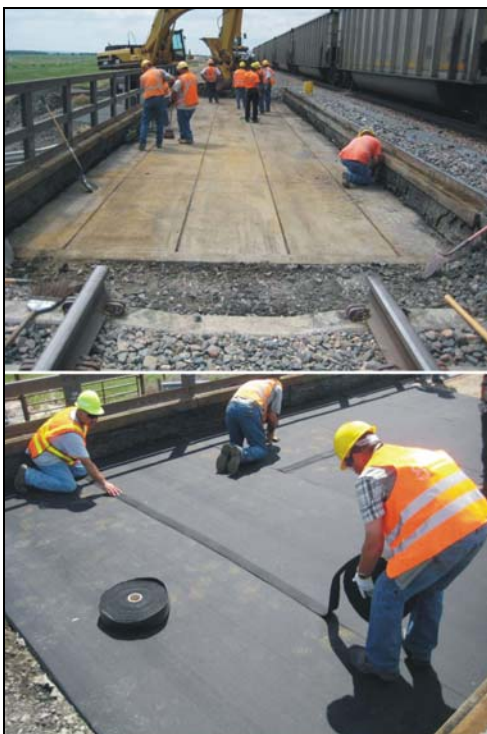
Figure 4. Ballast Mats for a Bridge at Western Mega Site

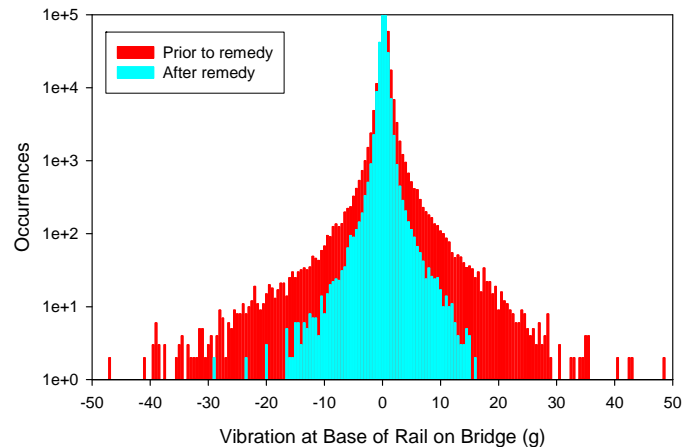
Consistent with what is shown in Figure 2, installation of the remedy led to a considerable reduction in high amplitude vibration expressed in terms of acceleration, e.g., from 50 g to 20 g for the vertical acceleration measured on the rails, as illustrated in Figure 5, indicating improved track component performance. In addition, for bending strains on the bottom surface of the concrete bridge, a 30 percent reduction was achieved by implementing this remedy, as Figure 6 shows, indicating improved bridge span performance.

Figure 5. Reduction of Vibration from Remedy

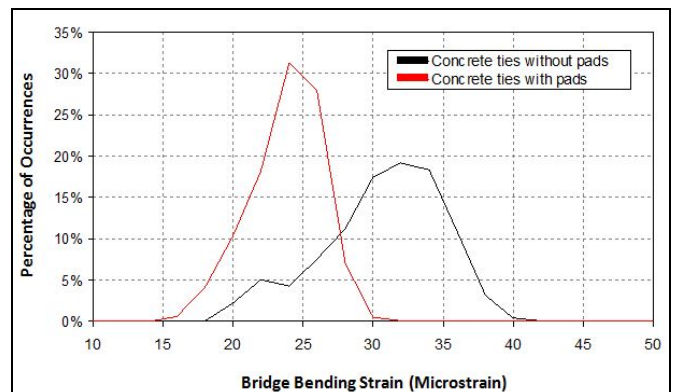
Figure 6. Reduction in Bending Strains from Remedy

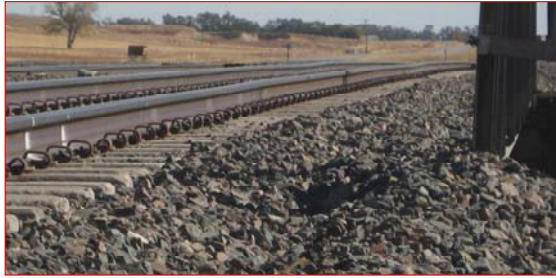
Figure 7 (top) shows rough track geometry already developing at the third bridge location only two months after the conventional undercutting and tamping operations. In contrast, Figure 7 (bottom) shows that good track geometry was sustained two years after the remediation at the second bridge location.

MP 80.5, two months (40 MGT) after conventional undercutting maintenance

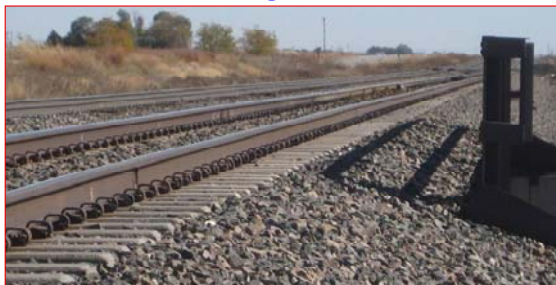
MP 78.2, two years (480 MGT) after ballast mat/drainage installation

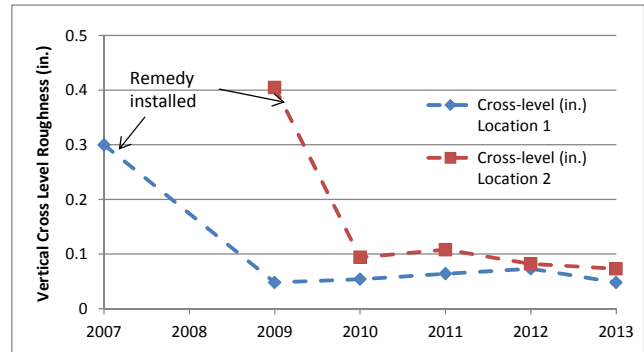
Figure 8 shows improvement of track geometry conditions. In Figure 8, track cross levels measured from track geometry inspection vehicles were processed as roughness from the years (2007 and 2009) when the installation of rubber pad and ballast mat remedies were completed. Both bridge locations show track surface geometry conditions have improved during the time the two remedies were implemented.

**Figure 8. Track Geometry Roughness Improvement for the Two Locations Implemented with Remedies**
