# Damage Observed on the Treads of Wheels Removed from Revenue Service

Harry Tournay, Sabri Cakdi, and Kerry Jones

## Summary

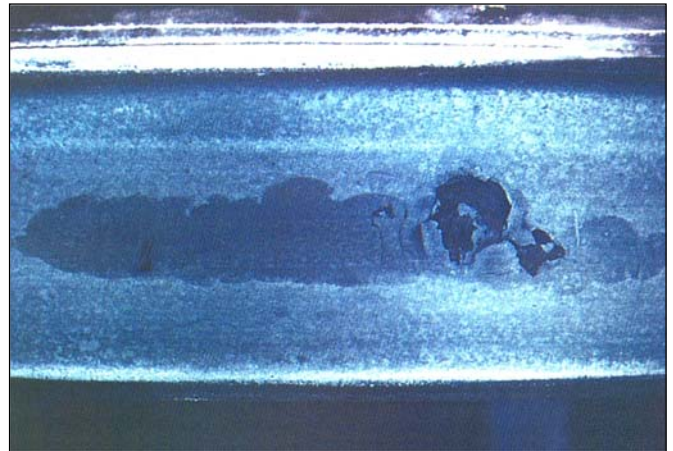
This damage is typically associated with unreleased hand brakes and is cataloged here for completeness (Figure 1).

Figure 1 shows the results of a single slip event; however, multiple slips can occur.

Figure 1. Typical Brake-Related Spalling showing Etched Martensite

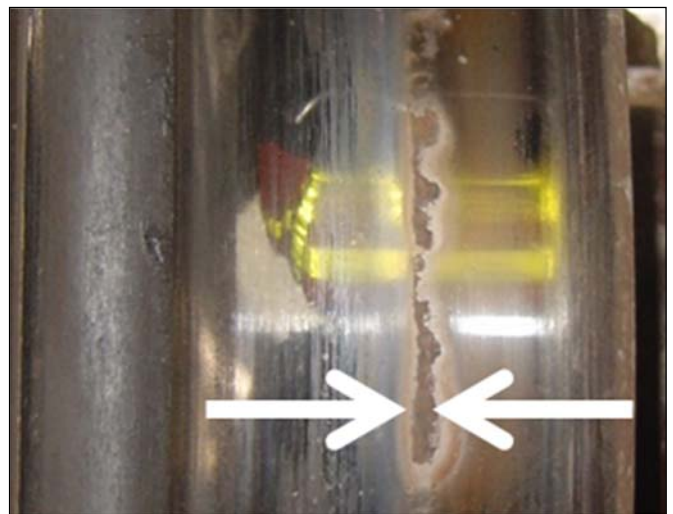
An unusual form of tread damage has been observed (Figure 2). It has been provisionally cataloged as "continuous spalling," because it has the appearance of a spall, but occurring in a continuous slip mode.

Figure 2. Continuous Spalling

Continuous spalling occurs on or near to the tape line (Figure 2). It is of limited width (Figure 3), which suggests a small contact patch and, in turn, light car conditions. The edge of the region of damage towards the flange is generally more sharply defined and linear than that to the field side. Material break out is preceded by lateral cracking (Figure 3).

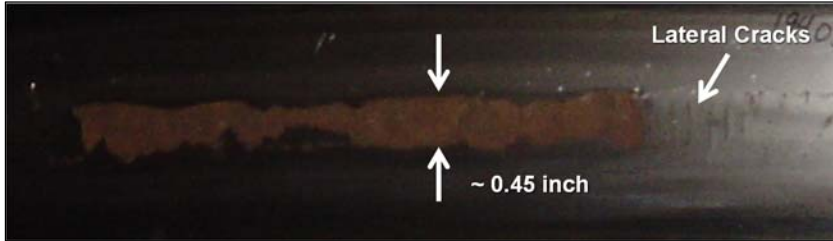
Figure 3. Continuous Spalling: Detail

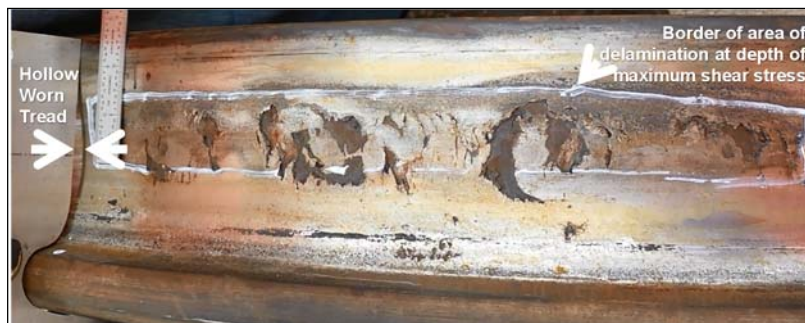
Delamination occurs typically at the depth of the maximum shear stress associated with Hertzian contact (approximately 1/8 inch below the tread surface) (Figure 4).

Delamination can occur without material break out. Figure 4 shows regions of delamination indicated by ultrasonic (UT) inspection. Care should be taken interpreting the borders of this delaminated area. The indicated area is probably larger than the actual delamination as UT measurement is a function of the size of the UT probe and the “spread” of the UT signal into the wheel.

Delamination can also result in material break out resulting in shelling, as Figure 4 shows. This results in HIWs and was the reason for removal of the wheel from service.

Figure 4. Delamination and Shelling

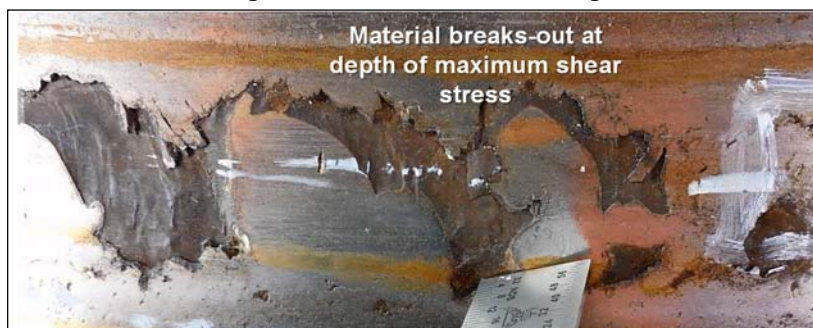
Note that the shelled wheel in Figure 5 shows no sign of surface cracks that might be indicative of scuffing-related failure discussed elsewhere in this TD. Figure 5 shows details of the shelling failure. There are no signs of fatigue beach marks that might be associated with crack growth. TTCI research suggests that beach marks may be worn-away through fretting during the delamination stage of failure prior to break out of the delaminated portion of the tread.

Figure 5. Detail of Shelling Failure

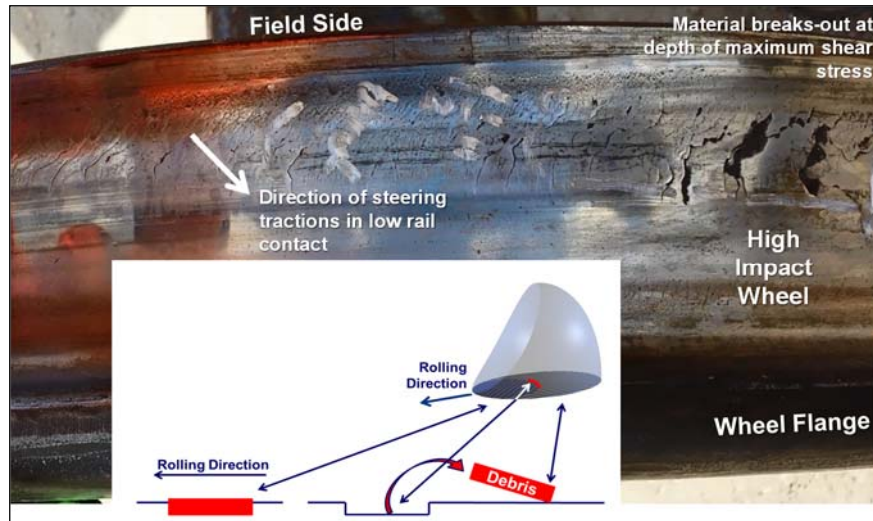
Scuffing-related tread failure is associated with surface damage (scuffing) of the tread, generally on the field side of the tape line. This progresses to the formation of cracks, generally at 45-degrees to the direction of rolling, and then to the break out of material from the wheel tread to form HIWs.

Failure is initiated by high tractions in low rail contact. The failure mechanism occurs as follows:

- Low rail tractions, acting generally at 45 degrees to the direction of rolling, cause wear debris to be removed from the tread surface.
- This results in lines of pitting or scuffing at approximately 45 degrees to the rolling direction (see Figure 6).
- Subsequent rolling results in surface flow and subsequent crack formation (see Figure 7 and left-hand side of Figure 6).
- Further rolling causes the cracks to widen and break out in a progression similar to what is observed from the left- to right-hand side of Figure 6.

Figure 6. Scuffing-Related Tread Failure

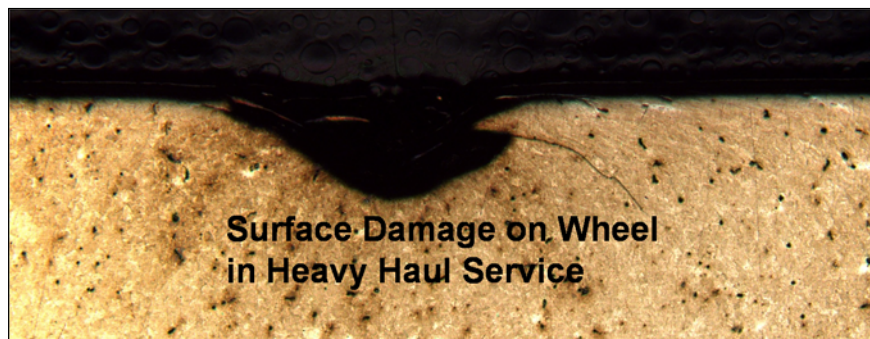
Figure 7. Material Flow and Crack Formation Associated with Scuffing

Scuffing-related tread damage may be related to the development of field-side crack bands.
