Testing of Thermite Welds with Treated Heat Affected Zones

Megan Archuleta, Daniel Gutscher, and Joseph LoPresti

Summary

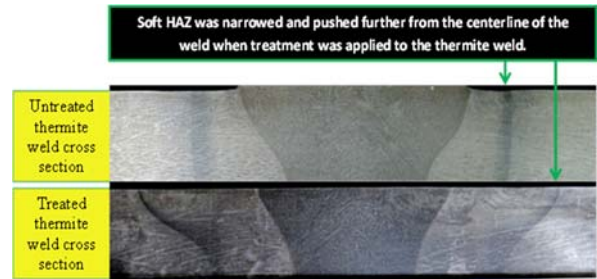
Figure 2. Image showing Narrowed Soft HAZ of a Treated Thermite Weld

The heat from the overlay narrows and pushes the soft HAZ outward from the weld centerline, which increases the width of the higher hardness re-austenitized HAZ of the weld along and immediately below the running surface.

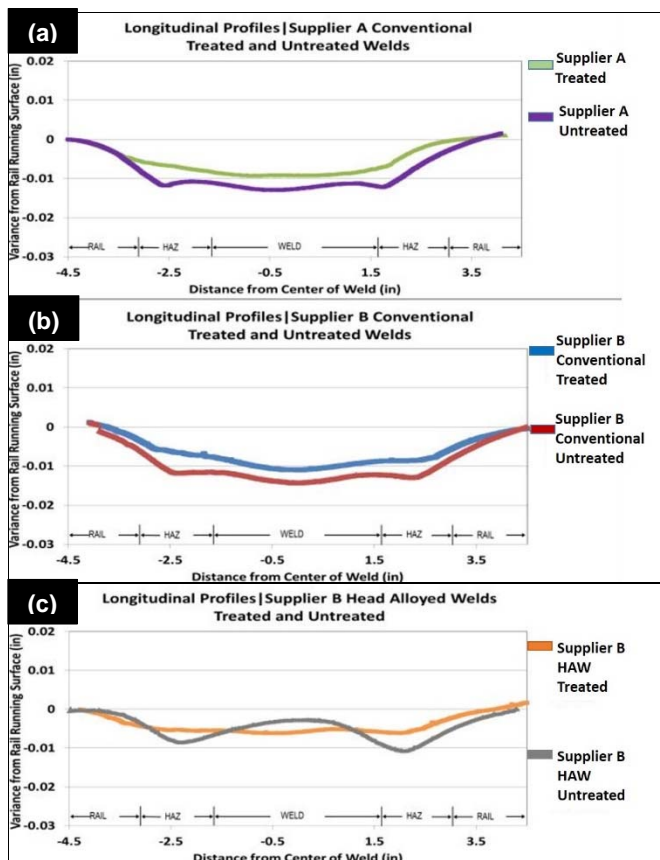
Figure 5. Longitudinal Profiles showing HAZ Overlay Treated vs. Untreated Weld for (a) Supplier A Conventional Welds, (b) Supplier B Conventional Welds, and (c) Supplier B Head Alloyed Welds at 166 MGT

Figure 5, (a) (b) (c), shows the longitudinal profiles taken down the center line of the rail for all types of welds and HAZ overlay combinations at 166 MGT. As Figure 5 (a) and (b) show, the conventional thermite welds without the overlay treatment of the HAZ indicate greater metal deformation (dips) at the soft HAZ locations. These dips represent the metal flow that occurs from dynamic wheel loading. The batter of the treated welds was about 30 percent less than the control and untreated thermite welds. In Figure 5 (c), the HAWs without the overlay treatment of the HAZ also show HAZ dipping similar to the conventional untreated thermite welds; however, the harder weld material resulted in less weld batter than in the conventional untreated and treated welds. The combination of a HAW and overlay treatment of the HAZ resulted in the least batter and provided the best running surface.

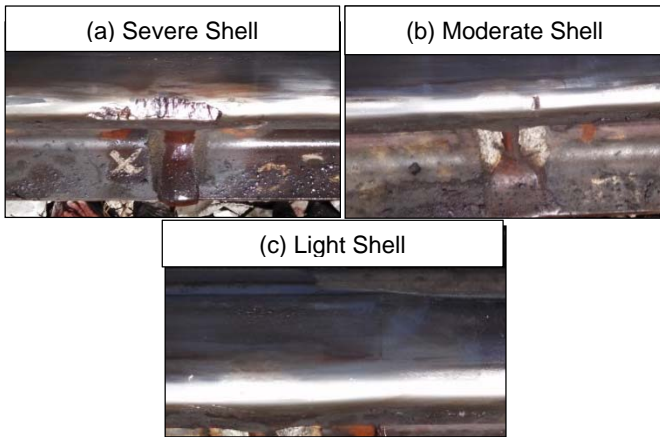
Figure 6. Photos of (a) Severe Shell, (b) Moderate Shell, and (c) Light Shell after the Welds were removed from Track

Supplier A had two treated welds that failed because of shells; both shells were labeled as light in severity, as Figure 6 (c) shows. For the conventional welds from Supplier B, five treated welds were removed at 166 MGT and 239 MGT. These welds, however, were extracted from the rail with more moderate to severe shell severity, as Figure 6 (a) and (b) show. All untreated welds, except for the two still in track, were of moderate to severe shell severity and failed within 192 MGT to 240 MGT.

A severe shell was labeled as a shell that was formed with chip out greater than an inch long; whereas, a moderate shell was described as a shell with less than an inch of chip out. A defect that was considered light in nature was a shell that was located visually or by using ultrasonic detection but has not yet chipped out.

Shelling is a common failure mode for thermite welds at FAST, which is more likely to occur when welds and adjacent rail are not periodically ground. There is no clear evidence that HAZ overlay treatment reduces the tendency for shelling under these conditions.

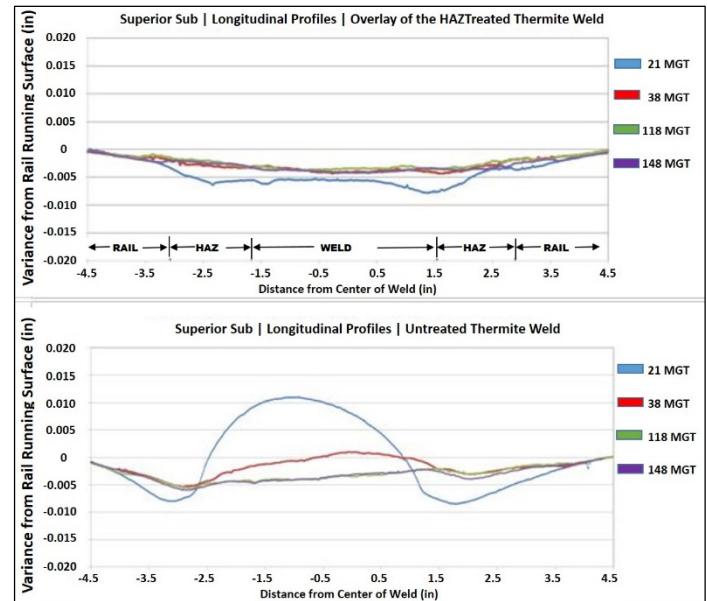
Figure 7. Longitudinal Profiles from an Untreated Weld and Overlay Treatment of the HAZ Weld at One of the CN Test Sites

At the CN test locations, the test welds receive approximately 60 MGT of traffic yearly. The rails are ground semi-annually. The rail grinds reduce the differences in longitudinal profiles, as Figure 7 shows. Frequent grinding removes the metal flow in untreated thermite welds and can provide a possible alternative to the overlay of the HAZ process.
