# Second-Generation Head Defect Repair Weld Testing at FAST

## Summary

**SECOND-GENERATION HDR WELDS**

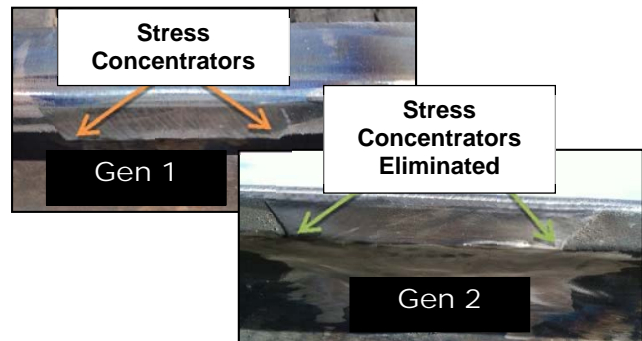
Special attention was given to the rough and finish grinding of the second-generation HDR insert in relation to the rest of the rail in order to address one of the failure modes of the first-generation HDR welds. With the first-generation welds, although the welds were ground by the supplier to meet their requirements, finish grinding did not completely smooth out the corners of the insert that were located at the point where

the lowest corner of the insert meets the bottom of the railhead. This created stress concentrators at these locations (see Figure 2).

Figure 2. Generation 1 vs. Generation 2 Welds after rough and finish grinding

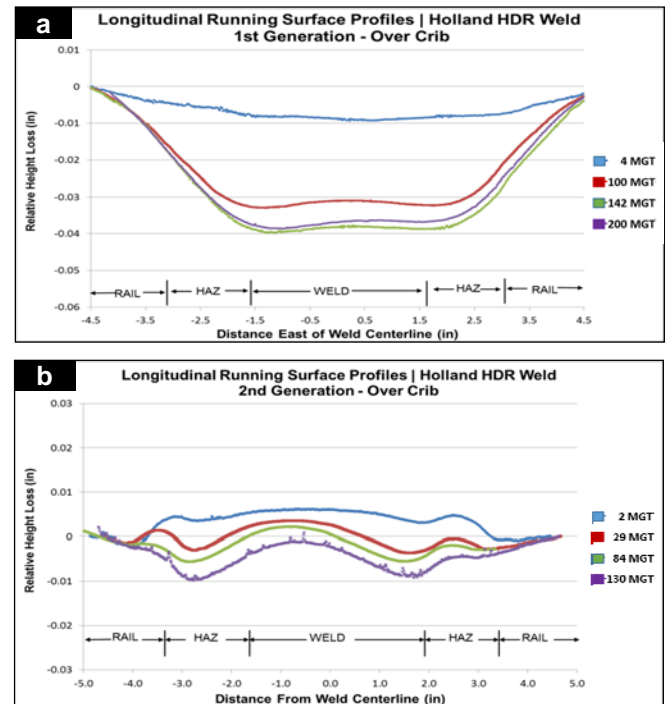
As with the previous HDR weld tests at FAST, longitudinal profile and hardness tests were periodically recorded for each second-generation HDR weld. Profiles taken at various million gross tons were overlaid to show the wear over time for the second-generation HDR welds. As Figure 3 shows, the amount of wear and deformation of the (b) second-generation testing is about 44 percent less than that of the (a) first-generation welds.

Figure 3. Longitudinal Profiles showing the Difference between the (a) Wear of the First-Generation HDR Welds and the (b) Wear of the Second-Generation HDR Welds

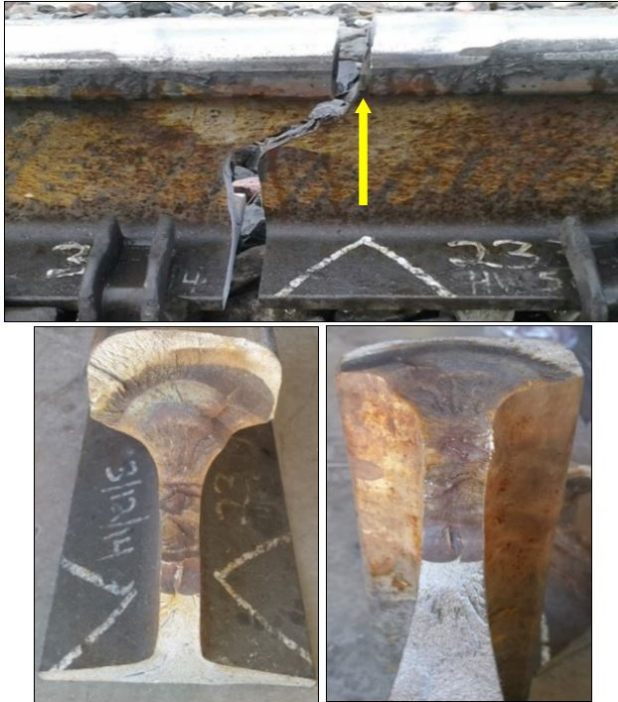
Even with the modifications implemented for the second-generation HDR welds, a weld break nevertheless occurred in August 2014 after only 86 MGT. The weld broke vertically near the center of the HDR insert location. Figure 4 shows different views of the rail break.

**Figure 4. Weld Break, August 2014**  
(The yellow arrow points to the center of the HDR insert)

Holland in collaboration with EWI examined this weld optically to find the initiation and cause of the break. Both sides of the fractured area were mounted and polished and the fatigue striations were carefully examined to find the crack initiation site. An apparent lip or lap was found to coincide with this initiation site. This lip was likely material that was not removed by the grinding process after the welding. This small lip remained even though the weld was carefully ground by the supplier, and the surface appeared to be smooth. A narrow layer of metal was not fully connected to the web of the rail, and this acted as a stress concentrator for fatigue crack initiation. The findings noted that the likely cause of this break was a lip or lap of weld material that was unground and acted as a stress concentrator.<sup>2</sup>

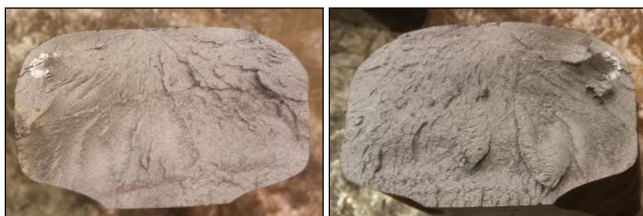
After the break that occurred at the end of August 2014, Transportation Technology Center, Inc. (TTCI) performed nondestructive testing (NDT) ultrasonic scans on the remaining welds. Indications were found at the fusion line in the railhead of most of the welds. TTCI removed one weld containing a 9-percent cross-sectional head area (CSHA) defect and opened it up in the laboratory to determine the cause of the indication (Figure 5).

**Figure 5. Weld Removed after Hand Scanning found a 9-percent CSHA NDT Indication within Weld**

EWI subsequently examined the weld that was removed using Scanning Electron Microscopy (SEM) and Energy Dispersive Spectrometer (EDS) chemical analyses. A “shiny spot” was located and SEM images indicated globular-shaped particles that melted and resolidified without any bonding. The EDS data suggested manganese-sulfur-silicate inclusions that were smashed flat during the welding process and created a “flat spot” in the joint. The flat spot acted as a stress concentrator allowing progressive crack growth with continuous fatigue of the rail.<sup>3</sup>

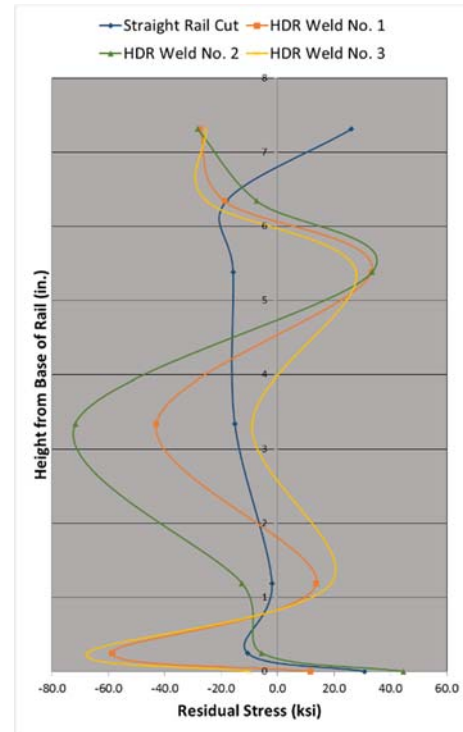
Figure 8 shows the results of the residual stresses when compared to each other. A straight rail which was cut longitudinally was also included for reference of the rail that the welds were installed in. This profile was obtained from a previous residual stress test when the rail was cut in April 2009.<sup>4</sup>

The longitudinal residual stress profile for the new rail was primarily in compression with the exception of the top of the head and the base of the rail, which were in tension.<sup>4</sup> This differs from the HDR residual stress profiles, which are in compression at the top of rail and web and in tension under the railhead making this portion of the weld more susceptible to fracture at stress concentrators under the railhead.

**Figure 8. Longitudinal Residual Stress Profiles for all Three Welds Tested and a Straight Rail Cut**
