# Analysis of Turnout Failure Modes in Revenue Service

Benjamin Bakkum, David D. Davis, and Rafael Jimenez

## Summary

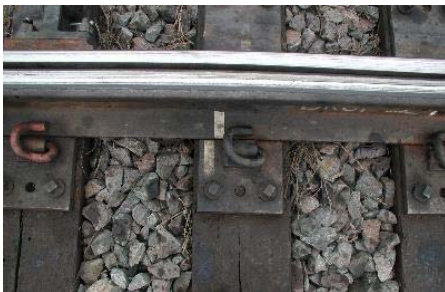
**Figure 2. Longitudinal Movement in Rail**

- **Rail Running:** Longitudinal movement of rail in the turnout that results in the switch operating rods becoming pinned or caught on switch timbers, which prevents the switch from lining properly when requested by the dispatcher. Proposed research includes an investigation into longitudinal movement of rail in switch points.

1. Longitudinal movement of rail in switch points (Figure 2) causes a substantial amount of failures and train delays, but relatively little research has been performed to date on how rail moves in a turnout based on daily fluctuations in temperature. TTCI would like to study this phenomenon more and address the unwanted movement of the rail that results in improper switch operation.

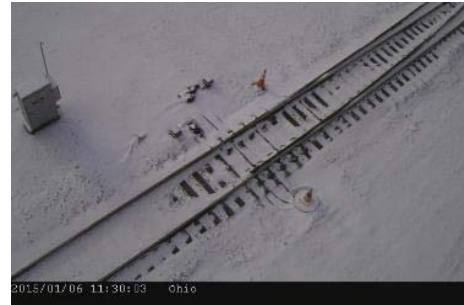
**Figure 3. Snow and Ice in Switch Point**

- **Snow/Ice:** Inclement winter weather overwhelms current switch heaters. Snow and ice build up in the switch points and prevent the switch from throwing properly. Proposed research includes an in-depth look at prevention of snow and ice buildup in turnouts using the switch heater/melter technologies available to the industry.

2. Another leading cause of switch problems is due to the buildup of snow and ice in the switch points (Figure 3). The railroads use various types of switch heaters to try and address these weather-based issues with varying degrees of success. TTCI would like to take an in-depth look at addressing the prevention of

snow and ice buildup in switches and study the impact of environmental variables.

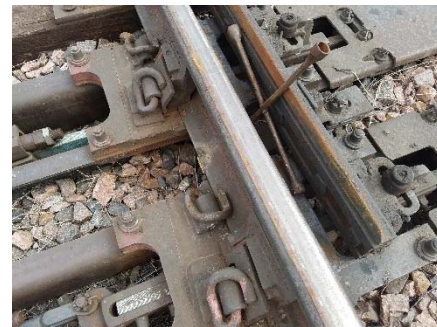
**Figure 4. Foreign Object in Switch Point**

- **Switch Obstructions:** Foreign objects often become lodged in switch points and result in the inoperability of the switch. Typically, these obstructions are either intentionally placed by trespassers, or are simply debris that falls off a passing train. Proposed research would address the operational impact caused by obstructed switches by investigating a conceptual obstruction detection technology.

3. Foreign objects become lodged in the switch point area (Figure 4) and prevent proper operation. TTCI would like to explore methods of detecting and preventing switch point obstructions before they cause train delays. While some work has been performed on detecting obstructions at grade crossings and in open stretches of track, little has been done on detecting obstructions in switch points.
