Member-Level Redundancy for Steel Bridge Girders

Anna M. Rakoczy, Ph.D. and Duane Otter, Ph.D., P.E.

Summary

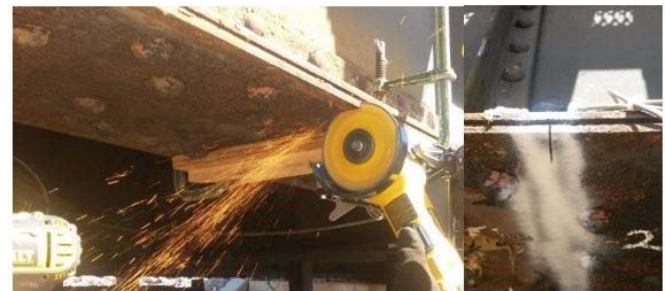
Figure 4. Three Notches Cut into Bottom Cover Plate of 32-foot Span South Girder

Defects were installed in the bottom partial length cover plate (tension flange) of the 32-foot span. The girder cross section at mid-span is shown in Figure 3. Defects were introduced in the partial length bottom cover plate of the most heavily loaded girder (south side, high rail) in order to provide stress concentrations in which cracks might initiate and propagate. Defects were installed at locations near centerline. Defects consist of three notches ground in the bottom cover plate (Figure 4).

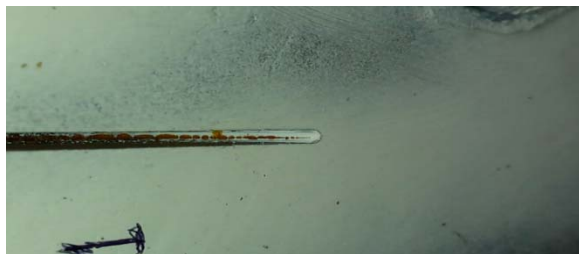
Figure 6. Crack in the Notch

The defects on the bottom flange were introduced in September 2015. Since that time, 154 MGT has been accumulated. There are cracks visible in each of the three notches (Figure 6). However, no cracks have propagated beyond the notches to date.

Figure 8 shows stresses on the south girder since September 2015, and they also are at the same level since the defects were introduced. The bridge will continue to be monitored, inspected frequently, and evaluated for repair should crack growth or a fracture occur.
