## Continued Performance of a High-Angle Crossing Diamond at FAST

### Part 1: Frog Bolts

Rafael Jimenez, Stephen Wilk, Kerry Jones, and David Davis

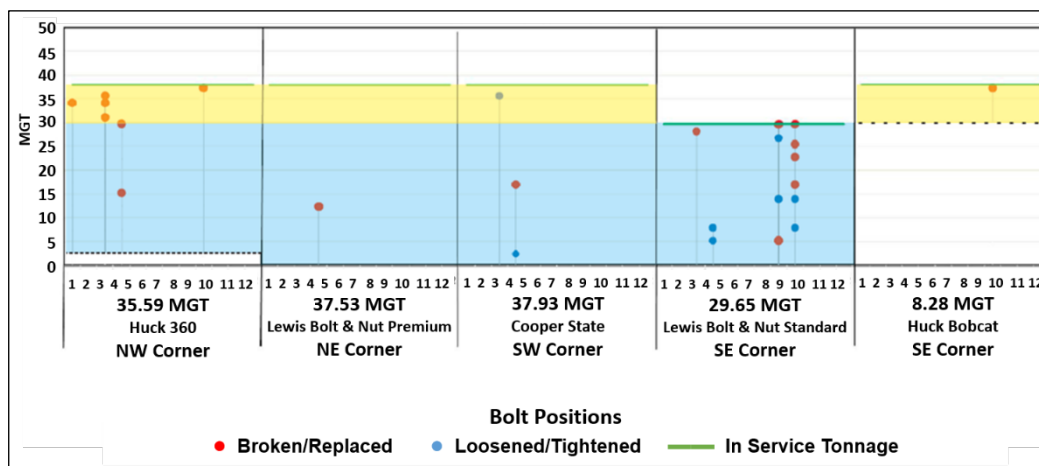
Figure 4. Record of loosened and fractured bolts

The primary failure modes/maintenance were fractured bolts, loosened bolts, and rail cracks. At the conclusion of the 38 MGT test, 17 of 65 bolts (26 percent) fractured and were replaced, and 8 of 65 bolts (12 percent) loosened and were retightened. Two bolts were retightened twice.

The graph in Figure 4 shows the record of loosened and fractured bolts over the course of the test. Six of the 8 bolts (75 percent) that loosened were in the difficult to tighten locations near the vertex of the acute angle (Bolts 3, 4, 9, and 10). When bolts loosened, they were re-torqued and when they fractured, they were replaced with the same type of bolt.

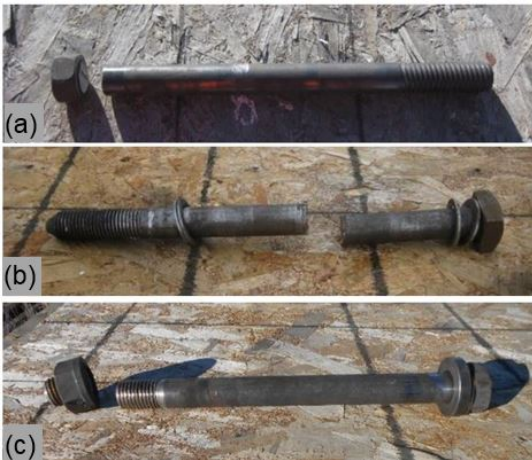
Bolt fractures occurred (a) near the head/shank radius, (b) at the shank, and (c) in the threads, as shown in Figure 5. The likely cause of failure was fatigue cracking.

Figure 5. (a) NW Corner, Bolt 3 (Huck 360), 33.23 MGT; (b) SW Corner, Bolt 4 (Copper State), 16.90 MGT; (c) NE Corner, Bolt 4 (LB&N Self-Centering), 12.32 MGT

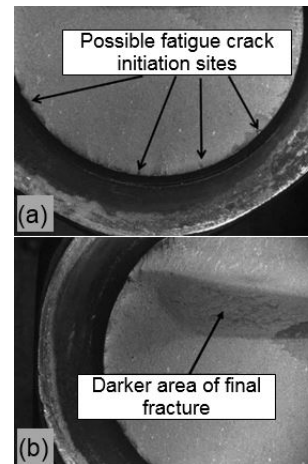
Two bolt heads were taken to TTCI’s onsite metallurgy lab for failure analysis: Sample 1 bolt hole 3, NW corner, fractured at 31.70 MGT, and Sample 2 bolt hole 3, NW corner fractured at 33.23 MGT. The fracture faces of both bolts were mostly light grey with a fine texture; each face also contained a darker, coarse grained area (Figure 6a). Because the fractures were similar, the photographs in this report were all taken from Sample 2. The likely cause of failure was fatigue cracking. The cracks initiated at multiple locations, some of which are shown in Figure 6b. No void, inclusion, or other discontinuity was found as a root cause for the fatigue crack. The propagating crack created the fine, light grey surface. When the bolt could no longer support the loading conditions, fast final fracture occurred and created the coarse, dark areas.

Figure 6. (a) Coarse region indicates final fracture area; (b) Possible multiple crack initiation sites

Given the bolt failures and related bolt hole-initiation cracking that occurred in the rail during this test, the focus going forward may be on eliminating contact between the bolts and the bolt holes, reducing/modifying contact between castings and rails, and providing a stronger rail section (e.g., thick web) at the connections. A simple solution may be to use larger diameter holes in the running rails than those used in the castings and filler blocks.
