Continued Performance of a High-Angle Crossing Diamond at FAST

Part 2: Casting and Rail Components

Rafael Jimenez, Stephen Wilk, Kerry Jones, and David Davis

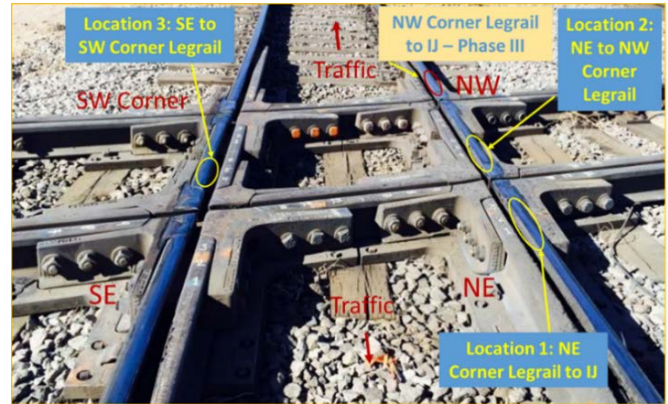
One broken rail that initiated at a bolt hole occurred at the northwest (NW) corner (red oval in Figure 1) of the crossing diamond before the start of the bolt test discussed in TD-17-026 Part 1, when the crossing diamond had been in service 59 MGT.¹ That leg rail was replaced. The test was discontinued on March 22, 2017, and the crossing diamond was removed from track due primarily to concerns over a series of cracks identified in additional running leg rails after 100 MGT of service (yellow ovals in Figure 1).

Figure 1. Rail break at the NW corner (red oval) at 59 MGT. The crossing diamond had been in service 100 MGT when a series of rail cracks were detected in the leg rails (yellow ovals)

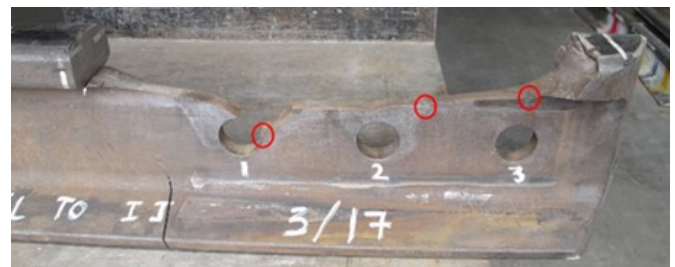
As an example, Figures 3a through 3d illustrate the fatigue crack initiation sites identified in the northeast (NE) leg rail at bolt hole 1 and above bolt holes 2 and 3, where the casting tab contacts the web of the rail. The crack initiations located at the bolt holes are directly related to contact with the bolts, where the walls of the holes are subjected to vertical wheel impact forces and longitudinal rail stress. The crack initiations identified at locations where the casting support tabs are in contact with the rail, high on the web, are directly related to vertical wheel impact forces.

Figure 3a. Leg rail between the NE corner and the insulated joint. Top portion removed along the crack for evaluation. The vertical band-saw cut in the base of the rail was made during inspection of the fracture surfaces.

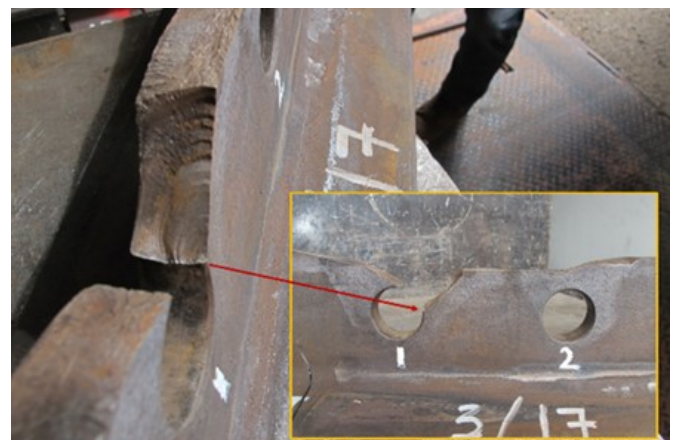
Figure 3b. Fatigue crack initiation at bolt hole 1, NE corner

Given the bolt failures and related bolt hole-initiation cracking that occurred in the rail during this test, the focus going forward may be on eliminating contact between the bolts and the bolt holes and providing a stronger thick web rail section at the connections.

One potential solution may be to use a specially designed application of AAR's keyed Insulated Joint (IJ) concept, where: (a) the bolts can be kept from contacting the holes, thereby providing tensile/clamping force instead of the shear conditions that cause failure, and (b) using thick-web rail section that provides a stronger connection.

Another simpler solution may be to use larger-diameter holes than those used in the castings and filler blocks, in thick-web running rails.

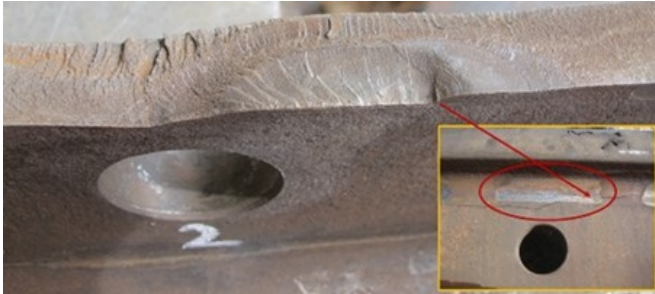
Figure 3c. Fatigue crack initiation at casting support tab contact with the rail above bolt hole 2. Red oval around surface fatigue caused by bearing on the casting support tabs.

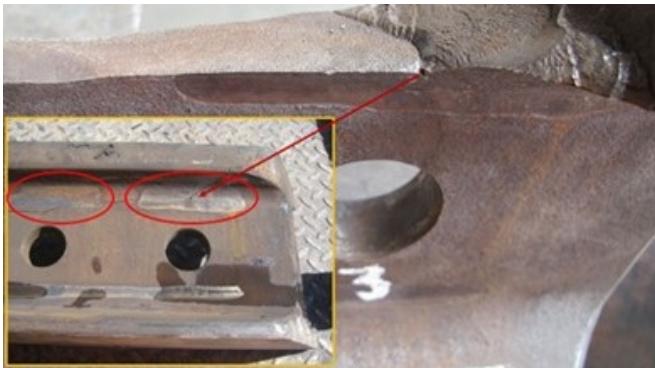
Figure 3d. Location of final fracture above bolt hole 3. Red ovals denote surface fatigue caused by bearing on the casting support tabs.

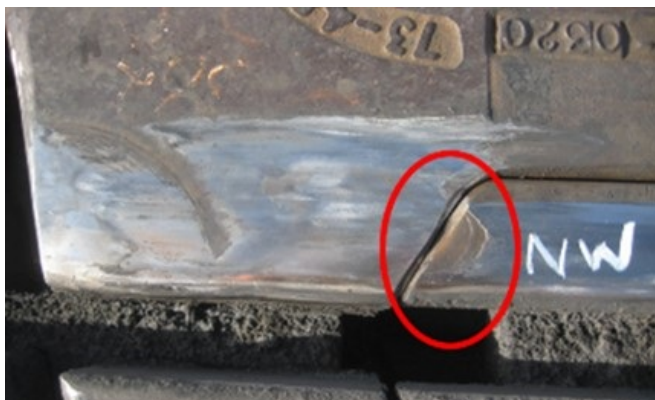
In addition to the flangeway gap, rail-end chips at the interface between the leg rails and the castings are a source of dynamic wheel impact loads. Figure 4 illustrates a 1-1/4-inch chip that developed at the NW corner during the 38 MGT bolt test. Bolts at the location nearest to this chip fractured in short succession. A 1-inch chip at the southwest (SW) corner and a 1/2-inch chip at the southeast (SE) corner developed prior to the start of the bolt test and remained until the end of test.

Figure 4. Rail chip at the NW corner developed during the 38 MGT bolt test

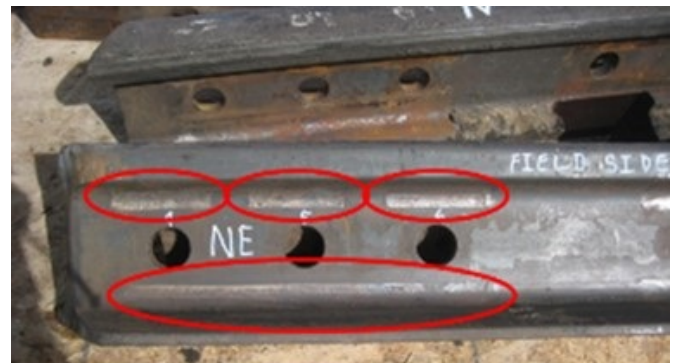
Evidence of high localized stresses was observed from rail web cracks that initiated at the rail/casting block interface (Figure 5). Since all the rail fractures not at bolt holes initiated from the rail/casting tabs interface and not at the rail/spacing block continuous interface, the higher stresses from the lower contact area of the tabs and increased relative movement are suspected as possible reasons.

Figure 5. Rail wear from contact with the casting tabs

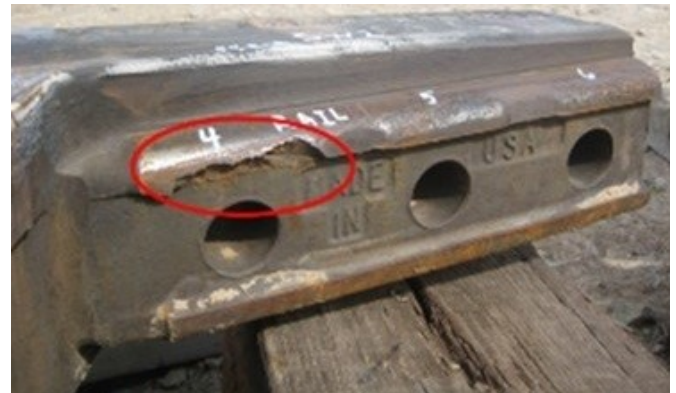
Figure 6 is an example of the seven chipped castings that were observed at the NW, SW, and SE castings during the post-test inspection.

Figure 6. Chipped casting tab that contacts high on the web of the rail at the SW corner

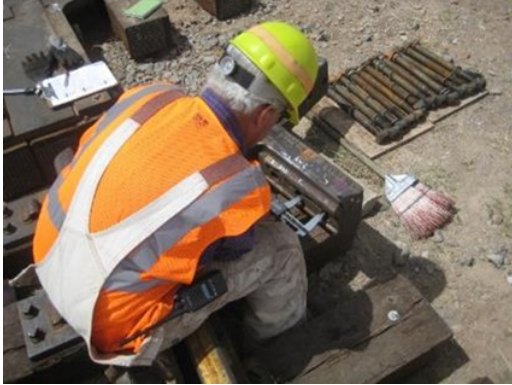
This misalignment can occur from manufacturing, which was investigated because the majority of bolt failures occurred due to shear stresses. After checking all the bolt spacings for all five components (Figure 7), no manufacturing bolt hole misalignments were observed.

Figure 7. Measurement of bolt hole spacing

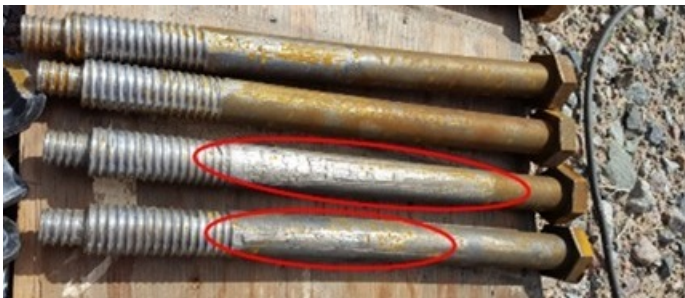
Evidence suggesting the influence of thermal expansion was the difficulty of installing one set of bolts in the midafternoon, but easily removing it in the morning about a week later. It took about 15 minutes to install three bolts. Figure 8 shows deformations from the installation process, as they were driven by a sledge hammer, which are evident on the horizontal sides of the bolts.

Figure 8. Deformation along the side of the bolts resulting from forced installation by sledge hammer
