Effects of Top of Rail Friction Control Materials on Rail in Revenue Service

Ananyo Banerjee[†], Kevin Conn[‡], Brad Kerchof[‡], Richard Reiff*
[†]TTCI, [‡]Norfolk Southern Railway, *Consultant

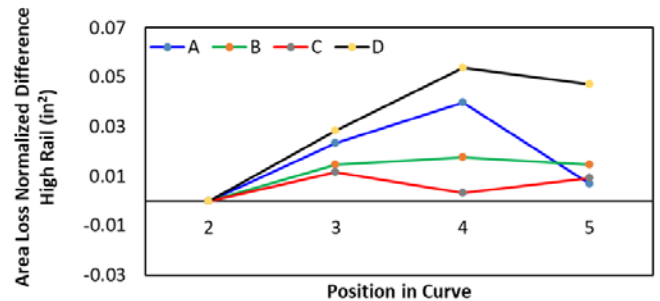
Wear results for Locations 3–5 were normalized to Location 2 (Table 2). This allows any change in wear along a curve to be assessed. Typically, the high rails exhibited increased total head area and GF wear from start to end of curve (Figure 1), while vertical TOR wear was somewhat more uniform along the curve. The low rail exhibited small but variable differences in total area loss at the end compared to the beginning of the curves (Figure 2).

Figure 1. Area loss of rail head of high rails of all curves

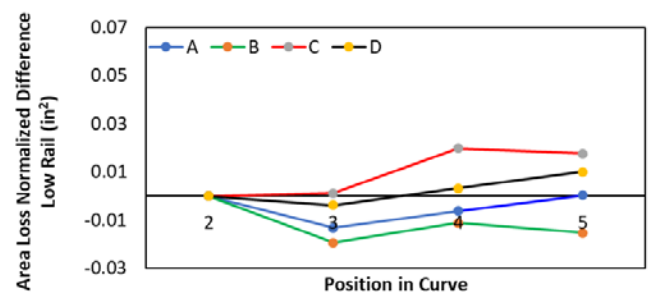
Figure 2. Area loss of rail head of low rails of all curves

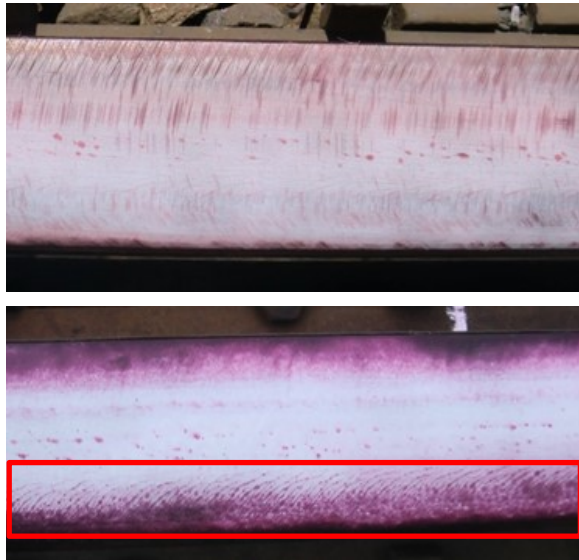
Figure 3. Comparison of Curve C, high rail, Location 5 on April 2016 (top) and after 40 MGT on March 2017 (bottom) showing increase in gage side RCF

Curve C: When TORFC was initiated, the high and low rails at the beginning and end of the curve exhibited minor cracking. After 40 MGT, the high rail at the end of the curve exhibited denser RCF and spalling (Figure 3), while the low rail exhibited some RCF, but little change from the start.
