# Analysis of Vertical Split Rim Wheels

Kerry Jones and Matt DeGeorge

## Summary

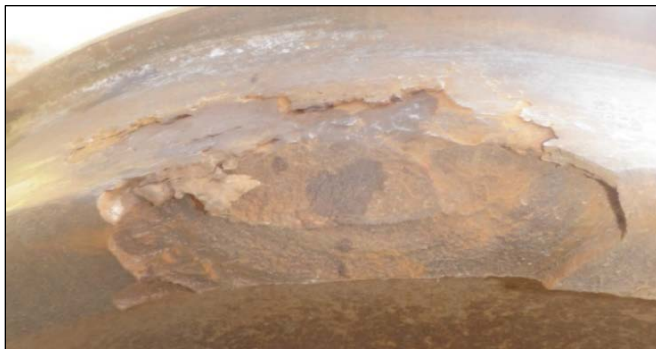
Figure 2. Fracture Surface of Wheel V7

Fracture surfaces of the VSR wheels were examined; one of these is shown in Figure 2. All but one of the fracture surfaces (Wheel V27) show evidence of fatigue, indicating that the crack grew for a period of time before final fracture.

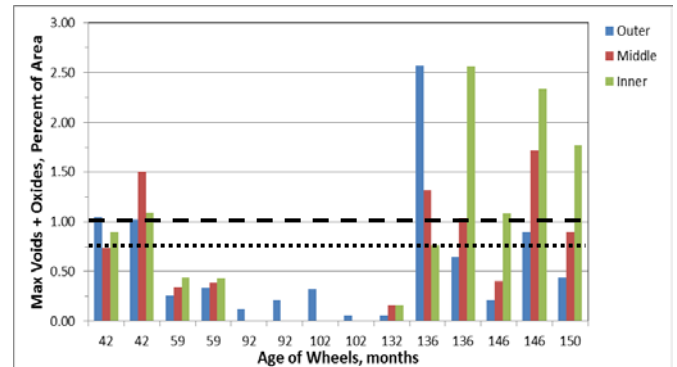
Figure 3. Maximum Void + Oxide Contents in Microcleanliness Samples

In all the samples, the maximum sulfide level was below the maximum allowable level. The maximum voids + oxides values in Figure 3 showed strong variation, both between the wheels and in the samples across the tread. Four of the wheels contained samples greater than 1.0 percent, and the highest value was 2.6 percent.

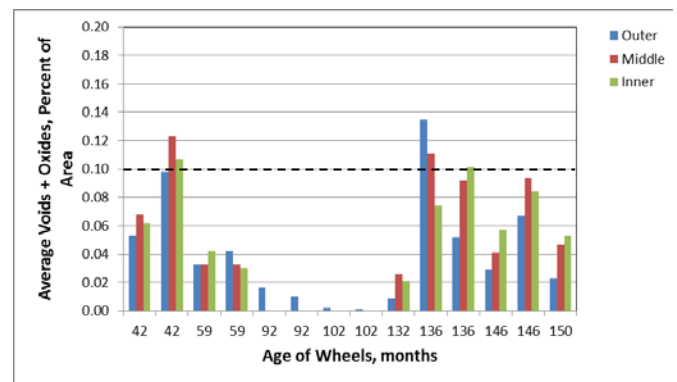
Figure 4. Average Void + Oxide Contents in Microcleanliness Samples

The average void + oxide values plotted in Figure 4 showed less variation as well as two samples above the maximum limit. The microcleanliness values were statistically analyzed by wheel age, sample position, and inclusion type. Statistical differences were found between some of the wheels, including wheels of similar age.

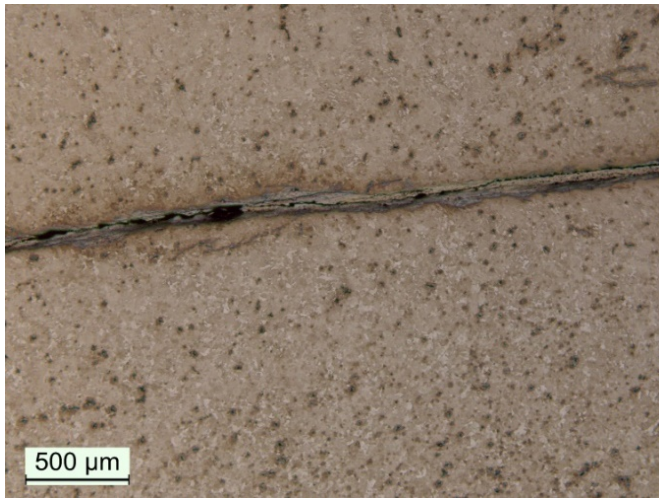
**Figure 5. Subsurface Crack with Untempered Martensite in Wheel V8**

Five VSR wheels and their mate wheels were sectioned for metallographic analysis (see AAR Research Report R-1022<sup>1</sup> for the complete set of pictures). Figure 5 shows a subsurface fatigue crack in Wheel V8. The light brown to gray color immediately surrounding the crack is martensite, thought to be formed when one side of the crack slides across the other side during rolling. Localized heating around the crack is then rapidly cooled by the large thermal mass of the wheel, forming untempered martensite. Martensite forms around some subsurface cracks, but is not visible around others.
