# Stabilization of Ballast Pockets with Geogrid in a Railway Embankment

Colin Basye and David Linkowski

## Summary

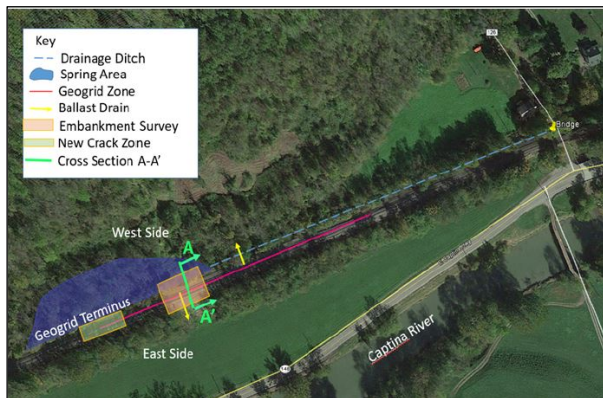
Figure 1 shows an aerial view of the site, including a spring area (discharge zone), which correlates with and may exacerbate problems in the study area. Hydraulic head differences of at least 8 feet are present between each side of the embankment.

**Figure 1: Test section overview**

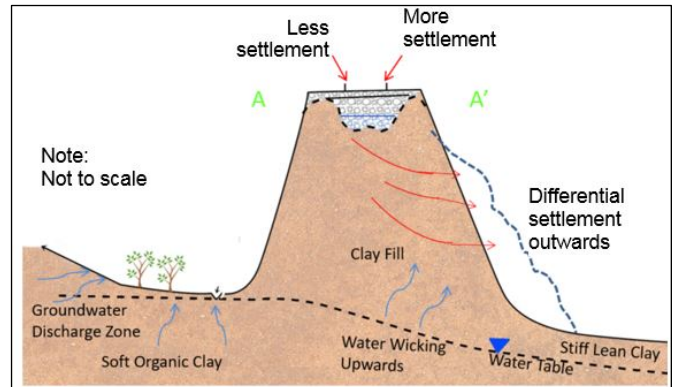
A conceptual cross section was developed of the area near the spring (Figure 2) to present and discuss mechanisms for observed embankment deformation. In 2012, the upper embankment area was stabilized by geogrid placement to test and observe geogrid longevity and stability in this environment. Initially, results were impressive, as ballast section maintenance was reduced from weekly to yearly. Approximately 1 to 2 years after installation, maintenance cycles began to increase again. By early 2017, track maintenance was needed 4 times in the first 5 months of the year.

**Figure 2: Clay embankment conceptual cross section**

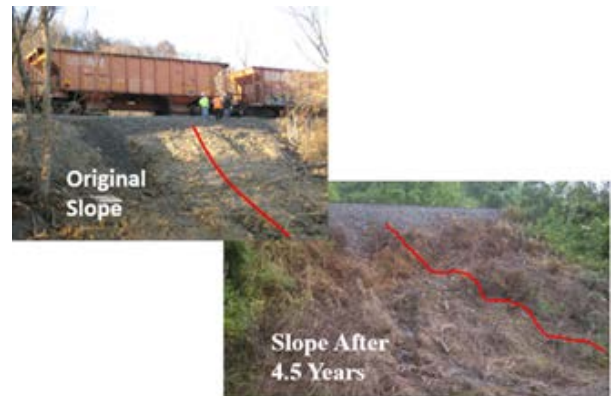
The east side of the embankment has also become deformed since installation, as the original smooth profile has been altered to a hummocky configuration from 2012 to 2017 (Figure 3).

**Figure 3: Comparison of planar embankment profile at installation and hummocky profile after 5 years**

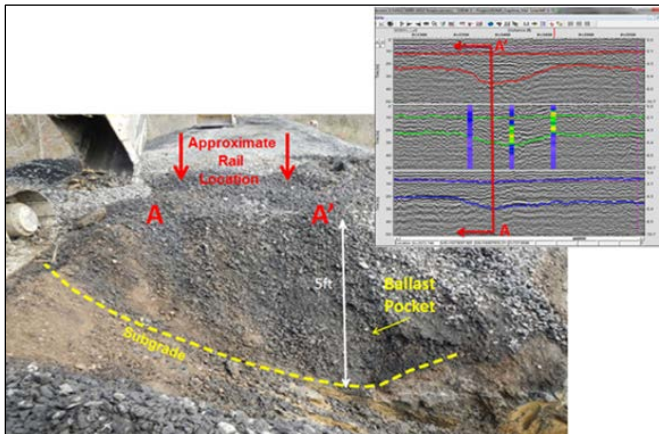
Figure 5 illustrates a cross section of one of the ballast pockets that was targeted with ballast drains, using GPR, during the 2012 investigation. The ballast pocket development is asymmetrical in response to embankment deformation to the east (right), which the geogrid was designed to address with development of stiffened subballast support.

Figure 5: Original profile of ballast pocket area during ballast drain excavation. Location was identified using GPR (upper right insert).

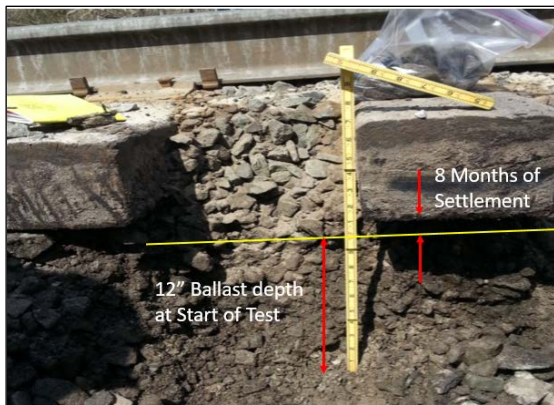
The 500-foot-long triaxial geogrid span performed well over most of the test area, but an 80-foot-long section spanning the east ballast drain encountered progressive deformation starting the year following installation (Figure 6) and evident in the 2015 TOR survey (Figure 7).

Figure 6: In early 2013, 0.10-foot of ballast settlement was already evident

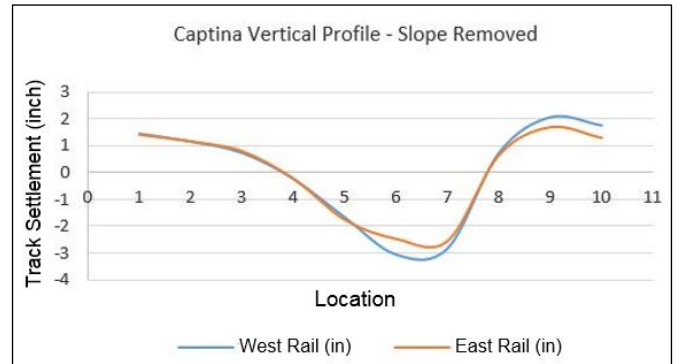
Figure 7: By 2015, TOR deformation was clearly evident before tamping and realignment

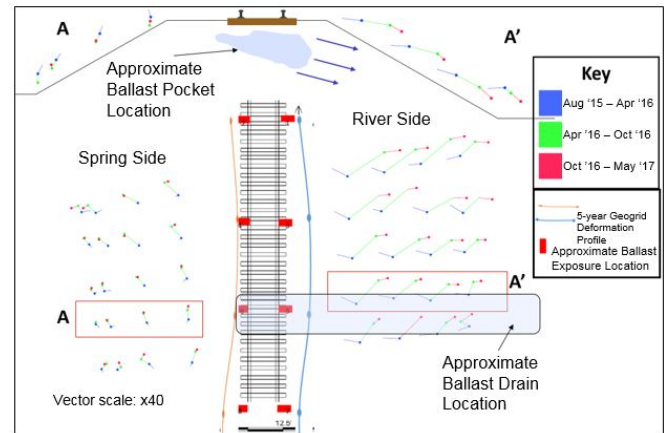
Although the geogrid was very effective in reducing ballast pocket development and in providing a stiff ballast foundation, deeper embankment shearing resulted in settlement and geogrid deformation (Figure 8).

Figure 8: A 3-year embankment survey grid monitoring effort showed progressive mid-lower embankment deformation in spring 2017 along with geogrid translation. (Geogrid exposure locations are indicated in red)

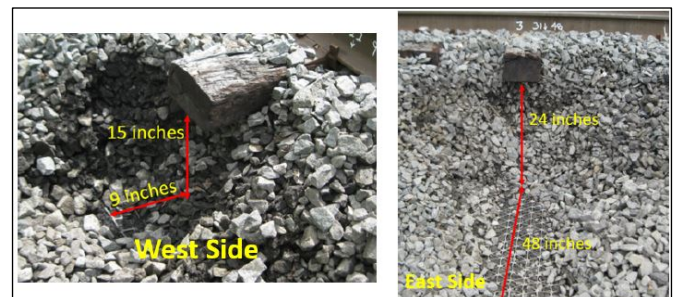
Progressive loss of TOR profile resulted in eastward and downward migration of the geogrid relative to original positioning (Figures 9 and 10).

Figure 9: Exposed geogrid measurements showed migration downward and to the east

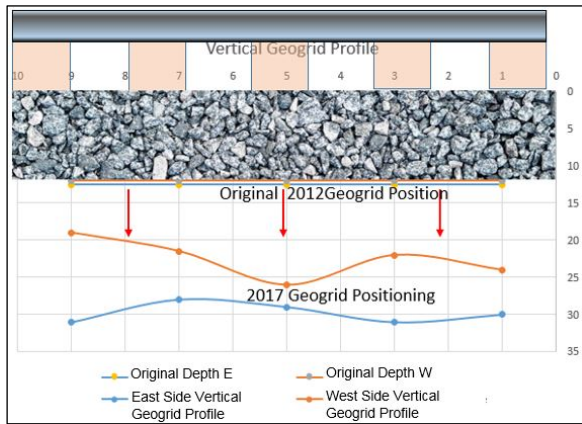
**Figure 10: Mid embankment vertical deformation induced downward migration of geogrid from 7 to 19 inches over 5 years (2012 to 2017)**

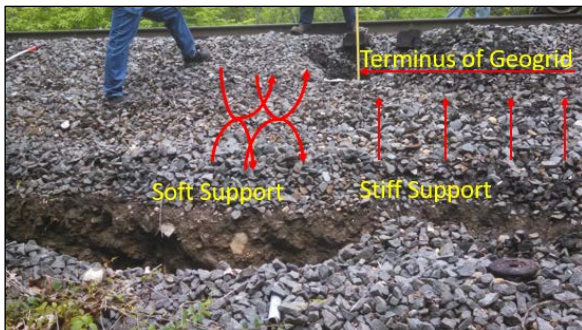
During the spring 2017 site visit, it was also observed that cracking of the east embankment had taken place (Figure 11). Embankment soils were water-saturated at this time, and the stiffness difference between unsupported and geogrid supported soils, along with ballast pocket influences, may have contributed to the 65-foot-long series of parallel cracks. Increased ballast pocket loading and moisture retention in unsupported zones resulted in development of failure planes (Figure 12).

**Figure 11: Cracking and translation of mid to lower embankment at geogrid termination point**

Stabilization measures for this site may include deepening the drainage ditch on the west side to reduce hydraulic head, and installing a retaining wall on the east side to stabilize embankment slopes.

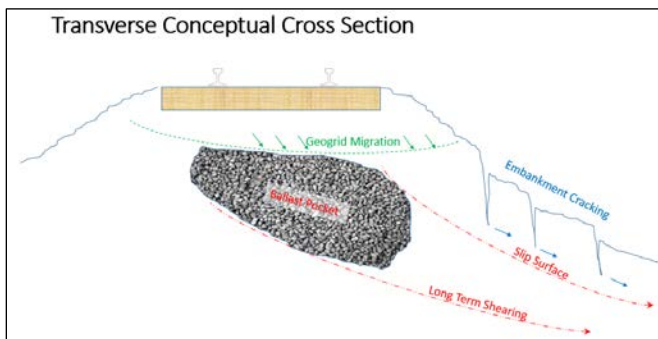
**Figure 12: Development of slip failure planes in differentially loaded subgrade soils**

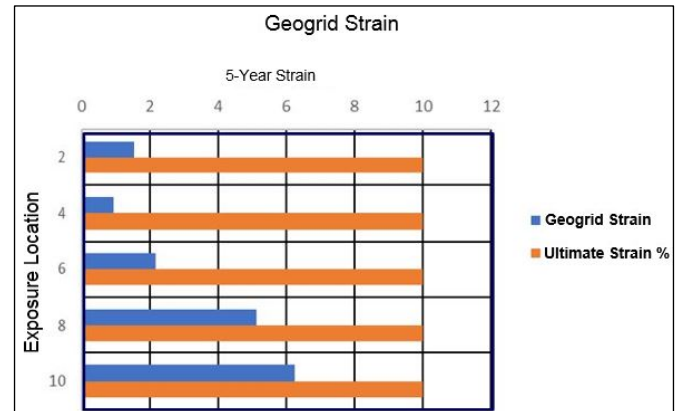
In addition to the eight geogrid exposure locations identified in Figure 8, two additional locations were exposed at the geogrid terminus (Figure 11). Measurements of the geogrid span at each location indicate that it is undergoing various amounts of transverse elongation in response to embankment and settlement influences (Figure 13). Accumulated strain is stretching the geogrid in a transverse manner, with over 6 percent strain evident at the terminus location. This may result in geogrid tearing and failure at some point.

**Figure 13: Transverse geogrid measurements indicate strain values from 0.94 to 6.25 percent**
