Settlement of Fine-Contaminated Ballast

Stephen Wilk, Colin Basye, and Yin Gao

This *Technology Digest* is second in a series of an ongoing study investigating the behavior of fine-contaminated ballast when exposed to moisture. The project was conducted by TTCI under the AAR Strategic Research Initiatives Program, with joint funding from the Federal Railroad Administration.

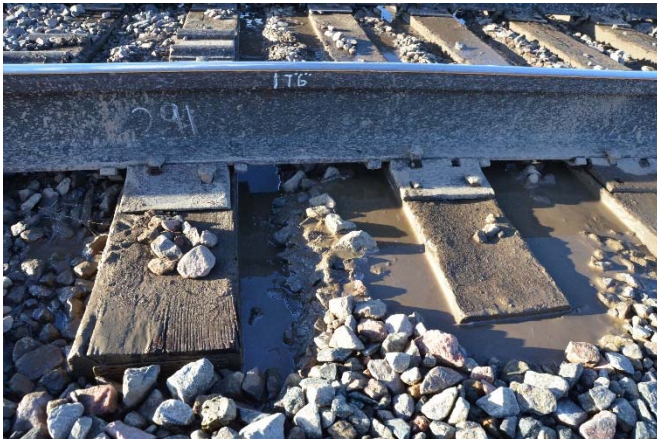
After the third night of testing, a mud pumping condition was observed in which fine particles appeared to accumulate near the track surface and prevent surface drainage (see Figure 3). Drainage valves were opened to drain any standing water in the lower ballast layer, but surface water remained, so the test section could not fully

drain for the fourth and fifth days of testing. This is discussed in more detail in TD-18-010.² On the sixth day of testing, the entire section was dried.

Figure 3. Mud Pumping after 4th night (10/11/2017)

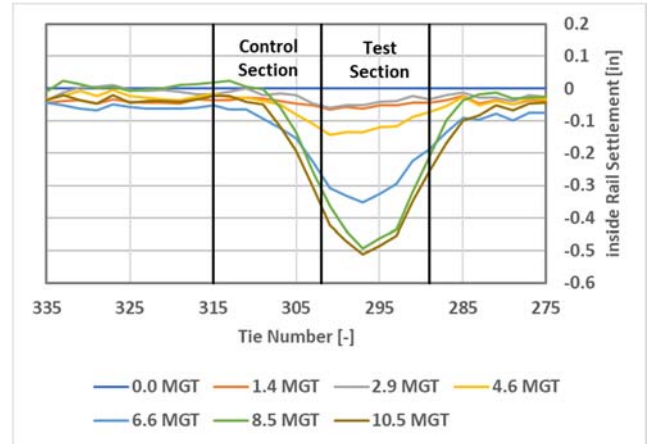
The Figure 5 rail settlement used 0.0 MGT as a reference point and clearly shows the wetted test section experienced greater settlement than the non-wetted control section and surrounding track. The maximum settlement was ~0.5 inch and was located in the middle of the test section.

Figure 5. Ballast Settlement with Distance

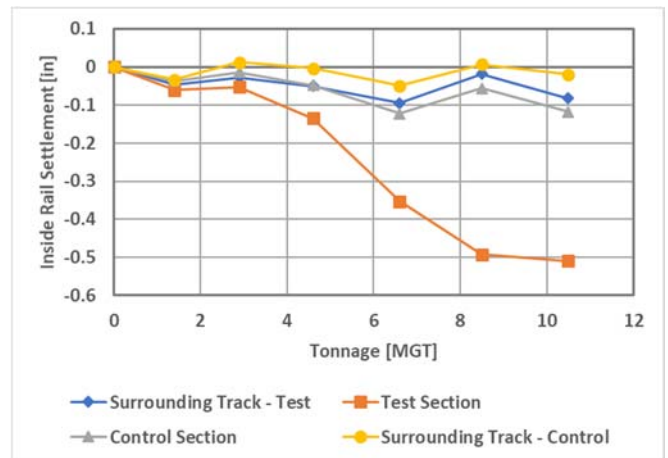
Figure 6. Ballast Settlement with MGT for inside rail

The results show minimal settlement for the first two nights of testing and then ~0.08 inch after the third night of testing. This means after wetting the test section and developing a 6-inch water table, the passing of 36 trains (~0.5 MGT) resulted in 0.08 inch of maximum settlement in the test section. The following night of FAST train runs resulted in settlement of ~0.22 inch. This is likely greater than the previous night because the mud pumping prevented drainage of the surface moisture, so the upper ballast was likely near-saturated and settled prior to the application of water for the last 37 laps. No water was applied the fifth night of testing, but settlement did occur because of the inability to fully drain the surface moisture. The entire section was dried by the sixth night and minimal settlement was observed.

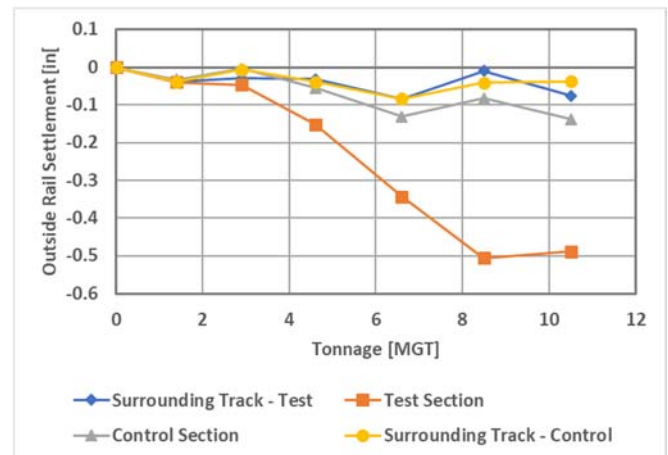
Figure 7. Ballast Settlement with MGT for outside rail
