# Survey and Analysis of Winter Rail Breaks on a U.S. Railroad

Harry Tournay and R.B. Wiley

## Summary

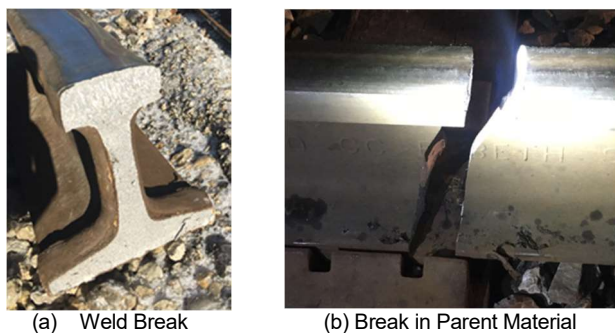
- Identify if the break was at a weld or in parent material, as displayed in Figure 1. The focus of the survey was on breaks in parent material and not those in welds.

**Figure 1. Photographs discriminate between a break in a weld and one in the parent material of the rail**

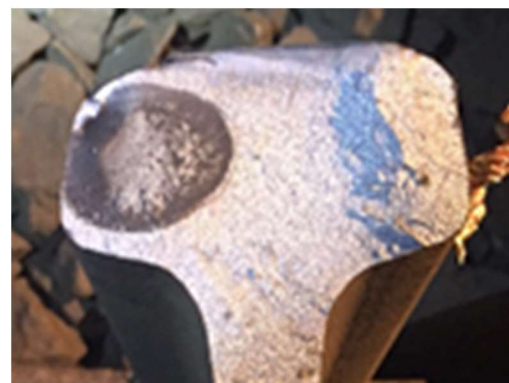
**Figure 2. Example of a TD**

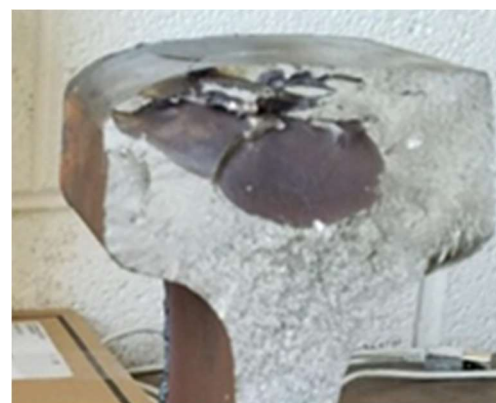
**Figure 3. Example of a DF**

- 37 percent developed from TDs or DFs of which:
  - Only 8 percent of fractures developed from what may be termed “traditional” TDs (Figure 2).
  - 29 percent developed from DFs or TDs that branched from shells; these failures appeared possibly to be “masked” from ultrasonic detection by RCF damage (Figure 3).
- 18 percent developed from reverse TDs.

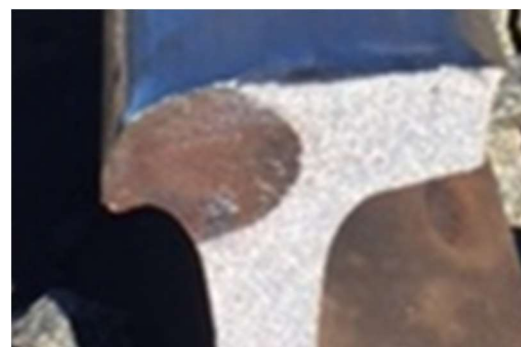
**Figure 4. Example of a reverse TD**

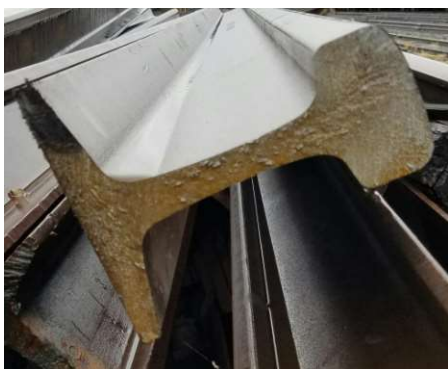
Figure 5. Example of fracture from a base defect

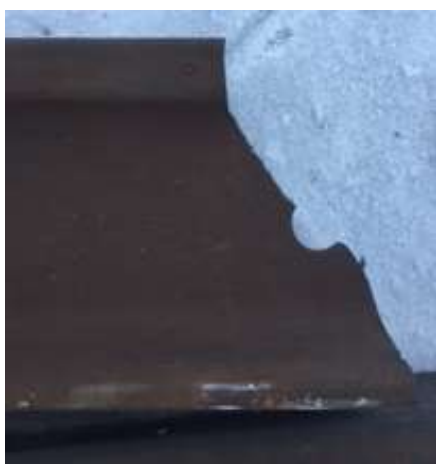
Figure 6. Example of fracture from a bolt hole

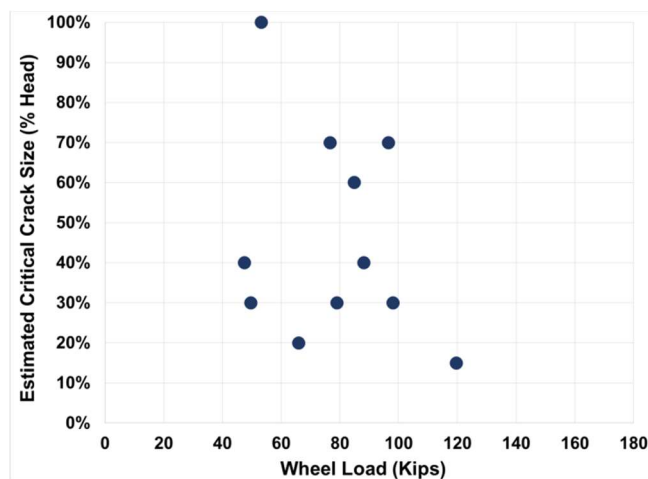
Figure 7 shows the relationship between the estimated critical crack size in the railhead, as a percent of the unworn head area, and the highest measured wheel load at the WILD site immediately after fracture. There is no clear indication that HIW loads cause premature failure in the railhead by causing fracture at reduced critical crack sizes, particularly for HIW loads less than 100 kips.

Figure 7. Relationship between the critical crack size in the railhead and the highest measured wheel load at the WILD site immediately after fracture

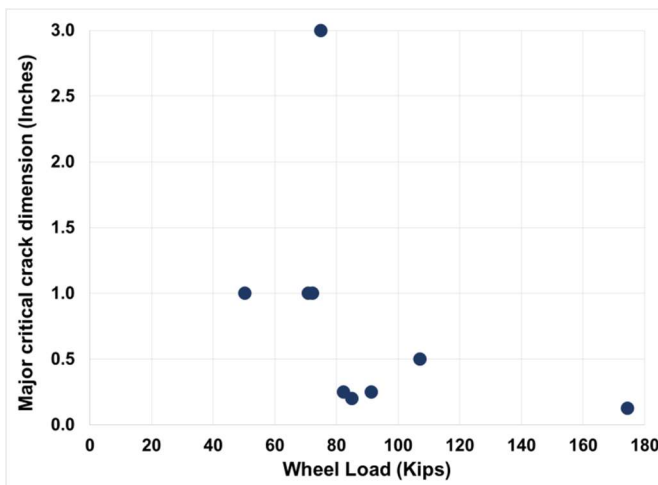
Figure 8 shows the relationship between the estimated major dimension of the critical crack and the highest measured wheel load at the WILD site immediately after fracture. Again, there is no clear indication that HIW loads cause premature failure in the railhead by causing fracture at reduced critical crack sizes, particularly for HIW loads less than 100 kips.

Figure 8. The relationship between the major dimension of the critical crack in the rail base and the highest measured wheel load at the WILD site immediately after fracture
