Top of Rail Friction Control Material Influence on Rolling Contact Fatigue and Rail Wear in Revenue Service

Ananyo Banerjee (TTCI); Kevin Conn, Brad Kerchof (Norfolk Southern Railway), and Richard Reiff (Consultant)

Summary

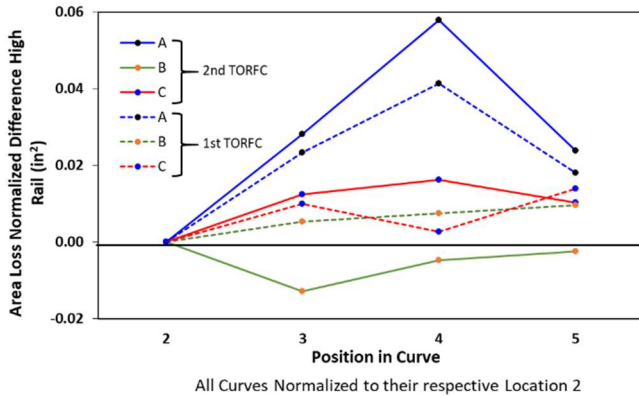
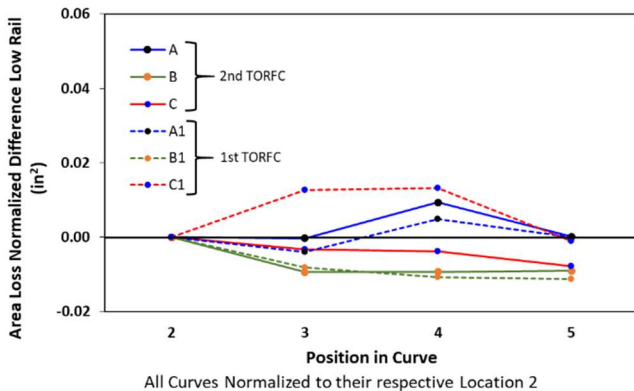
Rail wear in the full body of each curve during the second TORFC evaluation phase is summarized in Figures 1a, 1b, and Figure 2. As each curve has rail of different type and age, no direct rail wear rate benefit can be determined, and each curve represents a separate comparison of the effect of two different TORFC materials. Wear results for locations 3 through 5 were normalized to location 2. This allows any change in wear along the full body of a curve to be assessed. Examination of Figures 1a and 1b show

higher differences in wear between locations 2 and 4 for the high rails compared to the low rails and suggests the same trend of change in area loss along the body of the curves on high and low rails in both testing phases.

Figure 1. Area loss of high rail (a.) and low rail (b.) in all three curves for the two TORFM test periods

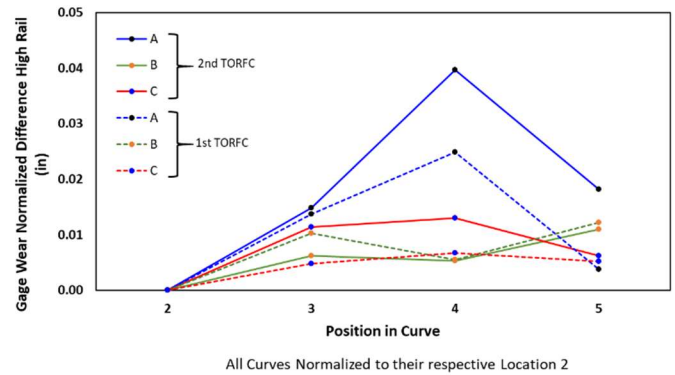
Examination of Figure 2, a comparison of gage face wear, indicates control curve A had a higher wear rate during the second TORFC phase than the first phase. This suggests there was less GF lubrication during the second TORFC period. Curves B and C show similar wear rates for both TORFC testing phases, suggesting similar influence on GF wear. It is noted that gage wear in Figure 2 is accounted in area loss shown in Figure 1a.

Figure 2. Gage wear comparison of high rail in all three curves between the two TORFC phases

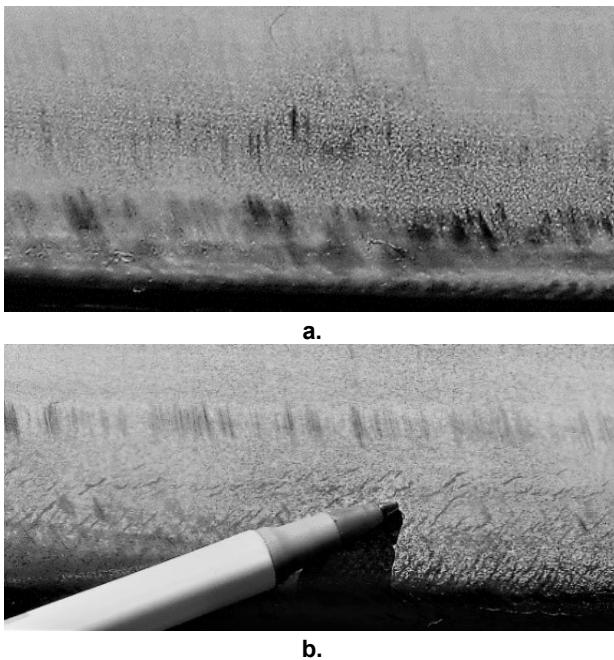
Figures 5a and 5b illustrate the observations summarized in Table 1. Photos of the high rail at mid-curve (location B3) indicate that at the start of phase 1 there was no RCF present (Figure 5a), but at the start of phase 2, RCF was present (Figure 5b). Gage side is at the bottom of all photos. Figures 6a and 6b show the same B3H location after 39 MGT at the end of phases 1 and 2. Dye penetrant inspection of curve C during the initial inspection of phase 2 was missed because of no available time to test the track, thus preventing comparisons in change to RCF performance.

Figure 5. Site B3H post grind at the beginning of Phase 1 (5a.), and Phase 2 (5b.)
(Pen is pointing to upper gage corner RCF)

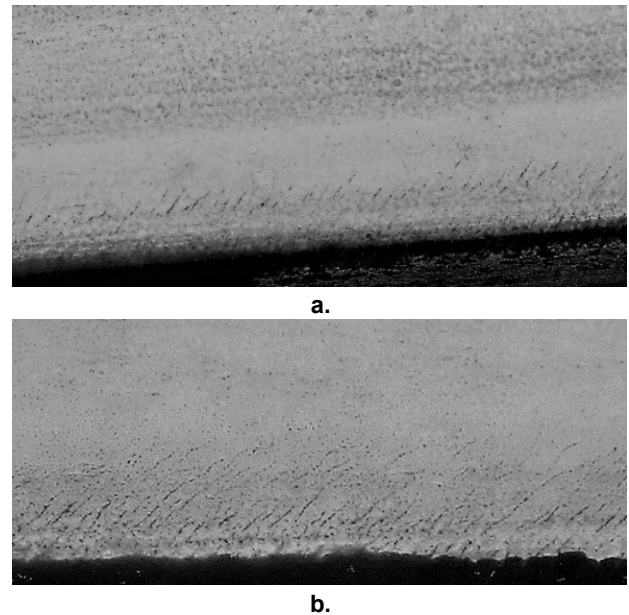
Figure 6. Site B3H after 40 MGT in phase 1 (6a.) and after 39 MGT in phase 2 (6b.)
