Performance of Two Frog Weld Repair Techniques

Stephen Wilk, Benjamin Bakkum, David Davis, Duane Otter

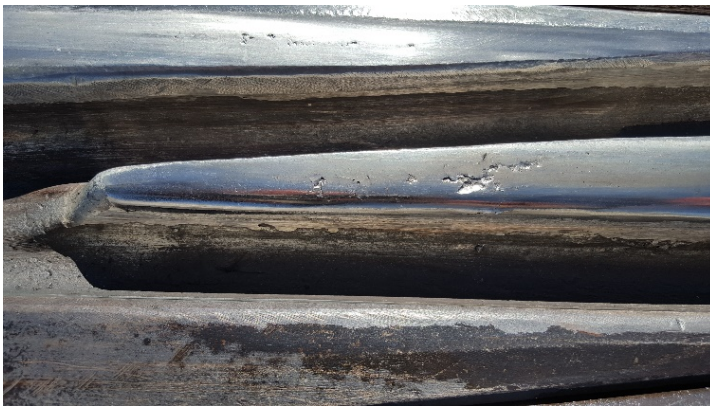
The laser cladding frog encountered 23 MGT before spalling appeared about 6 inches from the point and required a weld repair using conventional methods. The spalling at 23 MGT is shown in Figure 2. The repaired laser clad frog lasted another 45 MGT before removal for reasons unrelated to the weld repair after a total of 67 MGT. The control frog experienced 52 MGT and no defects were observed with the weld repair.

Figure 2: Chipping of laser cladding frog after 23 MGT

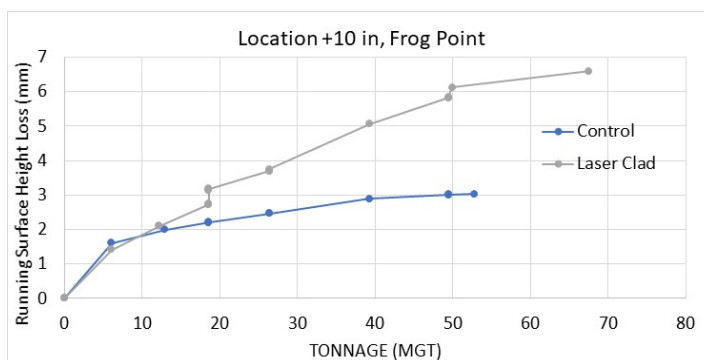
- The laser clad weld repair had a lower initial surface hardness. (220 BHN vs. 283 BHN). The two repairs show similar work hardening trends. The lower initial hardness may account for some of the larger height loss in the laser clad frog.

- Where most comparable, at the top of the point slope (+10 inches), the laser clad weld repair had about 6 mm of wear in 50 MGT. The control repair frog had about 3 mm in the same interval. This is shown in Figure 6. The laser clad repair frog also required more frequent metal flow grinding.

Figure 6. Vertical height loss of frog points vs. tonnage for test frogs
