FAST Premium Rail Test Results: 2016-2018

Ananyo Banerjee, Joseph LoPresti, Archit Kavishwar

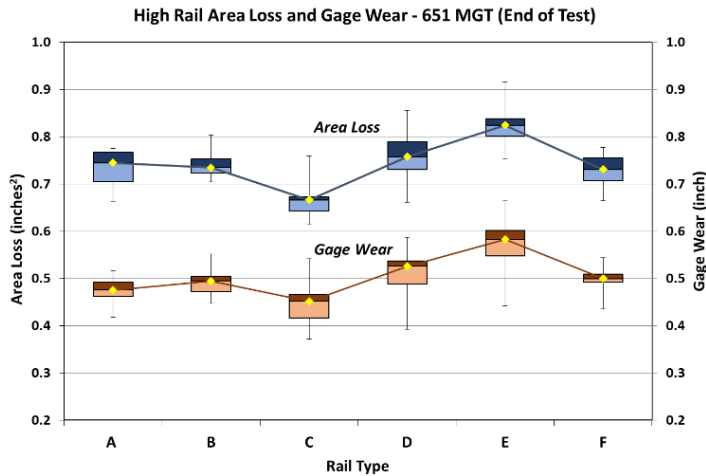
Figure 1 shows the comparison of metal loss of the high rail at the end of the test in terms of head area loss and gage wear. Area loss includes vertical head wear, gage corner wear and gage wear and thus gives an overall idea of the total metal loss due to wear and grinding. The gage wear data is shown in the same plot to give an idea that it is the main contributor to the area loss data. The yellow dots in each series represent the medians of each rail type. Based on the sample sizes of the test, type E showed the highest median head area loss while type C had the least. Type E was more worn than type C with 24 percent more head area loss. The median difference was statistically significant and expected to be between 19.7 and 26.0 percent at a 95 percent confidence interval.

Figure 1. Area loss and gage wear of high rail at 651 MGT

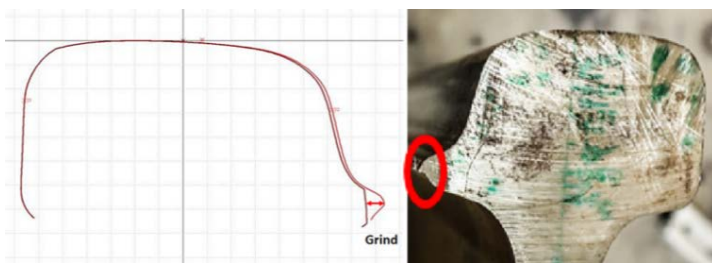
The high rail was ground twice at 255 MGT and 429 MGT to remove RCF and spalls from all the rail types. Corrective grinding on the head of the rail was done with approximately equal amounts of metal removed from all rails as the grinder made continuous passes. High amounts of gage wear, along with plastic deformation of the steel at the bottom of the gage face (metal flow), caused the high rail to form a profile that may have contributed to an increase in wheel flange shelling. To correct this, the metal lip formed at the bottom of the gage face was ground using a trolley-mounted grinder as shown in Figure 2. Compared to the high rail, there was significantly lower wear of the low rail for all rail types. The average area loss of the high rail was found to be almost nine times more than the average area loss of the low rail. The low rail received an additional corrective grind at 590 MGT due to the formation of severe RCF and spalls.

Figure 2. Grinding of metal lip formed at the bottom of gage face of high rail

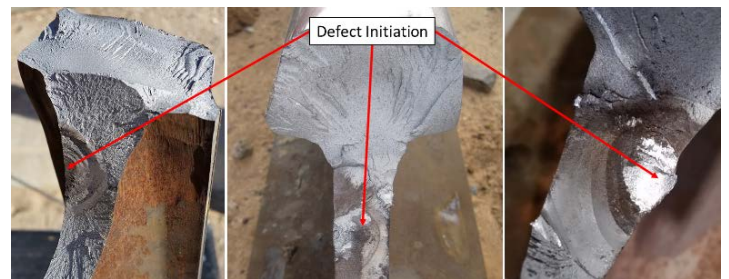
Eight EFB welds failed on the high rail during the course of the test. Out of the different rail types involved in EFB weld failures, type A rail was involved in five failures while type E rail was involved in four failures. Types C, D and F rails were each

involved in two weld failures while type B rail was involved in one failure. Initial EFB weld failures were not considered to be an important aspect of the test and thus failed weld specimens were not collected and examined. As more EFB weld failures occurred, five out of the eight EFB weld failures were recovered and examined and all had fatigue marks with defect initiation sites in the region extending from the top half of the web up into the head-web radius. Examples of three such EFB weld failures are shown in Figure 3. Microstructural examination of the defect initiation sites showed deformed pearlitic microstructure with no presence of martensite. No microstructural difference was observed from one rail type to the connecting rail type across the longitudinal EFB weld surface and thus it was impossible to determine any influence of differences in rail metallurgy on the EFB weld failures.

Figure 3. Defect initiation sites observed in failed EFB welds

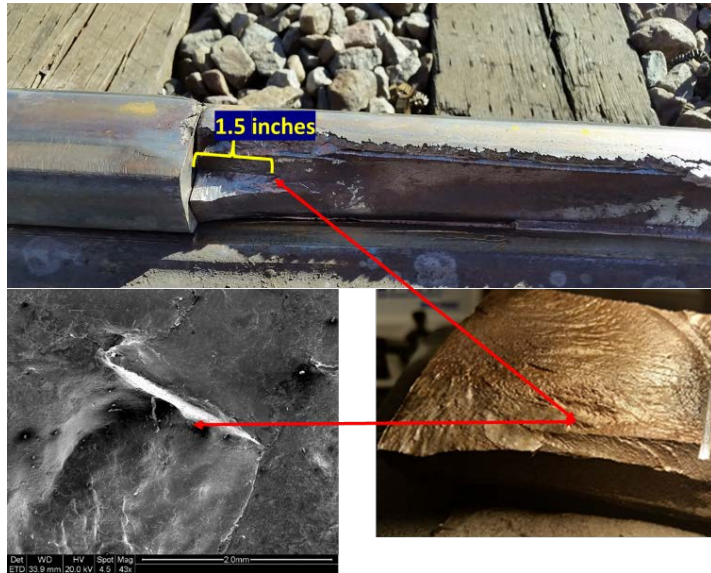
The second defect was a fatigue defect observed in a type F high rail that caused a vertical split head fracture. An EFB weld failure happened seven months earlier between the type F and a type C rail and was replaced by a thermite weld. The thermite weld failed, and the type F rail was temporarily joined to a non-test rail with joint bars. The fatigue defect initiated 1.5 inches away from the cross-sectional surfaces of the two rails towards the field side as shown in Figure 4.

The failed sample was machined and the top half containing the split was cut out to get a better view of the defect initiation location. The defect initiation location was examined at higher

magnifications using scanning electron microscopy (black and white image in Figure 4) and chemistry was scanned using electro-dispersive spectroscopy (EDS) at random spots at that location. No contaminants were found but some scans showed high sulfur and oxygen contents indicating the possibility of presence of sulfide and oxide inclusions.

Figure 4. Fatigue defect at various magnifications

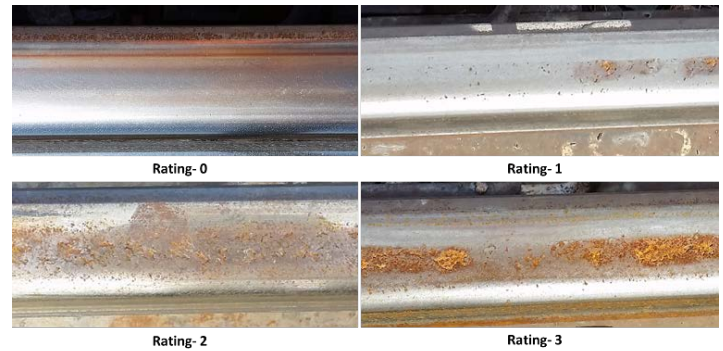
Change in head wear over particular tonnage intervals was analyzed and compared with the change in average RCF rating for all rail types. Considerable scatter in the data yielded no conclusive correlation. RCF growth rates were different across the same rail of any rail type as well as different across the six different rail types. As shown in Figure 5, type E rail had four different ratings during the last inspection at the end of the test. All rail types had instances where sporadic ratings of 3 were observed with the rating on the adjacent tie being 1 or 0. Thus a correlation between TOR RCF and head wear or any other wear parameter could not be analyzed.

Figure 5. Four different RCF ratings observed on type E rails at the end of the test

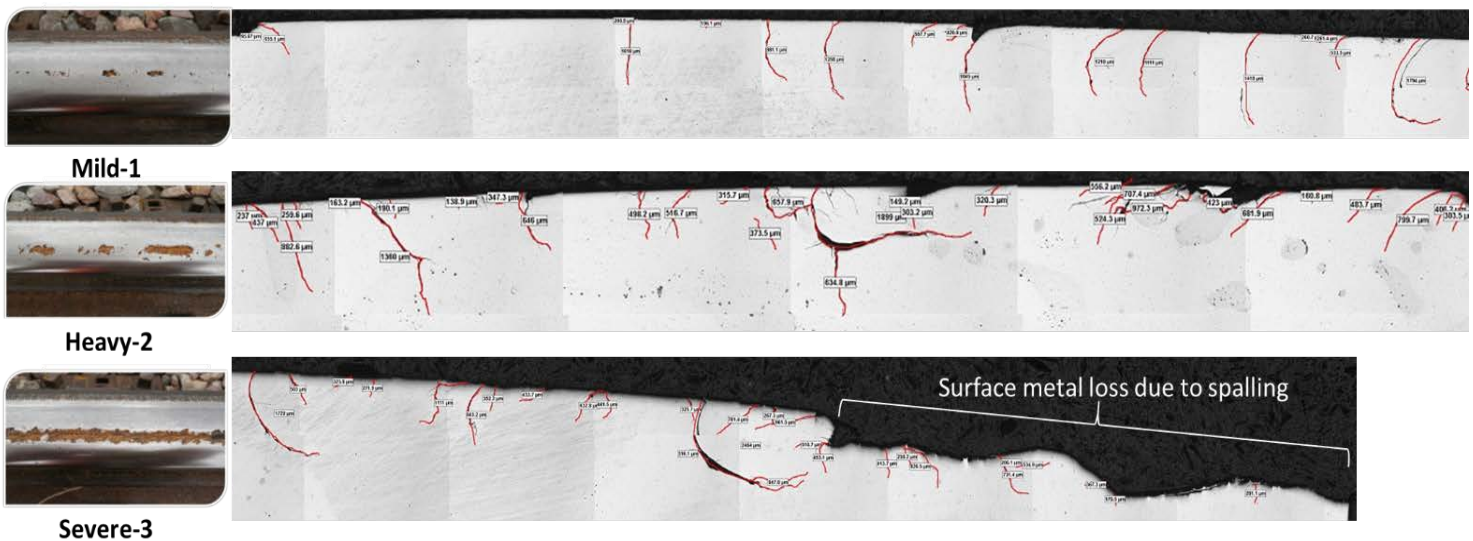
Figure 6. Comparison of RCF crack appearances along the cross-section of the rail head for different RCF ratings.

Samples of RCF ratings 1, 2, and 3 of types C and E were sectioned, polished and viewed under the optical microscope. Figure 6 shows the RCF ratings of 1, 2 and 3 of the visual rating scale and cross-sectional images of crack depth observed in type E samples at the end of the test. At the rating of 1, the cracks are vertical with zero or some curvature, but the surface of the rail looks free of spalls. At the rating of 2, longer cracks start changing directions while more cracks are found to initiate. The rail seems to be losing some metal due to spalling caused by multiple cracks growing in close proximity. At the rating of 3, spalling appears to be more prominent as cracks continue to grow. One arc-shaped crack left of the spalled area is a probable location for impending spalling as the crack travels upwards and joins other cracks moving towards it. It is to be noted that the images shown in are three different spots on the same rail and the TOR images shown on the left are not images of the type E rail.

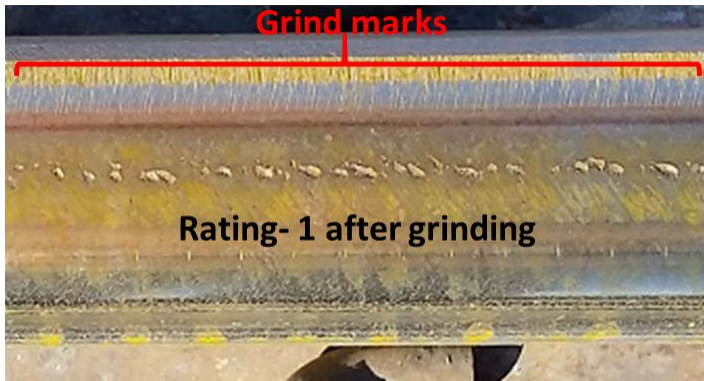
Grinding of the test zone was done when the overall test zone showed severe RCF and spalling and majority of the ratings were 3 for all rail types. Grinding did not completely remove RCF and some of the RCF existed after grinding as shown in Figure 7. The entire test curve at the end of the test had uniformly severe RCF across all rail types.

Figure 7. RCF rating of 1 on a type E rail after grinding at 429 MGT and one night of trail operations.
