## Assessment of Service-Worn, 110-ton M-976 Trucks

Alexander Keylin, Russell Walker, Chris Pinney, Tony Sultana, and Ryan Alishio

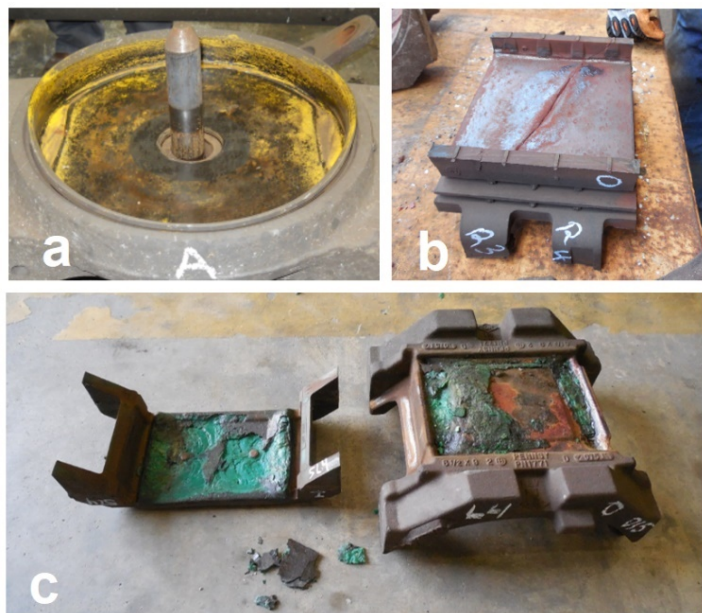
**Center bowls:** Two truck sets (Nos. 472 and 480) used metal center bowl liners with lubricating disks, which were heavily worn. Two other sets (Nos. 012 and 015) had non-metal horizontal liners and metal vertical liners. The liner of the B-end truck of set No. 015 was lost during transport and replaced with one from set No. 012. The liner was rotated from its original orientation when installed in set No. 015. The remaining two sets (Nos. 702 and 721) used a cup-type non-metal liner whose edges became significantly deformed in places where center plate chamfer contacts the liner (Figure 1a). Center bowl wear, as estimated from diameter measurements, was minimal.

Figure 1. a) Worn center bowl liner; b) cracked adapter pad; c) delaminating adapter pad

**Bearing adapters and pedestal thrust lugs.** One shear pad had a crack in the elastomeric material (Figure 1b). Two trucks (both from the same car set) revealed partial delamination in four adapter pads (Figure 1c).

Trucks that had adapter pads whose design prevented a direct contact between bearing adapters and pedestal thrust lugs were showing no wear on the bearing adapters. Wear on the pedestal thrust lugs on these trucks was below condemnable limits, except for one side frame. Trucks with elastomeric adapter pads that allowed metal to metal contact were generally showing more wear on bearing adapters and on thrust lugs (Table 2).
