Research described in this Technology Digest was performed by Transportation Technology Center, Inc., a wholly owned subsidiary of the Association of American Railroads.

Effectiveness of Corrective Grinding

Scott Cummings

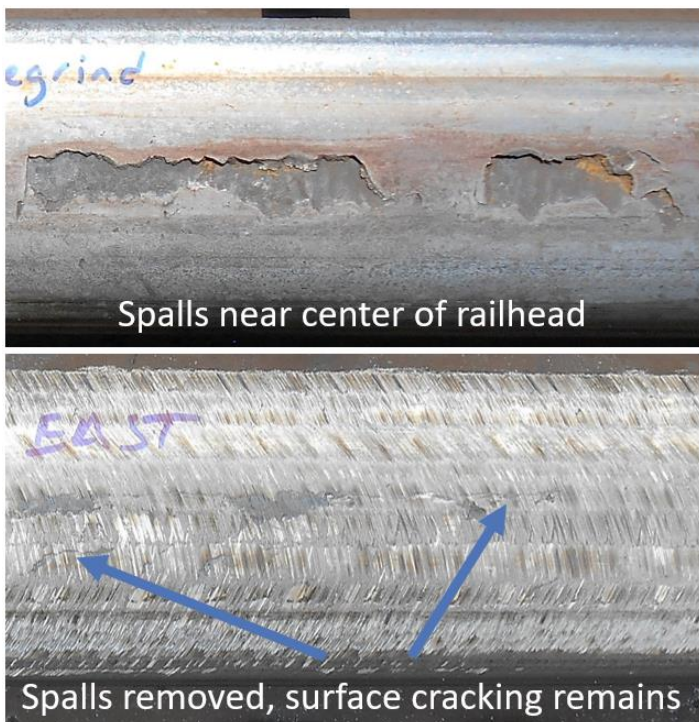
Four of the individual sites were within a 7-mile range on a single line and ranged from tangent to 3.3-degree curvature. This line typically is ground every other year and averages 15 million gross tons (MGT) per year. The rail is relay — it was manufactured and originally installed in the early 1980s on a heavy tonnage mainline and then relocated to its current location in 1991. Before grinding, the rail surface condition at these sites included spalls of many sizes and well-developed RCF cracks. Figure 1 shows representative images of rail surface conditions at one of these rail exception sites.

Figure 1. Representative pre-grind (top) and post-grind (bottom) rail condition at a site with older rail and annual tonnage of 15 MGT

These four sites were treated with five to 11 passes from a 96-stone production grinder resulting in 0.031 inch to 0.157 inch of metal removal from the center of the head. Inspection of the sites occurred before, during, and after grinding and included photographs of the rail surface condition and rail cross-sectional profiles. Between grind passes, observers noticed that, in some cases, as the grinder removed spalls that had been open to the surface, it was uncovering spalls that were previously hidden beneath the surface.

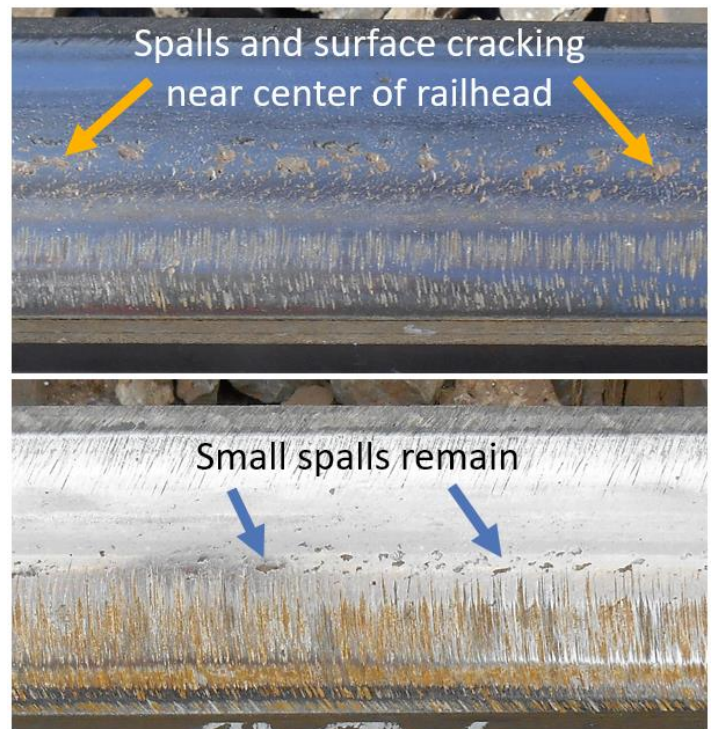
Another rail exception case study site, on a different line, was the low rail on a 3-degree curve that carries 43 MGT per year. Figure 2 shows representative images of the rail surface conditions at this rail exception site.

Figure 2. Representative pre-grind (top), post-grind (bottom) rail condition at a site with newer rail and annual tonnage of 43 MGT

The standard (non-premium) rail was produced in 2006. This site is at a congested area and has a permanent speed limit of 20 mph. The grinder typically visits this site semi-annually. Poor UT confidence was discovered and marked over a length of approximately 25 feet. The rail received two grind passes that improved the UT results, but not enough to remove the rail exception. No

inspection data is available regarding the grinding operation. A second visit from the grinder provided high confidence UT results after three additional grind passes. Pre-grind and post-grind inspections were made for this second grinder visit. By overlaying the pre-grind and post-grind profiles, the amount of metal removed from the center of the rail head during the second grinder visit was determined to be 0.012 inch. RCF cracks and small spalls were visible on the surface before grinding. After grinding, RCF cracks were no longer visible but spalls, though reduced in size, were present and visible.
