## Update: Wood Tie Fastening System Study

Yin Gao and Joseph LoPresti

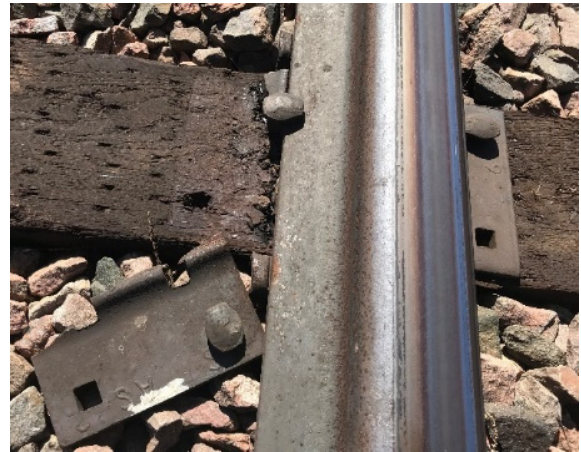
(a)

- Zone 5: 39 broken high rail spikes out of 300 installed.
- Zone 4: One broken high rail spike.
- Zone 1 (Figure 1a) and Zone 5 (Figure 1b): broken tie plates.
- Plate cutting was minimal through all nine test zones, and there was no meaningful difference between the zones with the tonnage tested.

**Figure 1. Broken tie plates**

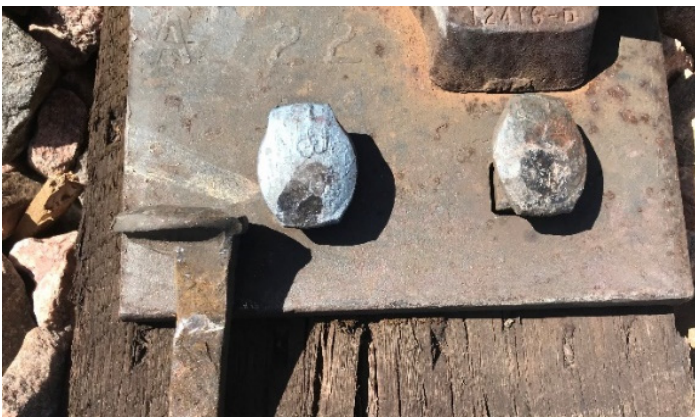
On April 16, 2019, after 230 MGT, 12 broken spikes were found on the high rail side in Zone 5. Once identified, these were removed and replaced. On September 18, 2019, after 284 MGT, 27 broken spikes were found on the high rail side in Zone 5; however, the new spikes installed on April 16 remained intact and were not in this group. The broken spikes identified in this second inspection were replaced by driving new spikes through the original spike holes (Figure 2). Broken spikes were usually found in elongated spike holes.

Figure 2. Broken spikes on 18-inch elastic fastener plates (Zone 5)

TTCI's tests on new types of wood ties with various fastening systems showed that plates with elastic clips are the most likely to suffer spike breakage, and elongated spike holes appear to be associated with this failure.

As a result of this test and TAG recommendations, several remediation methods for the broken spike issue were implemented in the summer of 2020, including:

- Installing rail anchors in Zone 5 and Zone 6 and monitoring their performance.
- Installing 50 wood ties with curve block plates.
- Monitoring the performance of drive/screw spikes on elastic fastener plates.

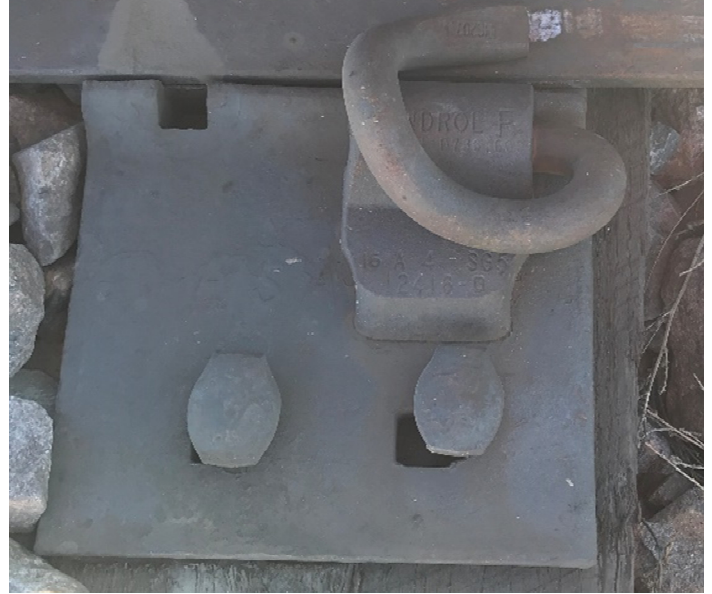
Abrasion marks on rails made by the elastic clips were found (Figure 3), indicating slippage between fastener and rail and suggesting that the spikes may have experienced high longitudinal forces in Zone 5.

Figure 3. Elongated spike holes and abrasion mark on rail

The study also showed that gage widening with these new ties is still within specifications, but there may be issues with abrasion and slippage.

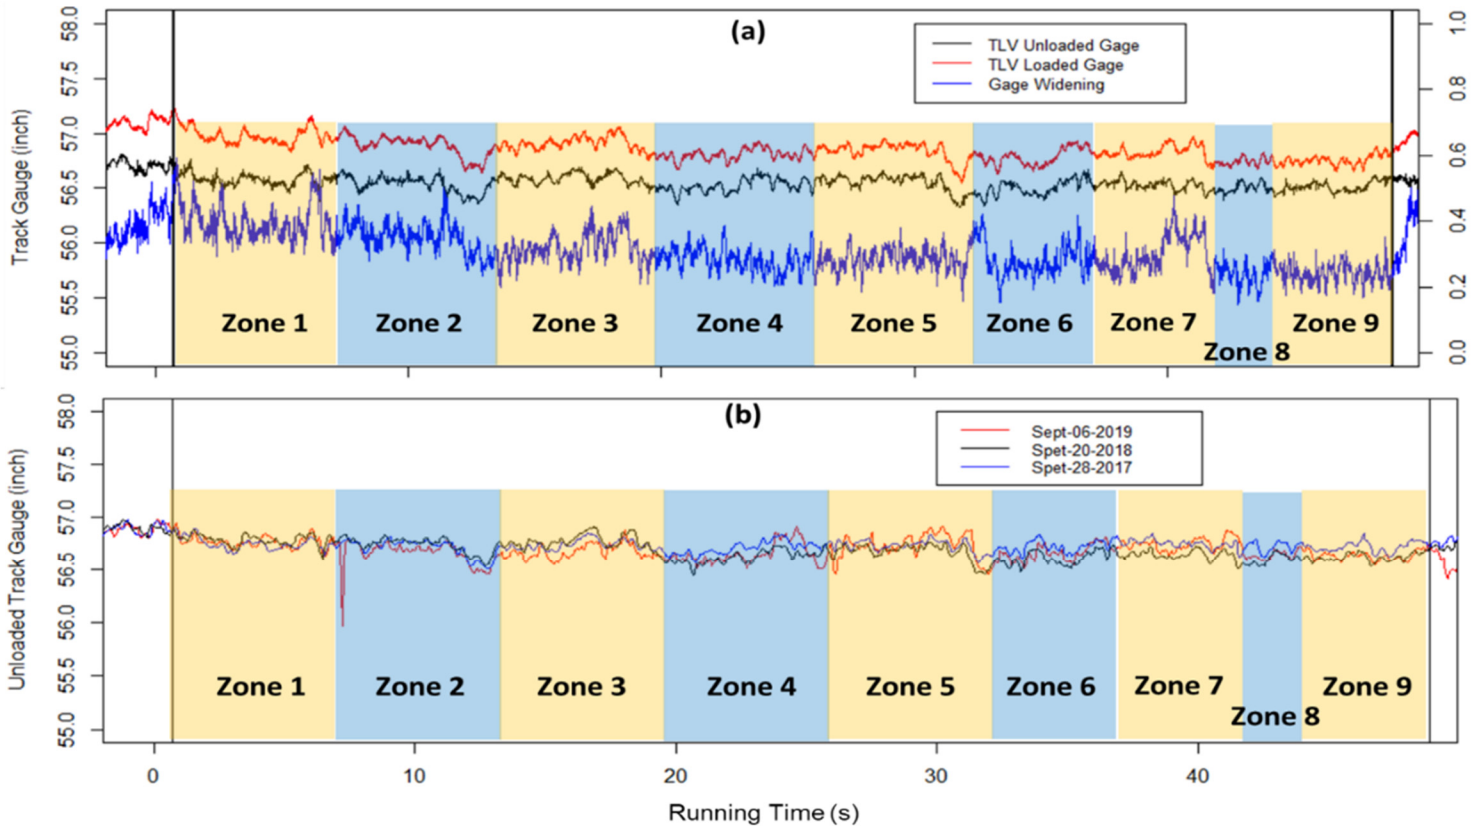
The results of this test (Figure 4) showed that the average gage widening from the TLV run was within 0.4 inch, which falls into the typical range for wood tie tracks.<sup>1</sup> Testing also showed that the unloaded track gage for each test zone remained at a similar level through 279 MGT.

Figure 4. Track gage measurements: (a) TLV at 124 MGT; (b) comparison of unloaded track gage at 0, 124, and 279 MGT
