High Performance Wheel Test 2 Update

Kerry Jones and Matt DeGeorge

[Transportation Technology Center, Inc. \(TTCI\)](#) has been conducting two long-term high performance wheel (HPW) tests under the Association of American Railroads' (AAR) Strategic Research Initiatives program on Wheel Performance and Integrity.

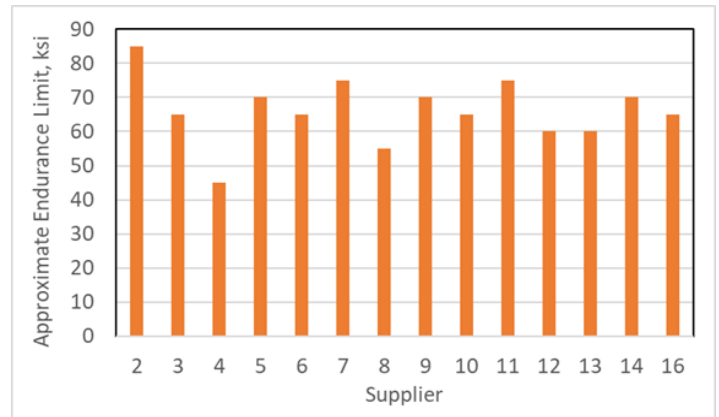
Figure 2. Endurance limits for the HPW2 wheel steels

Figure 2 indicates the approximate endurance limits, ranging from 45 ksi to 85 ksi, for all suppliers. The endurance limit by itself is not an indicator of performance but must be considered in conjunction with other mechanical properties. The experimental endurance limits will be compared to performance at FAST and during the revenue service portions of the test.

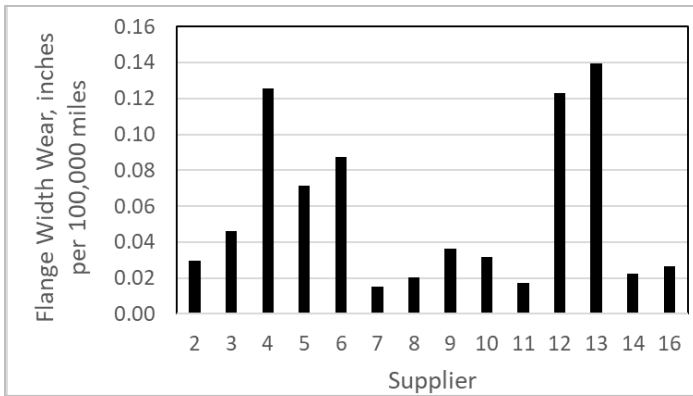
Figure 3. Normalized flange width wear for HPW2 wheels at FAST

Figures 3 and 4 show the average flange width wear and tread wear for the HPW2 wheels at FAST, respectively. The flange width and tread wear rates have changed little from the previous HPW2 reporting.¹ Wheels from Suppliers 4, 12, and 13 showed the highest wear rates for both measurements. These had lower hardness than wheels that currently show less wear.

Three wheelsets are nearing the AAR wear limit for flange width. When these wheelsets reach that limit, they will be removed and replaced with another test wheelset. No wheelsets have been removed for high impacts.
