Update on Cold Weather Evaluation of Premium Rail Performance

Benjamin Bakkum, Richard Joy, Ananyo Banerjee, Dustin Clasby

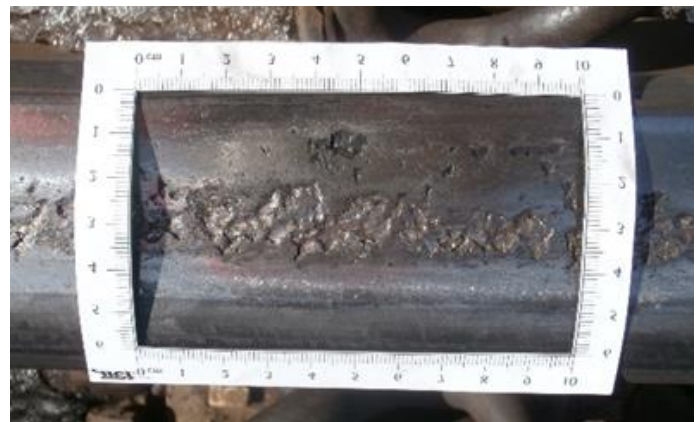
Following installation of the test rail strings, moderate to severe RCF developed throughout the test curve during accumulation of the first approximately 60 MGT. If not properly addressed, rail RCF can decrease the lifespan of rails significantly.

Initial analysis indicated that a likely cause of RCF was improper gage face lubrication throughout the test curve. Following corrective grinding of both low and high rails and adjustments to the nearby lubricator units, inspections have shown only minor RCF development. Figures 4 and 5 illustrate the difference in RCF seen at the test site between initial and subsequent inspections.

Figure 4. RCF, location No. 28 on low rail during April 2016 inspection

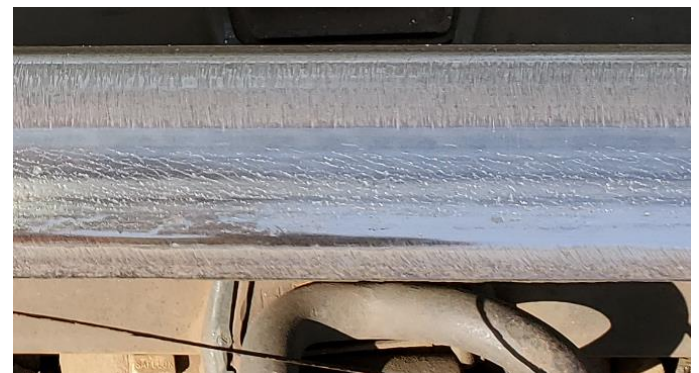
Figure 5. Location No. 28 on low rail during May 2019 inspection

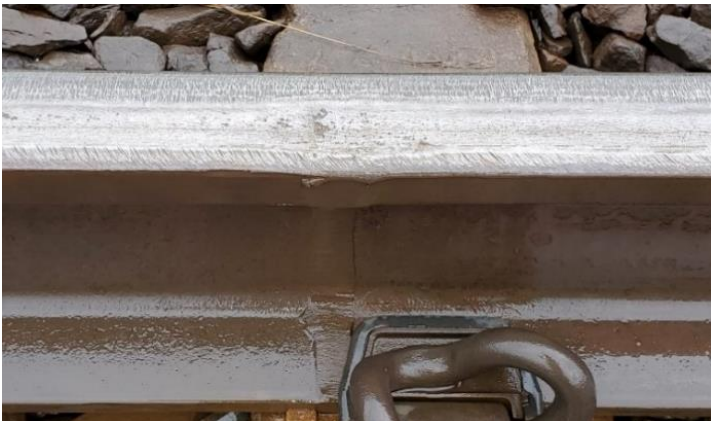
No additional electric flash butt welds have been marked as defective or removed as of the most recent inspection in May 2019. However, several have started to exhibit rail battering. It is to be noted that these flash butt welds made using the test rails were not air quenched to achieve extra strength and hardness of the welds. Figure 9 shows an example of this weld degradation.

Figure 9. Rail batter development on electric flash butt weld

Engineering forces have begun planning to replace a stretch of the low rail to remediate battered welds that are nearing the CN maintenance limits.
