Revenue Service Test of a Robotically Welded Frog

Stephen Wilk, Duane Otter, Benjamin Bakkum, and David Davis (retired)

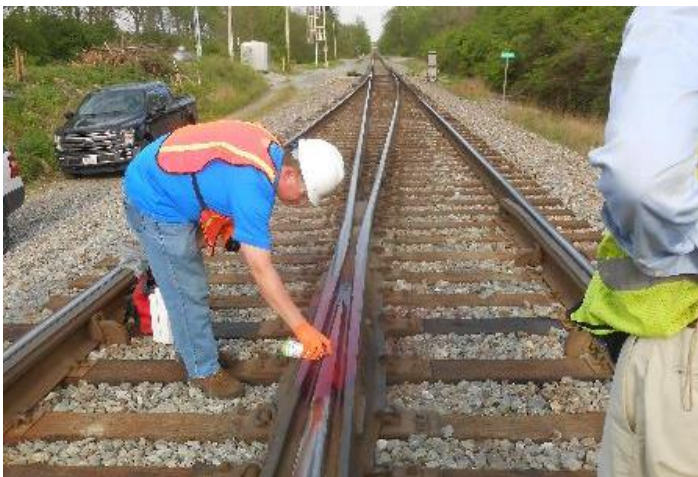
Figure 3. Corman, KY test location

Figure 2 shows the original frog installed at Kings Mountain, Kentucky in 2013. Figure 3 shows the repaired frog at Corman, Kentucky, installed in late 2018.

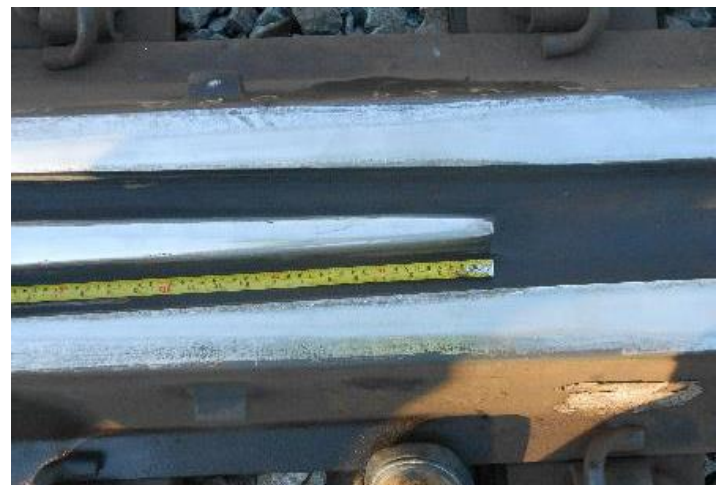
The weld repair has thus far proven to be durable. Figure 4 shows the running surface during the 65 MGT measurement. The running surface is almost free of cracking and spalling, with only a few spots on the frog point. Plastic flow has been managed through grinding, as can be seen in the grind marks on the gage corners of the wings. There is evidence of a smooth transition for wheels from wing to point (facing moves) and point to wing (trailing moves), as shown in Figures 4 and 5.

Figure 4. Running surface condition of weld repaired frog near 5/8-inch point

Note that there is minimal deformation on the wing gage corners and on the frog point, back toward the heel. The lack of gouges or worn grooves indicates that most wheels are transitioning with low dynamic loading.

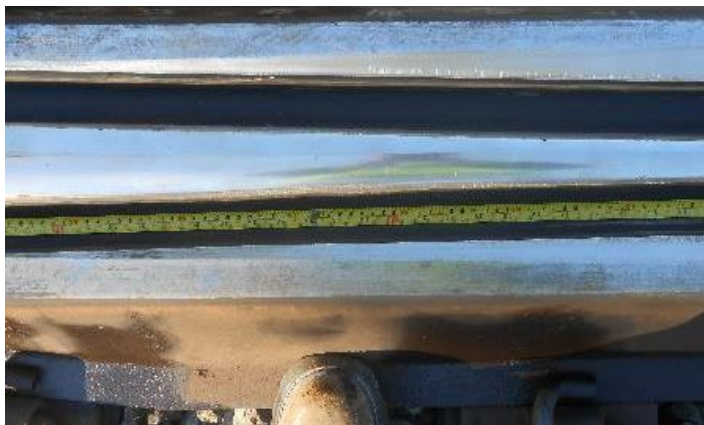
Figure 5. Running surface condition of weld repaired frog towards heel end of wheel transition zone

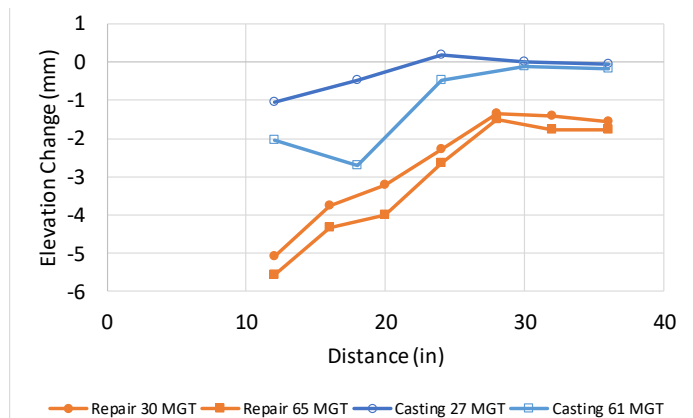
While the wear is generally even (i.e., proportional to point thickness) throughout the weld repair, the rate of wear and deformation is significantly higher than that measured on the original casting material. Figure 6 shows height loss versus location for the first 60 MGT on each frog.

Figure 6. Frog point height loss versus distance from the 5/8-inch point

The height loss is measured from the centerline of the frog point. The ratio of weld repair to casting height loss ranges from about 4 mm at location +12 (from the 5/8-inch point) to 2 mm at location +36 after 30 MGT. The difference in height loss rate decreases as tonnage accumulates. A major disadvantage of a weld repair is

difficulty hardening the running surface. The original casting was explosively hardened to ~360 Brinell hardness (BHN); whereas, the weld repair had a surface hardness of ~220 BHN.

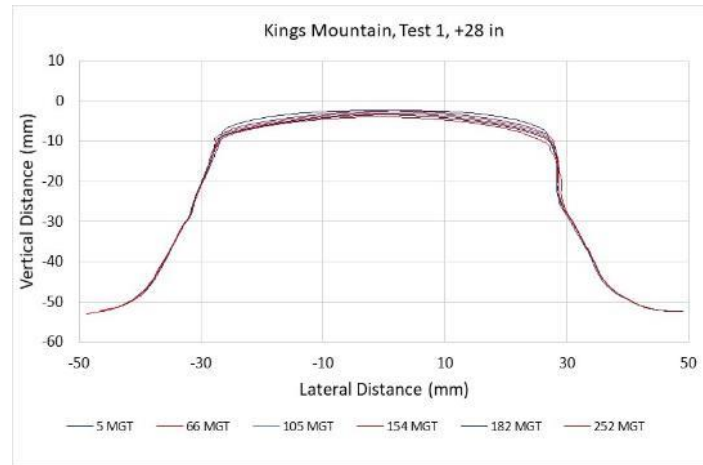
This initial height loss difference can be seen in the cross section profiles taken on each frog. Figures 7 and 8 show each frog at location +28 (from the 5/8-inch point).

Figure 7. Original casting frog point profiles at +28 inches from the 5/8-inch point

The most obvious difference between the two frogs is the initial height loss after installation. The height loss in the first 30 MGT for the repaired frog is about an order of magnitude higher than it is for the original casting.

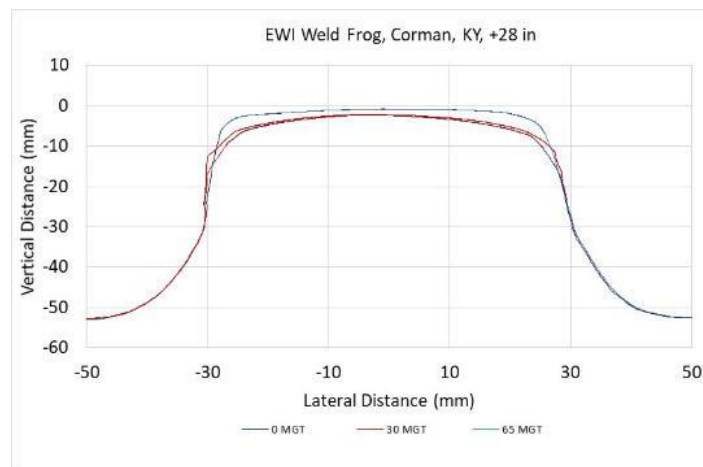
Figure 8. Repaired frog point profiles at +28 inches from the 5/8-inch point

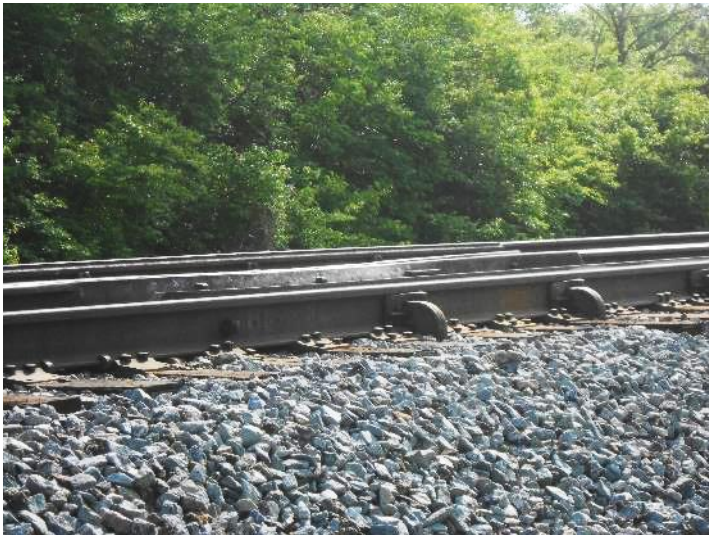
The repaired frog does exhibit a pronounced bowing of the casting, with the toe and heel ends being higher than the middle. This concavity was not noted at the 0 MGT measurement because the frog was placed on uneven ground near the tracks when measured prior to installation; however, it was noted at the first profile measurement made in-track at 30 MGT. It looked the same after 65 MGT of service. Figure 9 shows a side view of the frog in-track during the 30 MGT measurements. The photograph shows that the frog toe and heel ends are higher than the middle portion. It is not known whether the heat input from the rather large weld repair caused the frog to warp, but this possibility should be investigated.

Figure 9. Repaired frog in-track showing bowed shape

In addition to the bowing, casting cracks were noted just beyond the weld repair by inspection personnel.

Continued monitoring of the frog to determine the failure mode(s) and service life of the weld repair is necessary. Also, the vertical bending of the frog should be investigated to determine if the weld repair was the cause.
