# FAST High Strength Rail Test: Results through 325 MGT

Ananyo Banerjee, Kenny Morrison,  
Matt Witte, and Joseph LoPresti

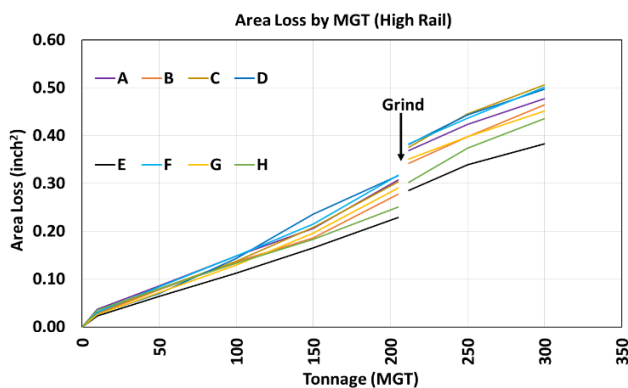
Rail profile measurements were collected at 0, 10, 100, 205, 212, and 300 MGT using a MiniProf profilometer. The rail profile measurements at 205 MGT were considered pre-grind profiles while the 212 MGT measurements were considered post-grind profiles. Gage face wear or simply gage wear was the main wear pattern contributing to the overall high rail head wear. This observation consistently aligned well with what was indicated by the primary wear type in previous HS rail tests conducted in the same 5-degree reverse curve on the HTL.<sup>2</sup> Figure 1 shows the overall head area loss of the different rails in the current test.

**Figure 1. Median head area loss of eight rail types A–H in the current 2018 HS rail test**

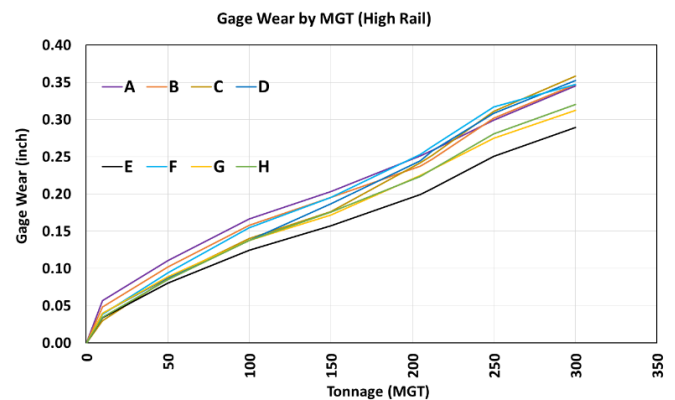
based on the measured profiles. Figure 2 shows gage wear on the eight rail types — the rapid wear in the data shown near the origin of the plot after 0 MGT is believed to have been caused by the removal of the soft decarburized layer on the surface of the rail heads for all types. No initial grinding was done during this test to remove the mill scale and decarburized layer. The same rapid wear can be seen in area loss in Figure 1, but it is less pronounced than what can be seen in Figure 2. Rail type E has the least wear in the test. Rail types G and H show higher wear than type E, but comparatively less wear than types A through D and F. Weak correlations were observed between vertical wear, head area loss, and the surface hardness of the eight rail types through 300 MGT in the current test.

**Figure 2. Median gage wear of rail types A–H in the HS rail test initiated in 2018**

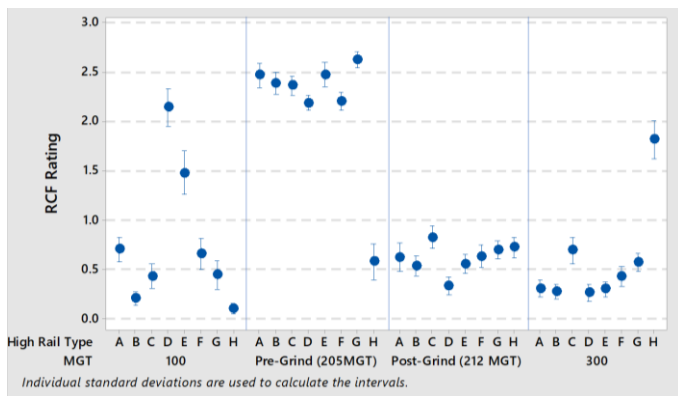
A visual RCF assessment was done using a visual RCF rating scale at 100, 205 (pre-grind), 212 (post-grind), and 300 MGT. The visual rating scale of 0 to 3 in increments of 0.5 was the same as the scale that was used in the previous test.<sup>2,3</sup> In the current test, an interesting trend was observed in the visual RCF assessment from 100 to 300 MGT with pre-grind and post-grind ratings in between. Figure 3 shows the mean RCF ratings for the eight participating rail types. At 100 MGT, rail type D showed a higher RCF rating than the other rail types did. All the rail types, except type H, had mean RCF ratings between 2 and 3 at 205 MGT. Type H had the lowest RCF rating at both 100 and 205 MGT. After grinding, all rail types except H saw a substantial decrease in the mean RCF rating at 212 MGT. At 300 MGT, rail type H had the highest mean RCF rating of close to 2 while the remaining seven rail types had ratings between 0 and 1.

Figure 3. Mean RCF ratings of eight rail types at 100, 205, 212, 300 MGT

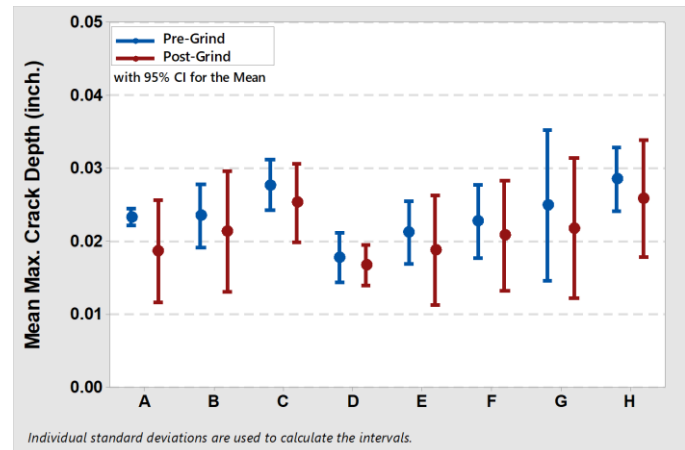
Figure 4. Pre-grind and post-grind mean maximum crack depths per rail type as measured by EMFI technology

The decrease in crack depth after grinding as measured by EMFI does not correlate directly to the decrease in the RCF visual rating. For rail type E, the mean RCF visual rating decreased from 2.48 at pre-grind to 0.56 at post-grind, while the mean EMFI maximum crack depth decreased by 0.003 inch. For rail type A, the mean RCF visual rating decreased from 2.47 to 0.62 while the mean maximum crack depth decreased by 0.005 inch. In contrast, rail type H had a low pre-grind RCF visual rating of 0.58 which increased slightly to 0.72 after grinding, but it had the highest mean maximum crack depth among all rail types as measured by the EMFI technique. This indicates that the extent of surface RCF and spalling can be different than the measured crack depths existing below the top of rail surface. Since visual evaluation is based primarily on surface coverage, no correlation was found between the difference in the visual RCF ratings and the difference in the maximum crack depth as measured by EMFI before and after grinding. This lack of correlation highlights the importance of a visual assessment of the extent of the existing RCF on a rail surface and an NDE inspection of the sub-surface crack depths before deciding on the extent of grinding, especially when the track consists of different rail types.

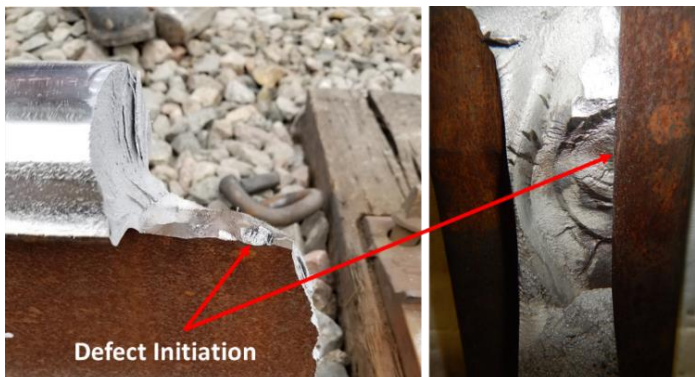
In this HS rail test that ran through 325 MGT and is still continuing, one EFB weld failure occurred at 210 MGT. The source of the failure was a fracture found along the weld fusion line. This failure appeared to be similar to most of the EFB weld failures in the previous HS rail test that had a total of eight EFB weld failures with four failures happening before 312 MGT. Figure 5 shows the fracture as detected in track with the location of defect initiation highlighted.

Figure 5. EFB weld failure between test rails
