The research described was performed by Transportation Technology Center, Inc., a wholly owned subsidiary of the Association of American Railroads.

## Performance of Reconditioned Bearings with Cup Spalls: Phase 1

Dustin Clasby and Steven Belport

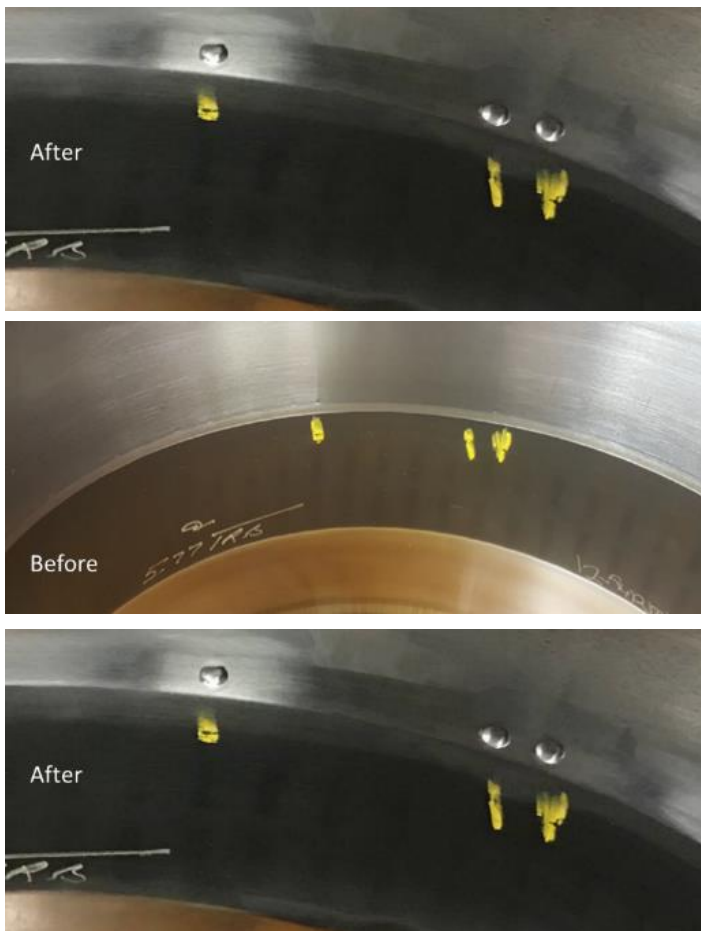
As bearings are pulled from revenue service for reconditioning, they are disassembled and visually inspected. Defects that meet the AAR standards are repaired, and the bearings are re-assembled to return to revenue service. Bearings with spalls can be returned to service if the repair is smaller than 3/8 inch in diameter and less than 1/8 inch deep.<sup>1</sup>

Figure 1. Before and after reconditioning spalls on bearing raceway

The repair of a raceway spall is completed by removing material around the spall with the intent of removing the visible defect and alleviating stress points that could have lead to further degradation of the raceway steel.

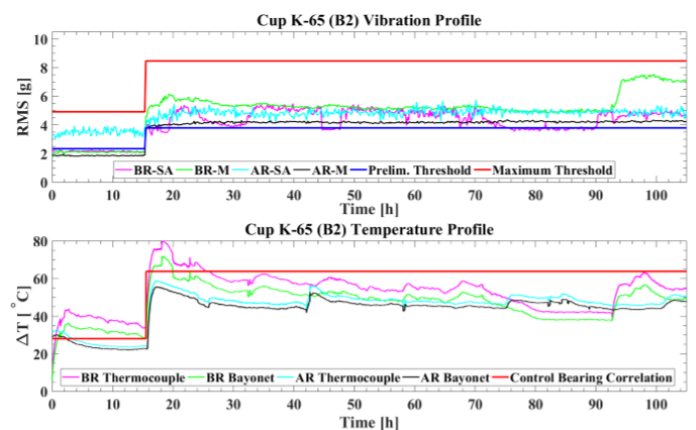
Figure 4 shows the vibration and temperature profiles for Test Bearing 2.<sup>2</sup> The solid red line in these charts indicates a threshold of poor performance used by UTRGV based on historical bearing tests. The solid blue line in the vibration chart is the average value for new bearings tested by UTRGV.

**Figure 4. Vibration and temperature profiles for test Bearing 2 before and after the reconditioning process**

Observation of the temperature profiles for Test Bearing 2 before and after reconditioning repair showed that the reconditioning process helped stabilize and noticeably lower the operating temperature of this bearing. Comparing the vibration profiles for Bearing 2 before and after reconditioning repair, the vibration levels after repair are more stable and slightly lower than before repair where the vibration levels exhibit some distinct fluctuations. Hence, the reconditioning process improved the overall temperature and vibration performance of Test Bearing 2 more so than it did for Test Bearing 1.<sup>2</sup>
