Comparative Examination of FAST Track Geometry and Vehicle/Track Interaction Exceptions

Abe Meddah and Silvia Galván-Núñez

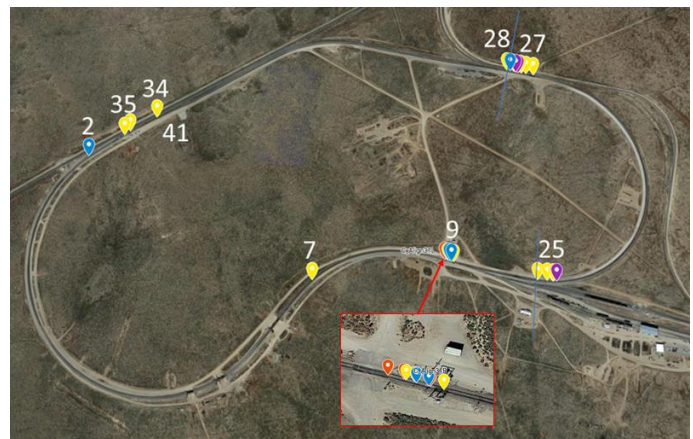
Figure 3. Combined geometry defects from six tests

Figure 3 designates all the defects from the six tests after accumulating approximately 87.4 MGT by the final test. Defects were overlaid on the FAST map using corresponding GPS coordinates. A color was assigned to each defect type to render it visually distinguishable. As can be seen, the defects were mostly clustered around HTL Sections 9, 25, 27, and 28. The geometry defects appear to be more repeatable in Section 9 in the vicinity of a crossing, the beginning of Section 25, in Sections 27, and Section 28 by a turnout.

Nearly 80 percent of recorded track geometry defects consisted of 31- and 62-foot MCO cross level deviations represented by yellow and purple markers, respectively.

Of the total defects, gage and 31-foot left and right alignment, MCO amounted to about 12 and 10 percent, respectively. Gage is represented by the blue markers in Sections 2, 28 and 9 while alignment is represented in red in Section 9. It is noteworthy, however, that no surface anomalies (i.e., bump or dip deviations) were detected during any of the six geometry tests.

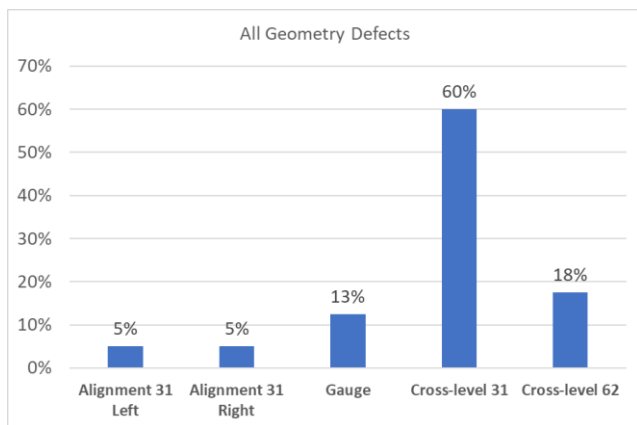
Figure 4. All track geometry defects per current standards

Figure 4 shows the distribution of all the defects from the six tests. Figure 5 shows the track geometry defect breakdown for each of the six tests conducted at FAST starting from the baseline test.

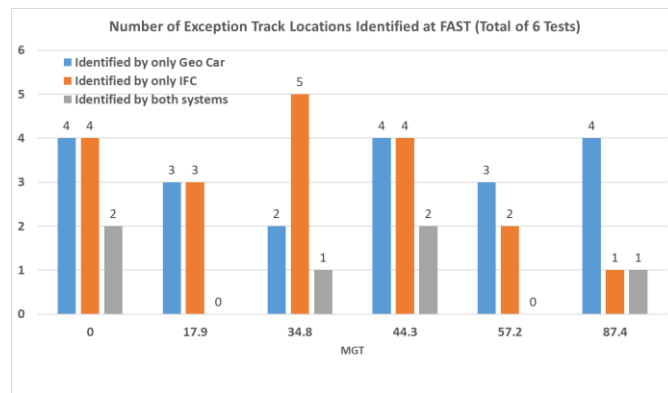
Figure 6. Geometry defects versus IFC for each test

Figure 6 shows a summary distribution of exception track locations identified by each technology for every conducted test, as well as the same locations identified by both technologies.

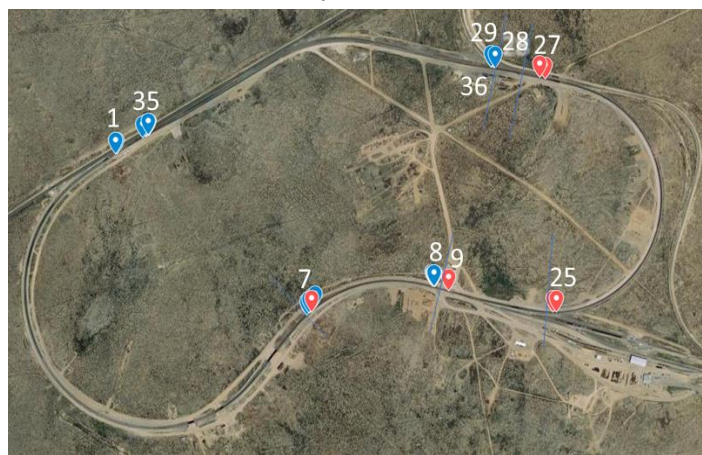
Figure 7. Regulatory geometry defects (red) versus IFC exceptions (blue) at 44.3 MGT

Figures 7 and 8 use GPS information overlaid with the numbered HTL Sections to show examples of geometry defects per current regulatory standards (red markers) contrasted with track locations identified by IFC (blue markers) at two MGT levels— 44.3 MGT and 87.4 MGT, respectively.

In Figure 7, all geometry exceedances consisted of 31- and 62-foot MCO cross level deviations. IFC exceptions coincided with geometry deviations in Section 7 and consisted of vertical side frame acceleration exceptions.

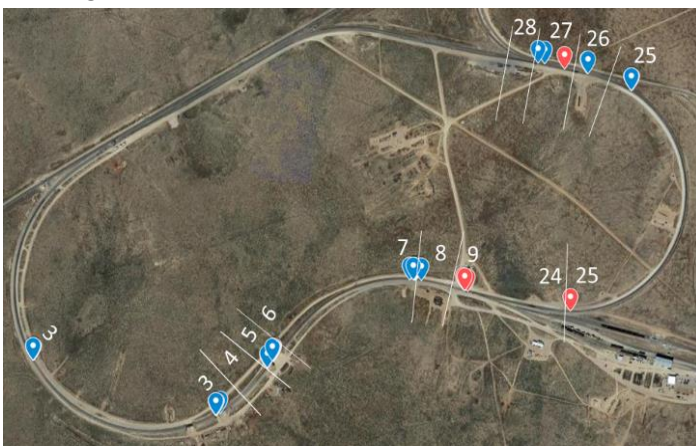
Figure 9. IFC worst responses (blue) versus geometry defects (red) at 57.2 MGT

Since no longwave length exceptions were recorded during the IFC runs, the longwave length worst IFC responses, consisting of carbody maximum and minimum accelerations, were computed at 57.2 MGT for one night's operations with the FAST train and compared with the geometry defects identified at the same MGT level. As presented in Figure 9 over numbered HTL sections, track geometry recorded in red markers point to three distinct locations: 1) over Section 9, 2) the beginning of Section 25 when traveling counterclockwise, and 3) over Section 27.

Considering that multiple hits indicate locations with repeatable events, the worst IFC responses, however, were recorded in seven distinct locations (blue markers, Figure 9). Out of the seven locations, one track geometry defect location was close to the IFC worst response on Section 28. IFC worst responses do not always appear to correlate with track defect

locations at 57.2 MGT. Under the assumption that no maintenance work is performed, some locations with the worst IFC responses can carry the potential to worsen overtime as track accumulates more tonnage.
