Locating Lateral Track Irregularities Which Cause Excessive Vehicle Loads

by
Semih Kalay
and
W. P. O'Donnell
TD93-004

Association of American Railroads
Research and Test Department

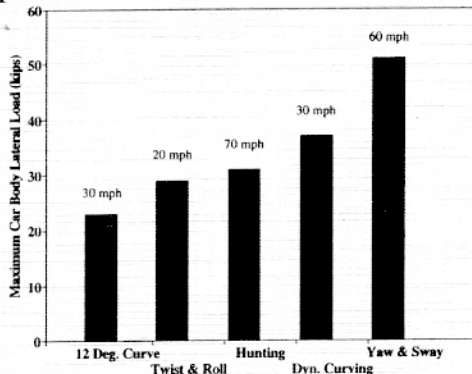
During testing over the twist and roll section, lateral loads on the bolster exceeded 28,000 pounds, at the vehicle's critical roll speed of 20 mph. The vehicle was tested over a test track with multiple irregularities in the lateral direction; the yaw and sway test section at TTC. Multiple type irregularities are usually associated with a series of periodic track irregularities. These irregularities which excite one of the vehicle's resonance modes in which maximum loads and displacements occur. Lateral bolster loads of more than 50,000 pounds were measured on tangent track constructed with five 39 foot long sinusoidal alignment perturbations with maximum amplitudes of 1.25 inches. This lateral bolster load was measured at a speed of approximately 60 mph, which appears to be the critical speed that excites the vehicle's sway mode.

During high speed stability tests, lateral bolster loads in excess of 30,000 pounds were measured at the full flange-to-flange hunting speed of 70 mph. Finally, the vehicle was tested over a 10 degree curved track segment with crosslevel and high-rail alignment perturbations. The lateral load on the bolster reached 27,000 pounds at 30 mph. Exhibit 1 shows the maximum lateral bolster loads measured in response to various Chapter XI test tracks at TTC.

Exhibit 1. Effect of Track Geometry on Car Body Lateral Loads.

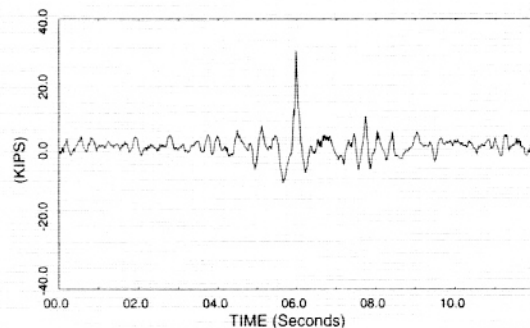
Single track irregularities caused large increases in loads and accelerations throughout the freight car, as well as on the track, and were usually associated with turnouts, and joints or welds in the track. One such example of a single irregularity in the lateral direction was found at a turnout where the lateral load on the bolster exceeded 30,000 pounds. Inspection of the track did not reveal obvious problems but it was inferred from the paint spray on the track and from examination of the lateral load time trace (Exhibit 2), that the exceedance started at the entry into the switch.

Exhibit 2. Car Body Lateral Load Exceedance at a Turnout.

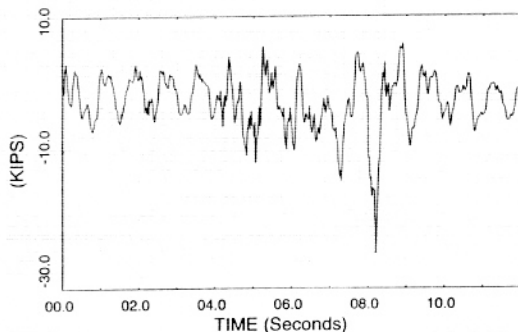
Occasionally, excessive lateral loads are experienced on the car body that are not associated with any special track installation. One such example was experienced during tests on revenue track. As seen in Exhibit 3, a lateral load in excess of 30,000 pounds was experienced, at approximately 8 seconds, while negotiating a moderate curve through a reverse spiral at only 30 mph.

The center plate load represents the force that the car body applies to the truck. Examination of the corresponding vertical bolster load time history showed that when the lateral load increased dramatically, the center plate unloaded up to 60% of its static load level. This indicates that the car body was rocking off the center plate, and onto the side bearing, a potentially undesirable situation.

Exhibit 3. Lateral Car Body Load due to Alignment Defect.

Inspection of data obtained from the track geometry car over this track location offered some insight into the cause of this response. Alignment, as measured at the midpoint of a 62 foot chord, deviated at this location by more than 1 3/4 inches from the design curvature. Consequently an urgent defect was reported by the track geometry car.

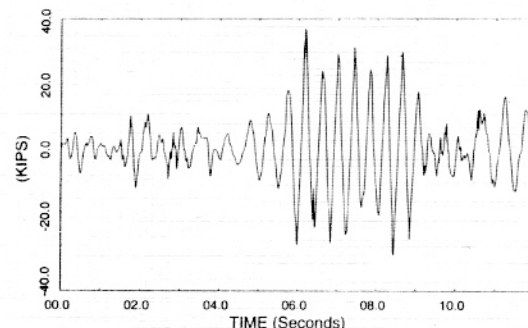
In Exhibit 4, the frequency of the bolster lateral motion was about 2 Hz, corresponding to the frequency at which the vehicle travels over a 39 foot rail length at 60 mph. Since the track input is oscillatory, the test vehicle is forced to vibrate at this frequency. If the frequency of excitation coincides with the yaw or sway natural frequency of the vehicle on its suspension system, resonance is encountered. As a result, large carbody motions accompanied by frequent gib contact may occur as seen in Exhibit 4. Results of the track inspection were inconclusive, however, several of the sites showed that the exceedances had occurred in open track and were associated with a series of parallel lateral alignment waves on continuous welded rails. At one site, the track had alignment waves coincident with square plant welds.

Exhibit 4. Lateral Car Body Loads due to Multiple Track Irregularities.
