Two Standard-Component Crossing Diamonds Tested Under HAL Traffic,

TD 93-005

Association of American Railroads
Research and Test Department

August 1993

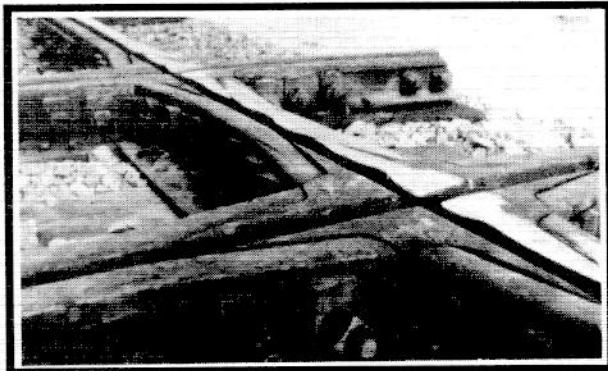
Exhibit 1. 89-Degree Crossing after 1.9 MGT of HAL Traffic

Exhibit 1 shows the excessive amount of batter and metal flow, on both the insert castings and the wing rails, after 1.9 MGT of 39-ton axle load traffic. The batter rate was about 1/8 inch per MGT. Exhibit 2 shows that the plastic deformation and metal flow resulted in a narrowing of the cross-direction flangeway to less than the American Railroad Engineering Association (AREA) allowable. The deformation included yielding of the manganese steel casting walls, as measured using strain gages applied at various locations on the castings. This indicates that more than just a harder casting surface is necessary to withstand HAL traffic. In addition, there was a significant loss of vertical track geometry, as the crossing settled with accumulating tonnage.

Given the extent of the damage to both the castings and the wing rails, and the rapid rate at which it occurred, it was deemed impractical and prohibitively expensive to attempt to repair the crossing and maintain it in track for any length of time.

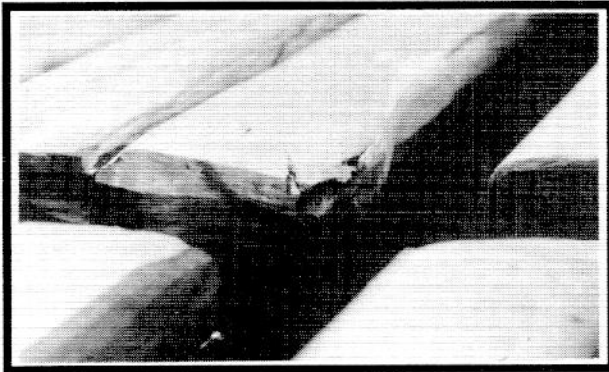
Exhibit 3. Crossing Rail End after 4.6 MGT of HAL Traffic

The 62-degree crossing was subjected to 4.6 MGT of HAL traffic at FAST before being removed from track. The reason for removing the diamond from track was excessive damage to the rail ends at the gaps in the crossing. As might be expected, the rail ends downstream of the gap suffered the most severe damage after a day of train operation in one particular direction. Exhibit 3 shows a damaged rail end after 4.6 MGT of HAL traffic. Notice the extensive plastic flow and cracking. The cracks went so deep that very little of the original railhead material would have been left if the cracks were ground. Perhaps this rail end might have lasted longer if train operations were stopped before the damage had progressed this far, and a repair could still be made.

The rail ends at the crossing gaps required frequent repairs, particularly the downstream ends. Most of the damage was in the form of plastic flow which needed to be ground off. Weld material was then used to build up the surface.

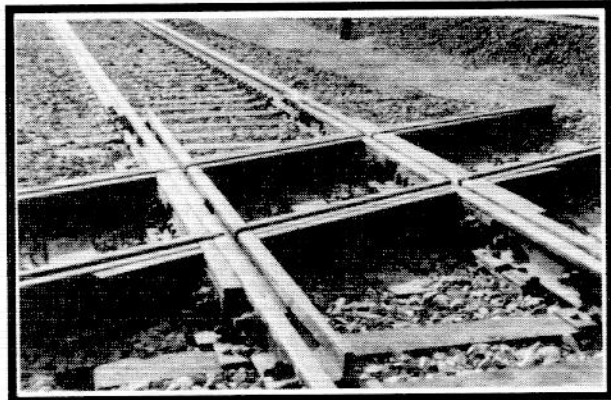
**Exhibit 4. 62-Degree Three-Rail
Crossing Diamond**

The 62-degree crossing diamond was donated by CSX Transportation. This diamond was constructed by the Conley Frog and Switch Company using Bethlehem 136 RE fully heat-treated rail. The steelwork closely follows AREA Plans No. 700F-80 and No. 701-80. AAR personnel performed the timber work following the AREA plans. Exhibit 4 shows the crossing installation.

Before installing the crossing in track at FAST, the rail ends on the mainline running rails were built up to repair the damage sustained during the 2 years of revenue service traffic over the diamond.
