**"TRUCK CHARACTERIZATION
TESTS PERFORMED ON
SERVICE WORN CARS,"**

**by Curtis L. Urban and
Huimin Wu**

TD 94-009

**Association of American Railroads
Research and Test Department**

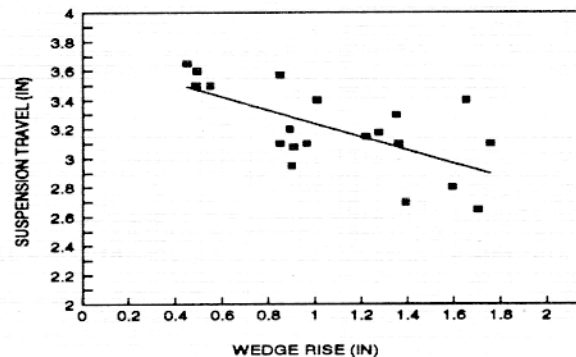
Exhibit 1. Suspension Travel vs Friction Wedge Rise

All of the 100-ton trucks were exercised through their full available suspension travel using new and worn D5, inner, outer load coils, and double side control coils. The available vertical travel of the suspension coils was 3 11/16 inches. Exhibit 1 shows the results of suspension travel using new D5 coils.

In Exhibit 1, the available travel of the vertical suspension is plotted against friction wedge rise. The correlation between available travel and wedge rise is clearly seen. A regression line has been added for easy interpolation of the results.

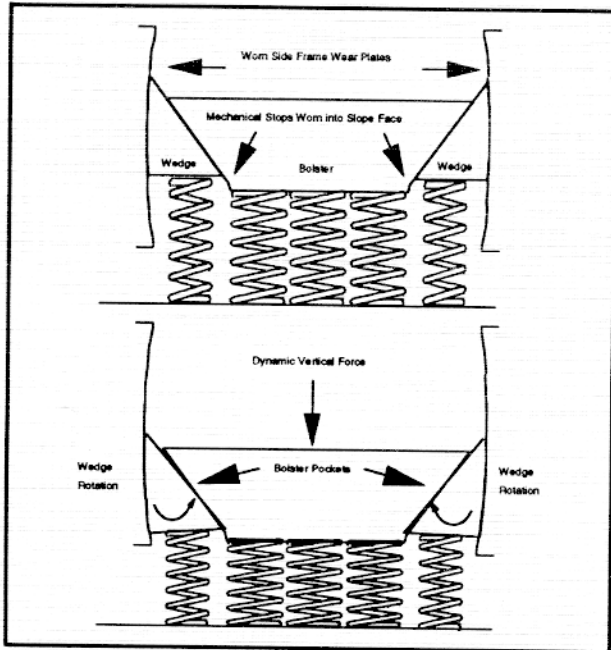
Exhibit 2. Mechanism for Loss of Travel Due to Friction Wedge Lock-up

Notably if the D5 coils were replaced with longer travel coils, the results would have been similar; i.e., wedge binding would reduce the overall suspension travel. The friction wedges are locking up the suspension prior to the D5 coils going solid. Exhibit 2 shows the mechanism for wedge lock-up as determined from observations and truck inspections.

Exhibit 2 also shows a side view of the truck bolster, friction wedges, and side frame wear plates. The top diagram of Exhibit 2 illustrates the normal wear pattern for these trucks in the loaded condition. As might be expected for a variably damped truck, the most amount of wear occurs when the truck is in loaded configuration. Normal vertical and lateral motion between side frame and bolster creates a three-dimensional concave wear pattern to develop on the surface on the side frame wear plates and a conformal convex wear pattern on the surface on the friction wedges. It also creates a mechanical stop along the bolster slope face in the pocket.

The bottom diagram in Exhibit 2 shows what occurs when the truck is stroked beyond the normal loaded range due to a high dynamic load. The wedges must slide down the bolster slope face and rotate toward the bolster to allow for vertical motion. Due to the wear patterns on the bolster slope face, the wedge can only slide down and rotate a slight amount. Eventually the wedge locks up the suspension due to binding prior to the suspension reaching its normal solid displacement.

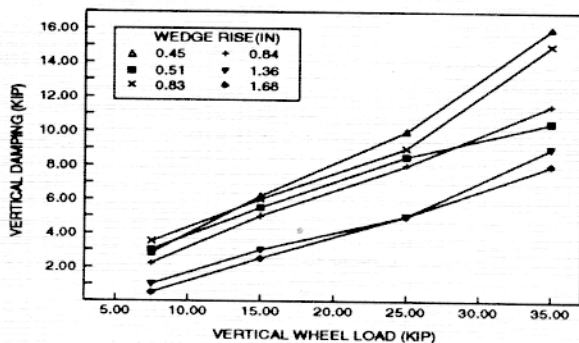
Exhibit 3. Vertical Suspension Damping vs Vertical Wheel Load

Exhibit 3 shows the correlation between vertical truck damping and wedge rise. Total vertical truck damping is plotted against vertical wheel loads for various wedge rise conditions.

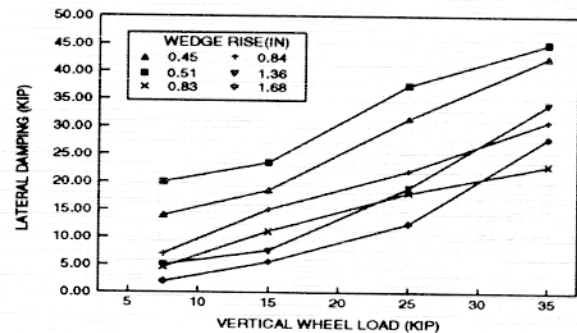
Exhibit 4. Lateral Suspension Damping vs Vertical Wheel Load

The trucks were exercised through their full lateral suspension travel using four loaded configurations: 7,500, 15,000, 25,000 and 35,000 pounds wheel loads. Data presented in Exhibit 4 shows the correlation between total lateral truck damping and wedge rise. The trucks showed a similar trend when exercised through their full shear/warp suspensions using the same loaded configurations.

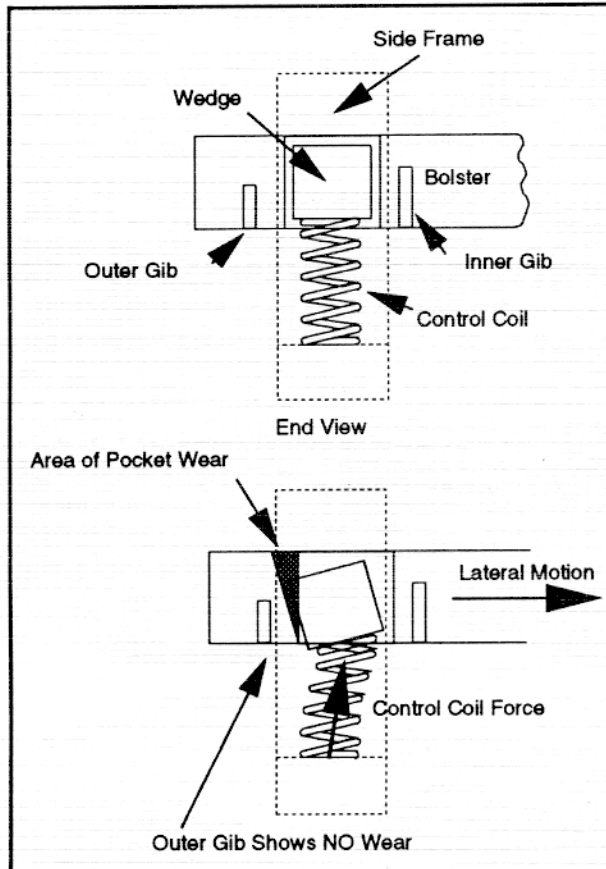
Exhibit 5. Mechanism Depicting Damage Due to Moving Outer Gib

Depicted in Exhibit 5 is the mechanism that is causing increased lateral wear in the bolster side wall area due to the non-symmetric gib spacing. The top and bottom diagrams show the end view of the side frame, bolster wedge pocket, and friction wedge. As discussed in the summary, gib clearance was increased during the design of these trucks to reduce wear.

In the bottom diagram of Exhibit 5, the bolster has been displaced laterally. With larger lateral displacements, the control coil eventually becomes angled. The force in the control coil is then reacted in the vertical and lateral directions. This causes a moment to be set up on the friction wedge, which in turn must be reacted on the side frame wear plate and the bolster wedge pocket side walls. As the truck is stroked vertically, the force in the control coil increases. This causes a larger moment to be reacted on the side frame wear plate and bolster wedge pocket side walls.

If the lateral and vertical displacements are small, the moment on the wedge can be reacted by a friction moment on the side frame wear plate. However, the maximum value of this moment is limited by the available friction. As the lateral and vertical displacements increase, the friction wedge can no longer react this moment, which in turn must be reacted on the side walls of the

bolster wedge pocket. As the truck suspension is stroked vertically, the reacted moment on the side wall eventually causes a wear pattern to develop on the bolster side wall as depicted by the shaded region in the lower diagram of Exhibit 5. This wear pattern has been observed on these trucks and is over 0.5 inch wide at the top and 0.125 inch at the bottom.

When the truck is placed in a situation where the truck is required to damp out both vertical and lateral oscillations, the control coil forces increase with addition vertical motions. This causes an increased lateral force on the bolster wedge pocket side wall, thereby increasing the wear. This continuous wearing action of the wedge on the side wall causes vertical and lateral mechanical stops to form.
