### Performance of Weld Repairs on Rail-bound Manganese Frogs in Heavy Haul Service

by David D. Davis  
TD95-002

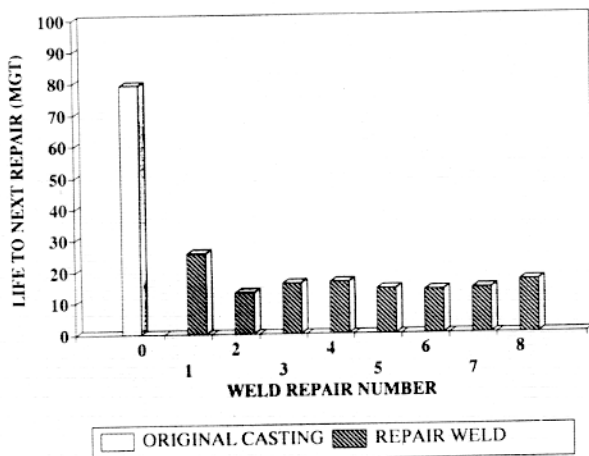
**Exhibit 1. Components of a Frog's Service Life.**

Exhibit 1 shows the various components of a frog's service life. The time to first repair is the largest component; averaging 79 million gross tons (MGT). The typical frog receives an average of 8 weld repairs with an average of 18 MGT between repairs. First weld repairs last 26 MGT on average. Subsequent repairs last an average of 15 MGT.

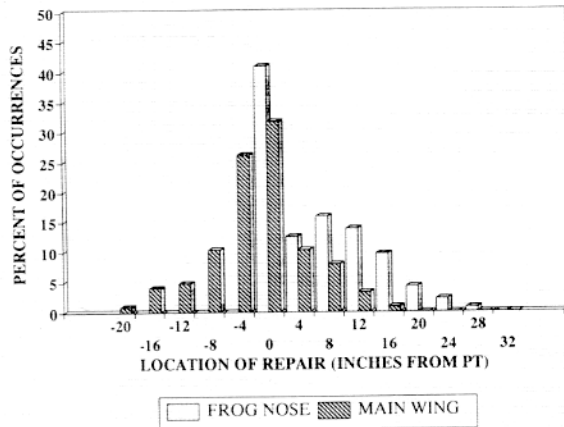
Exhibit 2. Location of Weld Repairs (Leading Edge).

Because of the unique operating pattern on the line, weld repairs occurred almost exclusively on the frog nose and main wing. The side wing, used by diverging route moves, suffered little damage. The loaded trains, all traveling eastbound, always hold the mainline at meets. Only empty trains use the diverging routes (sidings). The number of nose and wing repairs was about equal (150 to 131). Exhibit 2 shows the location of the leading edge of each repair (facing point move) as measured from the nose tip. One can see the wide range of repair locations from -20 to +20 inches on the wing and from 0 to 20+ inches on the nose. The locations of the leading edges of the wing repairs is centered on the frog nose point. The frog nose repair locations suggests a bi-modal distribution. There is a large mass of data at the tip of the nose and another mass centered at 8-12 inches. With average lengths of repair of 15 and 19 inches, the range of repaired areas is about 60 inches on the wing and 40 inches on the nose. This wide range suggests that the lateral location of the wheel on the rail and frog is not fixed; nor is the lateral location of the contact area on the wheel. Research into the design of frog/turnout rail surface profiles to accommodate service worn wheels is needed. The effects of hollow tread (i.e. "false flange") wheels are present in this data. However, they could not be isolated from the variables measured.

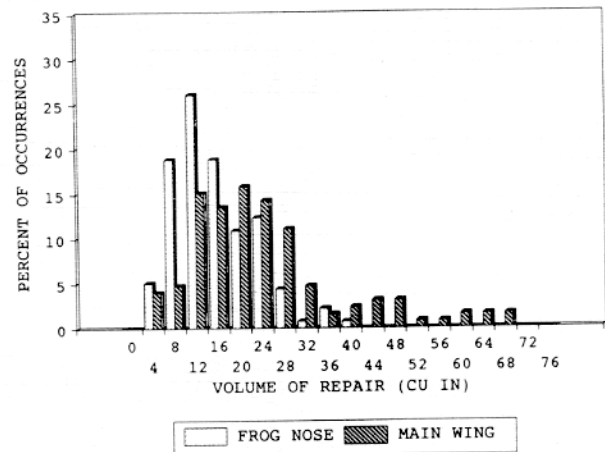
Exhibit 4. Volume of Weld Repairs.

The approximate dimensions of weld repairs are presented in Exhibit 3. Some repairs extend through the full thickness of the casting. Exhibit 4 shows the repair material volume distribution by repair location. A significant portion of this volume is devoted to "building up" the running surface (i.e. replacing metal flow).

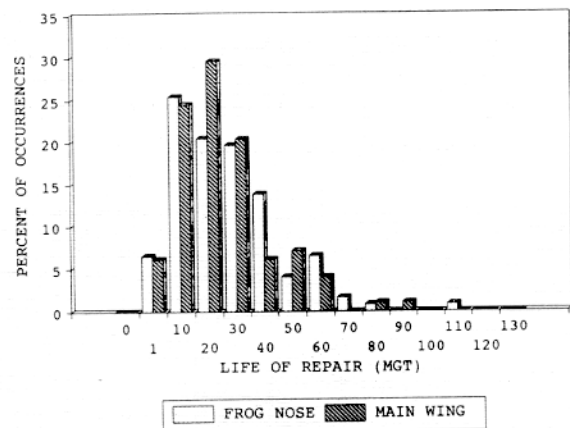
Exhibit 5. Life of Weld Repairs.

short lived repair intervals showed that many were multiple day repairs. Often the frog nose was repaired one day and the main wing was repaired the next. Exhibit 5 shows the distribution of repair life (i.e. tonnage between repairs) for the nose and main wing. There is little difference in the life of main wing and frog nose repairs. They are 14.9 MGT and 16.9 MGT, respectively. The "tail" of the

distribution is most interesting in that these are the repairs that survived more than twice the average life.

The repairs that lasted less than one MGT are multi-day repairs on the nose or main wing. Some are repairs large enough to require two days. Others are repairs that cracked during or shortly after welding. These "early failure" repairs are symptomatic of lines that have insufficient track time available for in-track repairs.

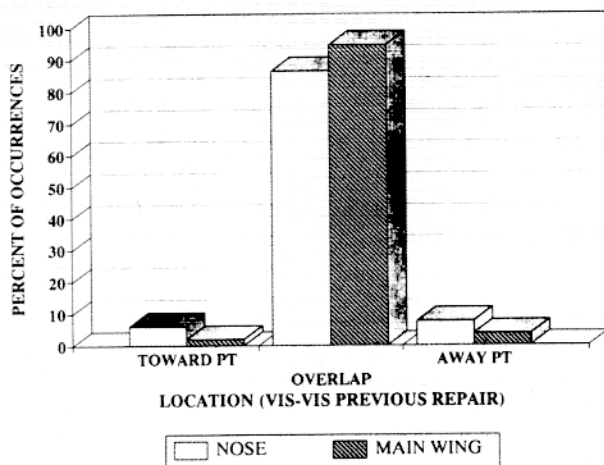
**Exhibit 6. Location of Weld Repairs in Relation to Previous Repairs.**

Comparison of the locations of consecutive repairs on the nose and main wing showed that repaired areas almost always overlap (Exhibit 6). Possible explanations for this phenomenon include:

- Weld repairs are incomplete. All of the damaged material is not replaced.
- The weld material is inferior to original casting.
- The weld repair process damages the underlying material.
- While the location varies from frog to frog, traffic on a given frog tends to damage the same areas, before and after repairs.

Comparison of the locations of consecutive repairs on both the nose and main wing showed that repaired areas overlap about 90 percent of the time. This suggests that improvements in welding procedures and/or materials are needed.
