Testing a 76-Degree Crossing Under Heavy Axle Load Traffic by Duane E. Otter and Joseph LoPresti TD 95-014

Association of American Railroads
Research and Test Department

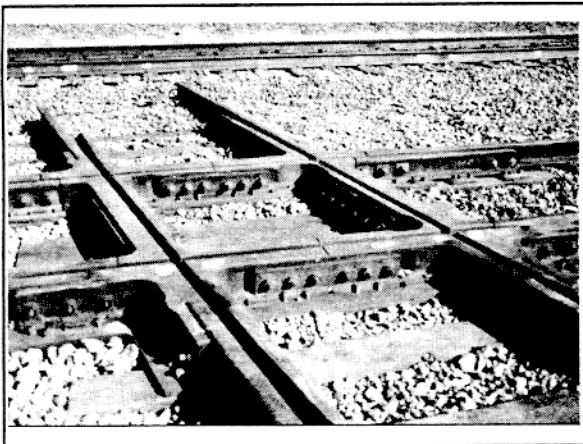
Exhibit 1. 76-Degree Solid Manganese Crossing

A 76-degree solid manganese crossing survived 15.9 million gross tons (MGT) of 315,000-pound heavy axle load (HAL) train traffic at the Facility for Accelerated Service Testing (FAST), Transportation Technology Center, Pueblo, Colorado (Exhibit 1). After 10.8 MGT of traffic, the crossing was removed from track to repair a crack in one of the castings. After the repair, the crossing was reinstalled and withstood an additional 5.1 MGT of HAL traffic. It was removed again due to additional cracks in the same casting. The new cracks were not in the repair welds or the associated heat affected zones.

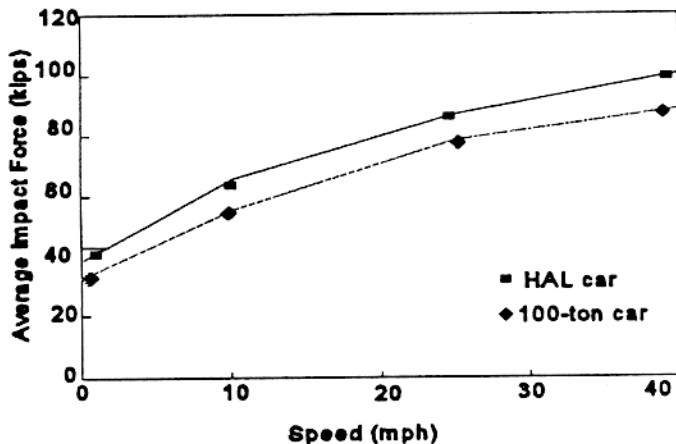
Exhibit 2. Average Impact Forces

Exhibit 2 summarizes the impact force data as measured using instrumented wheel sets. The average impacts under the HAL car are significantly higher than those under the 100-ton car. The impact forces increase with speed through 40 mph. The nonlinear increase may be due to yielding of the casting material. The impact forces produced by a HAL car are roughly equal to those produced by a conventional car at 5 to 10 mph higher speed. At 40 mph, the average impacts are more than 2.5 times the static wheel load for both cars.

Each point on Exhibit 2 represents the average of 32 measured impacts. At zero speed, the static wheel loads are plotted. The maximum impacts measured at 40 mph were 157 kips for the HAL car and 159 kips for the 100-ton car. This data complements measurements reported earlier for a 62-degree crossing. The forces are somewhat higher under the 76-degree crossing, most likely due to the higher crossing angle, which results in a larger effective gap at the flangeways (TD 94-018).

These force measurements were made after 10.9 MGT of traffic passed over the crossing. The corners at the flangeway gaps had just been built up, and batter was minimal. Data was collected at a rate of 512 samples per second and filtered at 200 Hz.

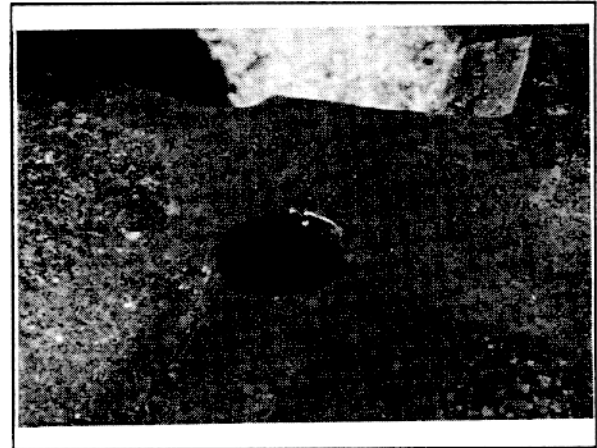
Exhibit 3. Crack in Casting of 76-Degree Crossing

One of the four castings was cracked extensively enough to warrant removal of the crossing for repairs after 10.8 MGT. The crack extended across the full width of the base of the section (Exhibit 3) and up into the vertical

walls of the casting. The crack was visible in the bottom of the flangeways.

Welders from Conrail and Sante Fe volunteered to supervise and assist in the repair. The portion of the crack that was readily accessible from the bottom of the casting was air-arc'd out, then ground into a smooth v-shape. It was decided it would not be cost effective to try to repair the cracks in the interior vertical walls of the casting.
